November 16, 2023
File: Tis23001

Memo: Drainage planning, Tisdale Developments Ltd., Tisdale property, PID 028-270-304.

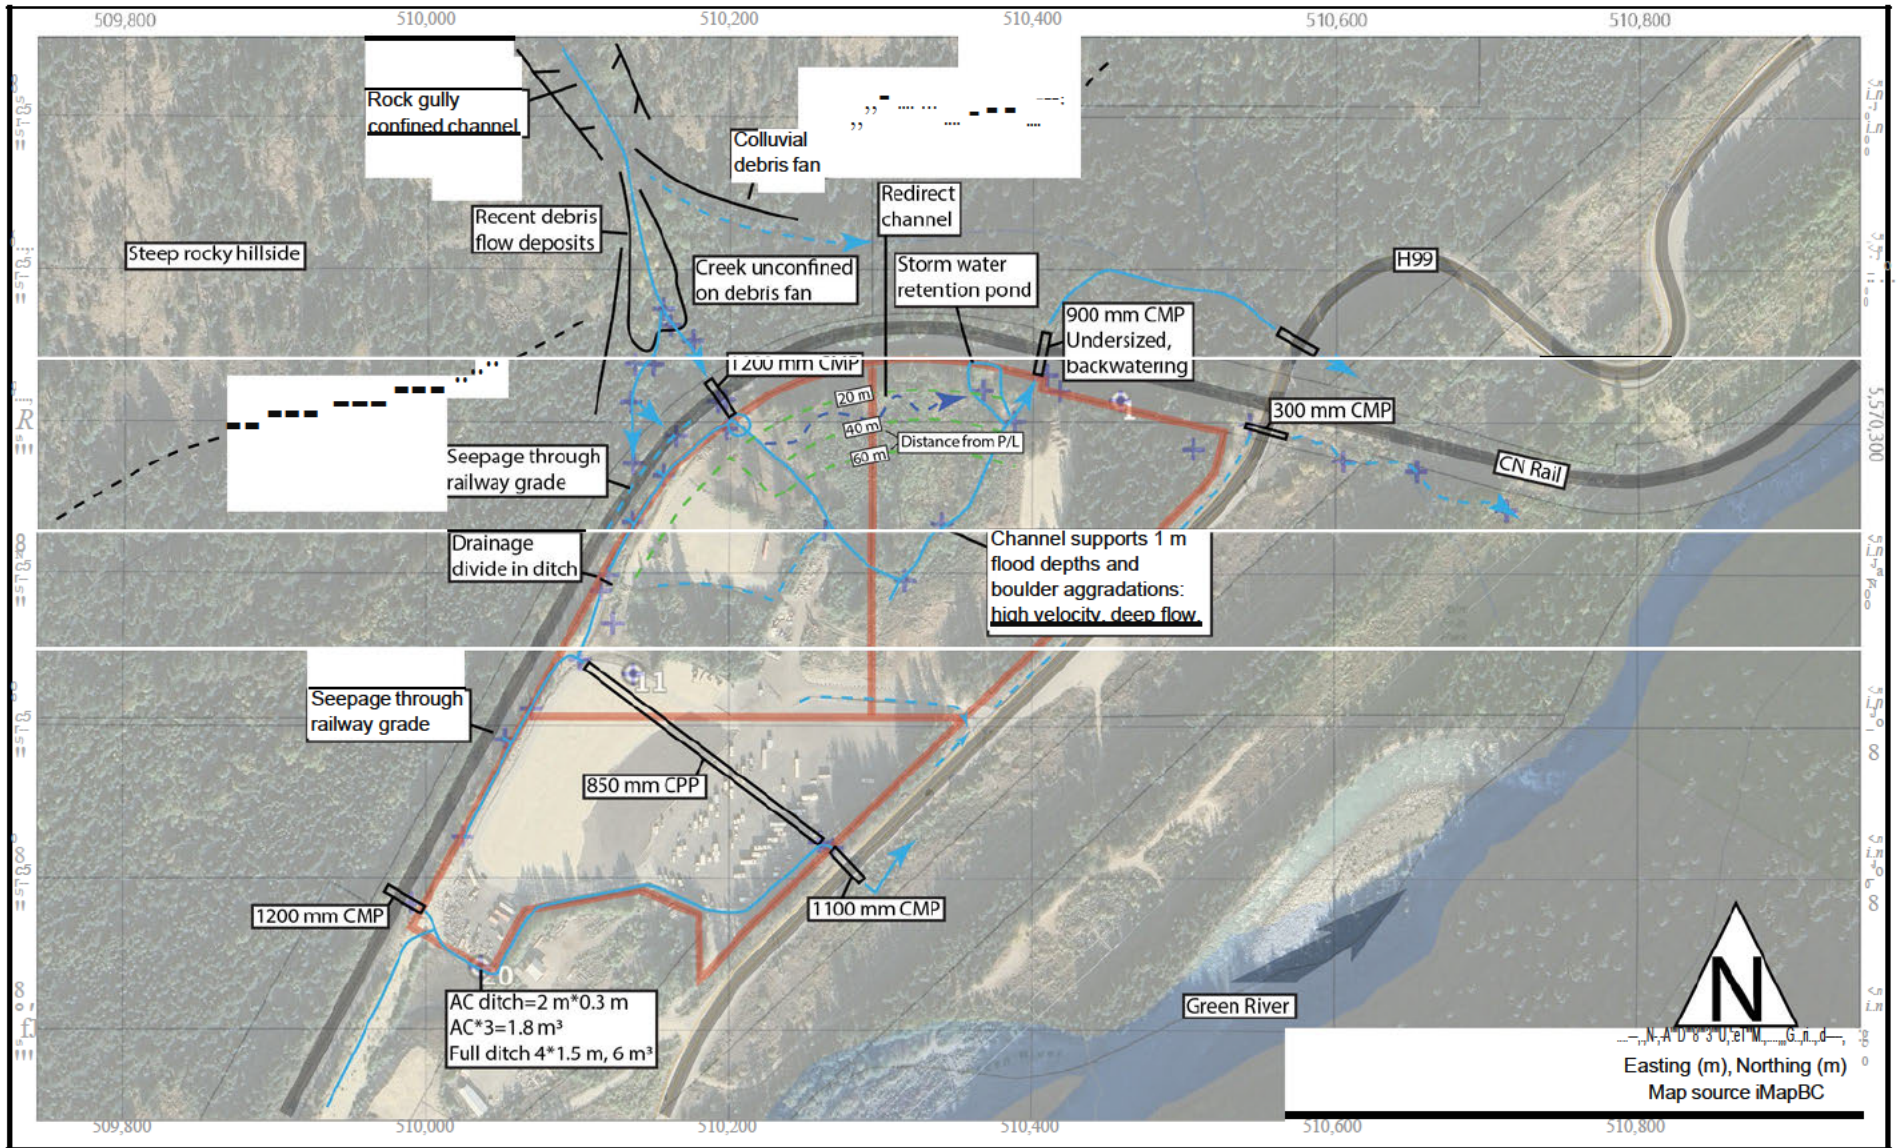
The existing drainage has been mapped by Cordilleran (Figure 1). The surface water inflowing to the site comes from two sources:

Figure 1. Map of the existing drainage conditions on the Tisdale Developments property, located near Pemberton, BC. The red lines delineate individual properties that make up the Tisdale site discussed in the text. Observations were compiled October 13, 2023.

- 1) An 1100 mm diameter culvert under Highway 99, located about 400 m south of the CN rail crossing on Highway 99. This culvert takes all the incoming water from the adjacent property to the south and from the 1200 mm diameter inflow pipe located at the southwest corner of the site. On the south half of the Tisdale site, this water is managed by a south perimeter ditch and by an 850 mm diameter storm sewer pipe buried under the existing open storage area. The outflowing 1100 mm diameter culvert under Highway 99 has had no reported issues to date.

- 2) A 900 mm diameter culvert through the CN rail grade located ~150 west of the CN rail crossing on Highway 99. This culvert takes the water from seepage through the CN Rail berm and from the 1200 mm diameter culvert conveying the hillslope creek. The outflowing 900 mm diameter culvert was almost fully plugged by debris before the December 2015 flooding incident, but has since been cleaned by Tisdale Developments. However, it continues to backwater streamflow during heavy runoff events, requiring Tisdale Developments to accommodate backwatering by construction of an ephemeral pond that fills and drains slowly after the passage of the rainfall peak. This system appears to be functioning well.

The drainage conditions on the south half of the property appear to be functioning adequately. However, it is apparent that on the north half of the property, the capacity of the 1200 mm diameter culvert conveying water onto the property is larger than the capacity of 900 mm diameter culvert conveying water off the property. That situation is out of the control of Tisdale Developments, as the inflow and outflow culverts are the responsibility of CN Rail. Assuming CN Rail will be leaving the culverts as is, then the existing inflow/outflow situation must be accommodated as is. The situation will be monitored after CN have completed their work within their right-of-way.

With respect to the existing path of the channel on the north half of the property between the 1200 mm diameter inflow and the 900 mm diameter outflow, it is evident that the channel was artificially created by machine excavation at some time in the past; it flows in a straight line ~200 m southwest to a 90 degree bend, and then ~200 m northwest to the 900 mm diameter outflow culvert. This configuration is not optimal for best use of the site, and it is not optimal from a habitat perspective as the southern riparian area is degraded by clearing and development. Also, if the creek were to remain in this position, then future maximization of land for development would require crossing the creek to access the remainder within the north side of the right-angle jog. This land contains the only mature vegetation on the property and would be partially cleared.

In Cordilleran's opinion, the best future drainage arrangement would be to realign the creek that crosses the north half of the property such that it follows a course through the remaining mature vegetation. This realigned course could be reconstructed to mimic a wandering natural stream planform, and could be done with minimal impact to the natural mature vegetation onsite, so as to provide a mature riparian condition and provide more shading for fish habitat.
