**GEOTECHNICAL ASSESSMENT
Residential Development
Pemberton Benchlands, Pemberton, BC**

Document Type: Issued for Review

Date: February 26, 2020

Project No.: **K-191204-00**

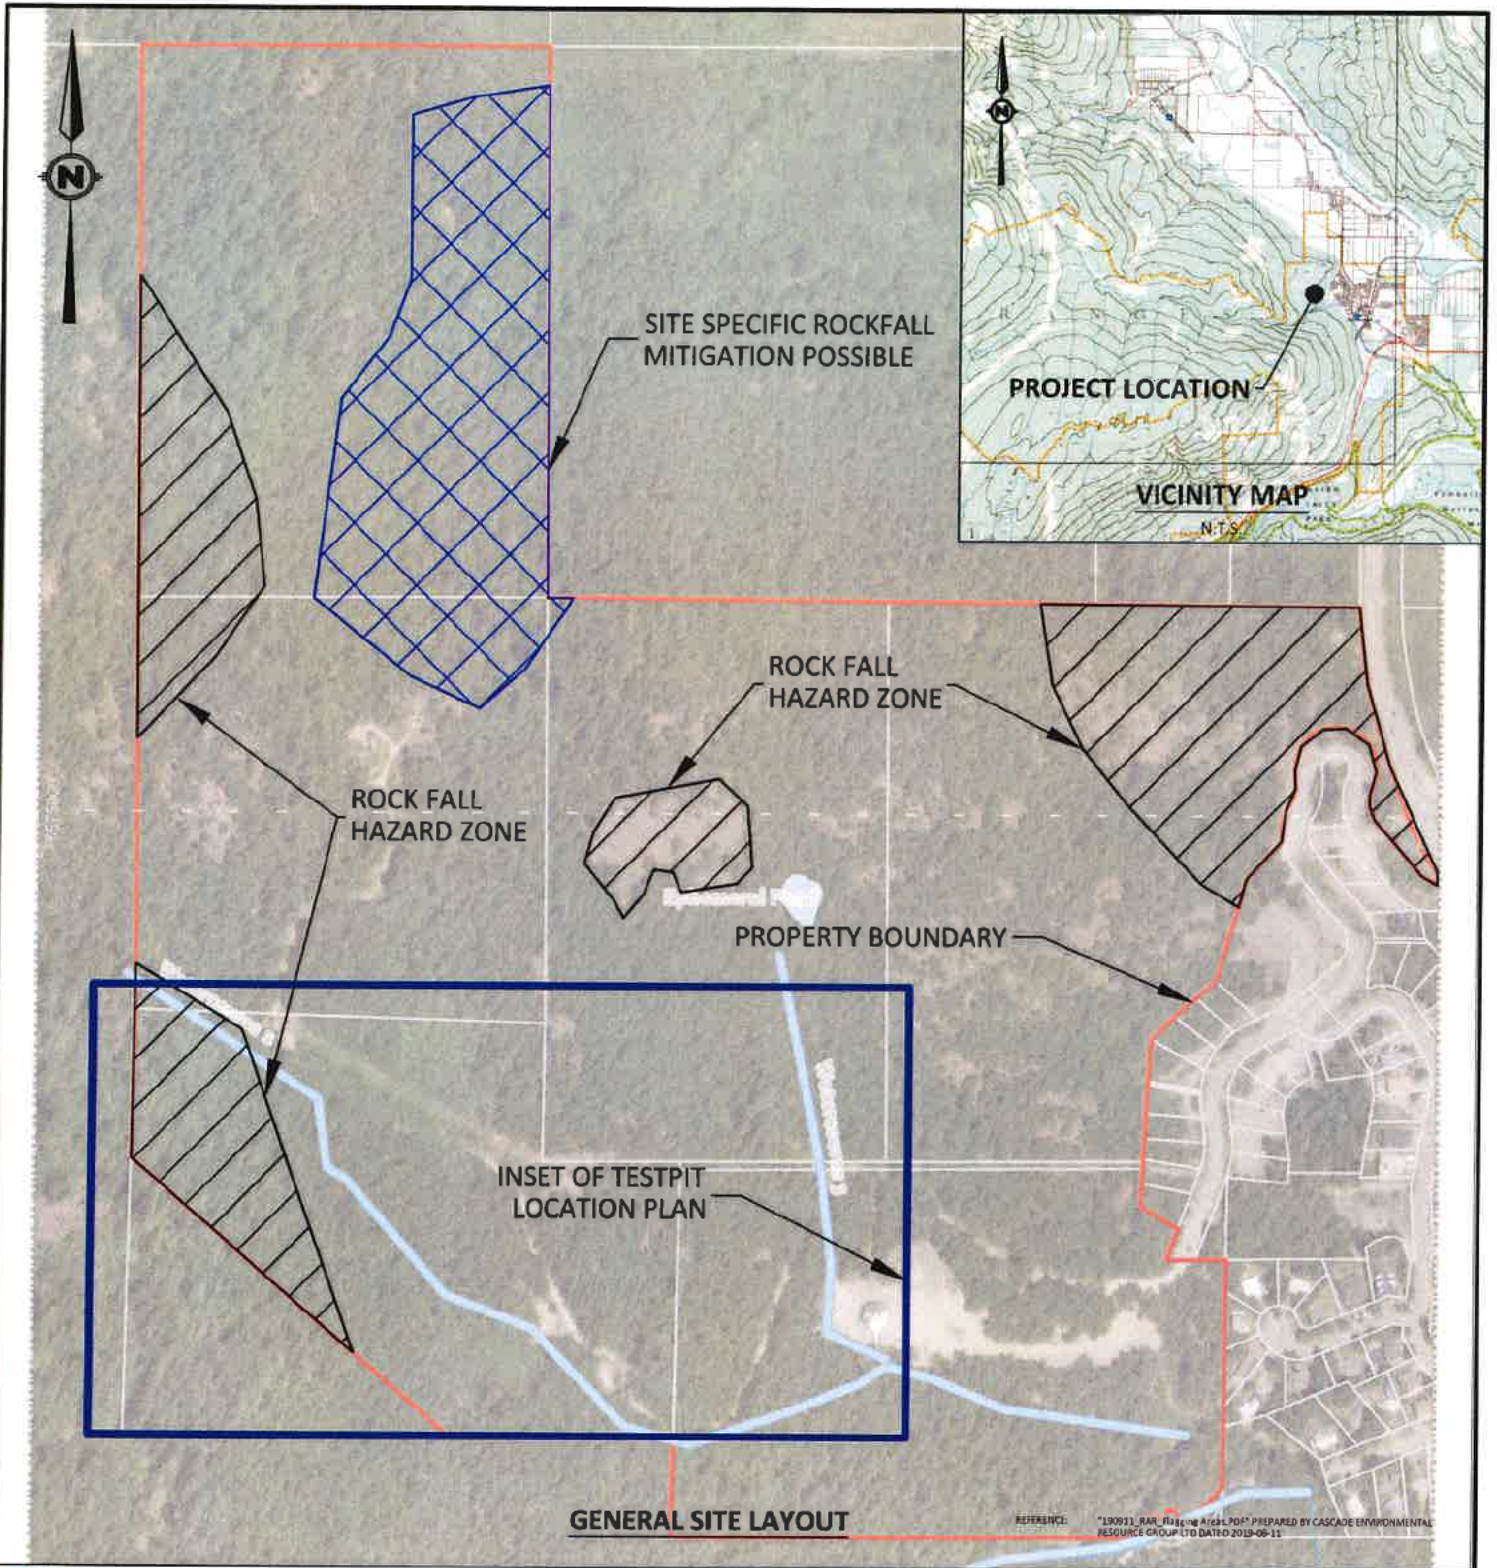
TITLE ROCKFALL HAZARD AREAS	DATE: 2019-10-23		PROJECT NO.: K-191204-00
	SCALE: 1:5500		DWG NO.: FIGURE 1
CLIENT SKENKENAM DEVELOPMENTS INC.	NO.	REVISIONS	DATE
	0	ISSUED FOR REPORT	2020-02-21
PROJECT PROPOSED BENCHLANDS DEVELOPMENT PEMBERTON, B.C.	DRAFT: JL		DESIGN: -
			CHECK: EGS

Based on review of aerial photographs, the talus deposits located in the area of the southwestern property originate from very steep bedrock bluffs up to about 500m above the elevation of the property. Field observations of loose isolated boulders originating from the same source were noted up to about 75m from the western property boundary at the north end to about 175m along the diagonal boundary in the southwest corner of the property.

Loose boulders were noted in the area of bedrock bluffs located in the northeastern portion of the property. Rockfall mitigation of the existing Eagle Drive below some of these bluffs consists of rock anchoring and a rockfall fence. Similar bluffs exist throughout this area and extensive on-slope or catchment structures would be required to reduce the potential hazard to very low.

Isolated, localized talus/ colluvium deposits located on the eastern side of the northern portion of the property were generally limited in extent from the source bluffs. This area is identified on the attached site plan in blue hatch. It is considered that the potential hazard from rockfall in this area could be reduced to very low with on-slope and/or catchment structures (fencing/ ditches and berm). Development in this area should be reviewed by a Geotechnical Engineers on a site specific basis.

Recommended setbacks to mitigate the rockfall hazards presented for bedrock bluffs are shown on the attached Site Plan. Setbacks for southwestern, western and central talus deposits and the rockfall area on the eastern portion of the property are identified with black hatching and proposed development should avoid these areas. Implementation of rockfall barriers of other mitigative measures is considered to be economically prohibitive.

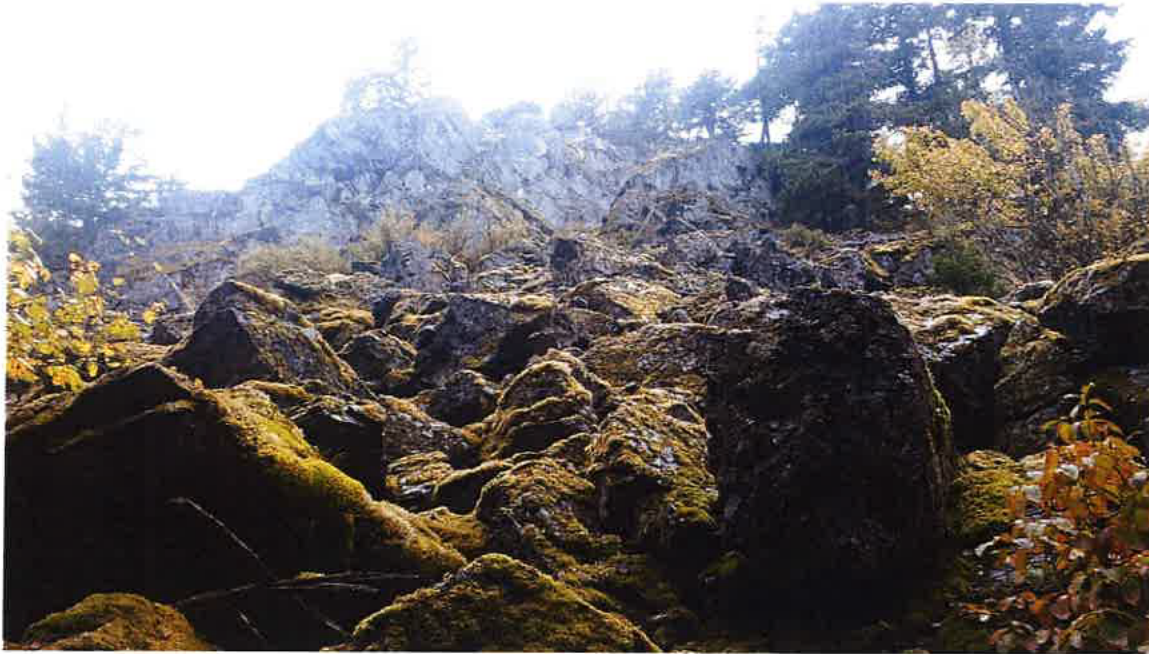
Photograph 1 – Talus Deposit, Large Boulders - P1

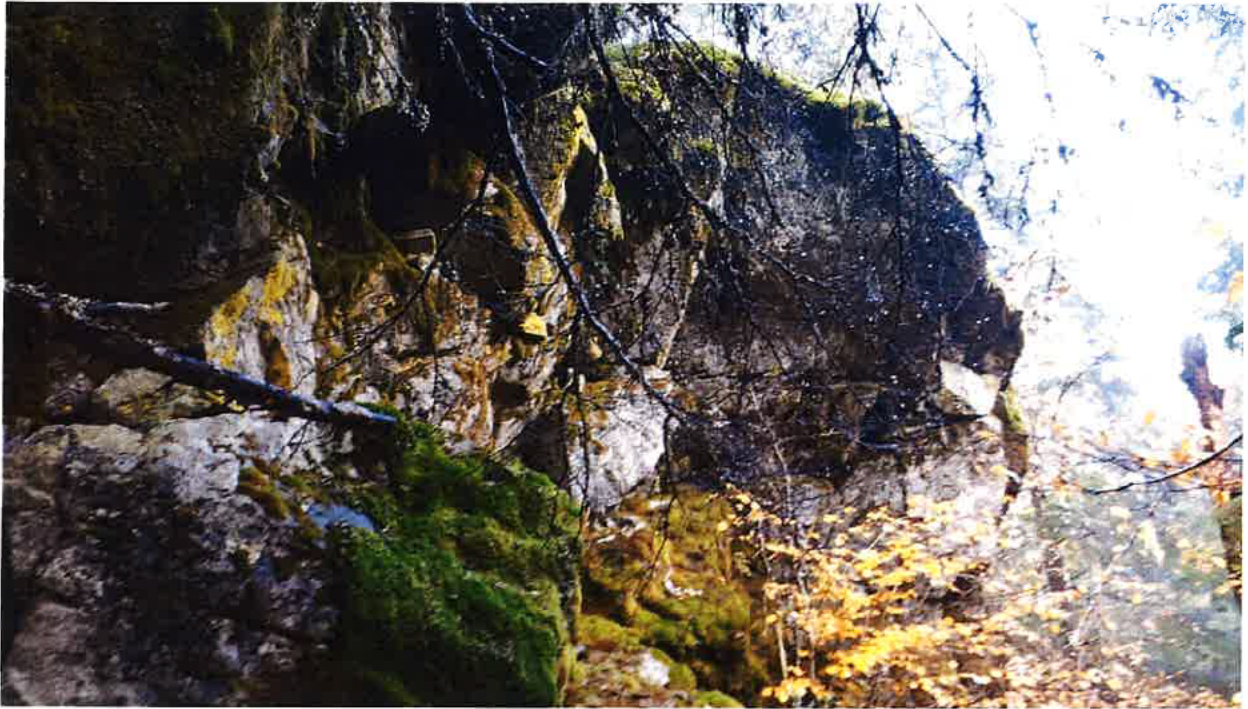
Photograph 3 – Overhanging Bluff, Rockfall Source– P3

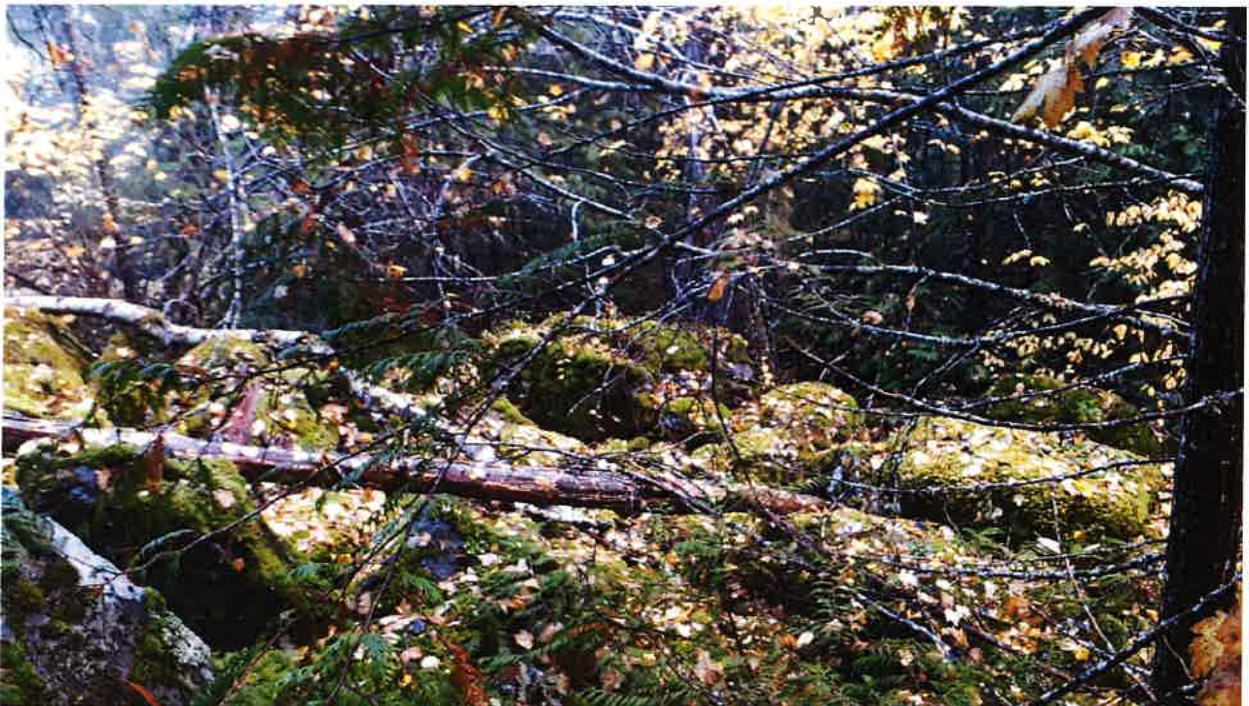
Photograph 4 – Talus Deposit – P4

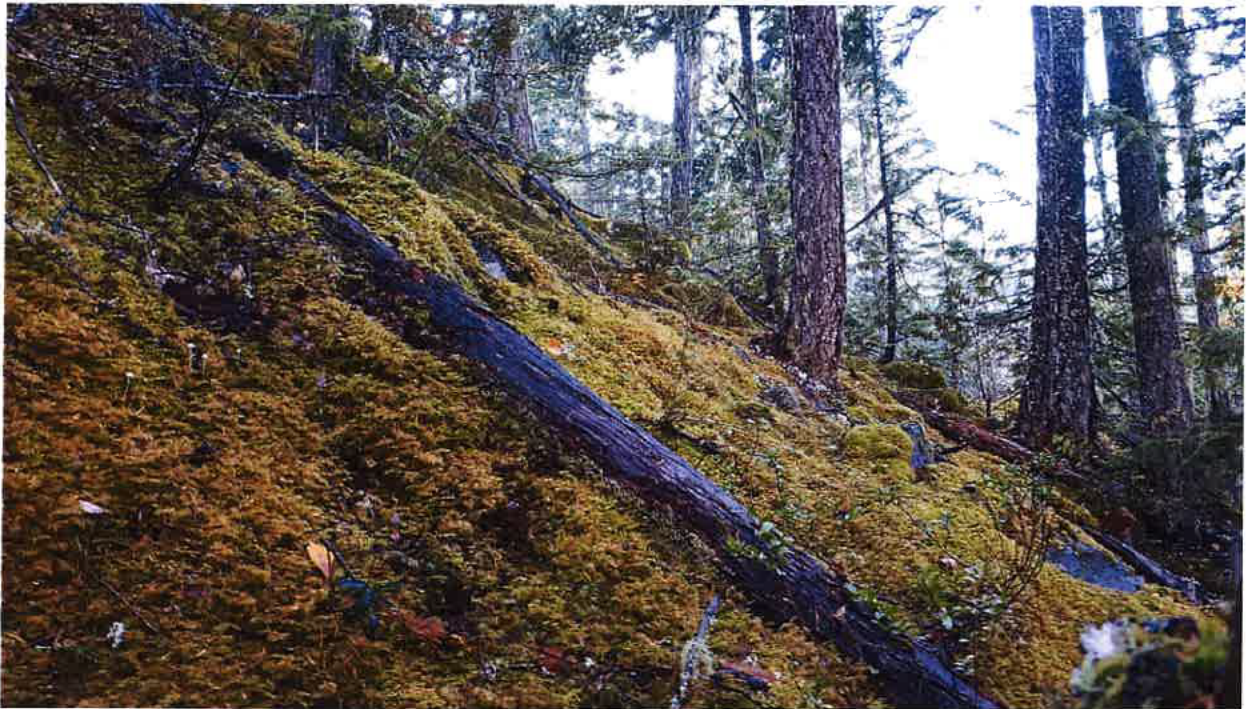
Photograph 5 – Moss Covered Talus Slope – P5

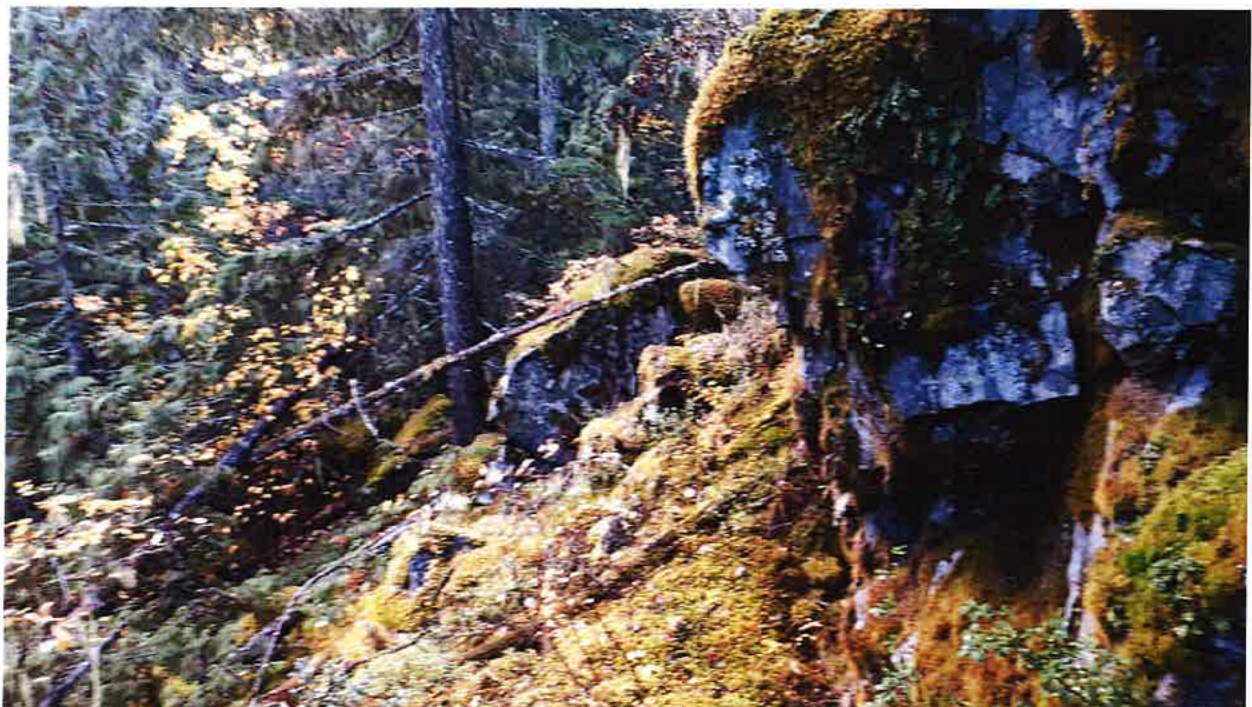
Photograph 6 – Bedrock Bluff, Talus Source – P5

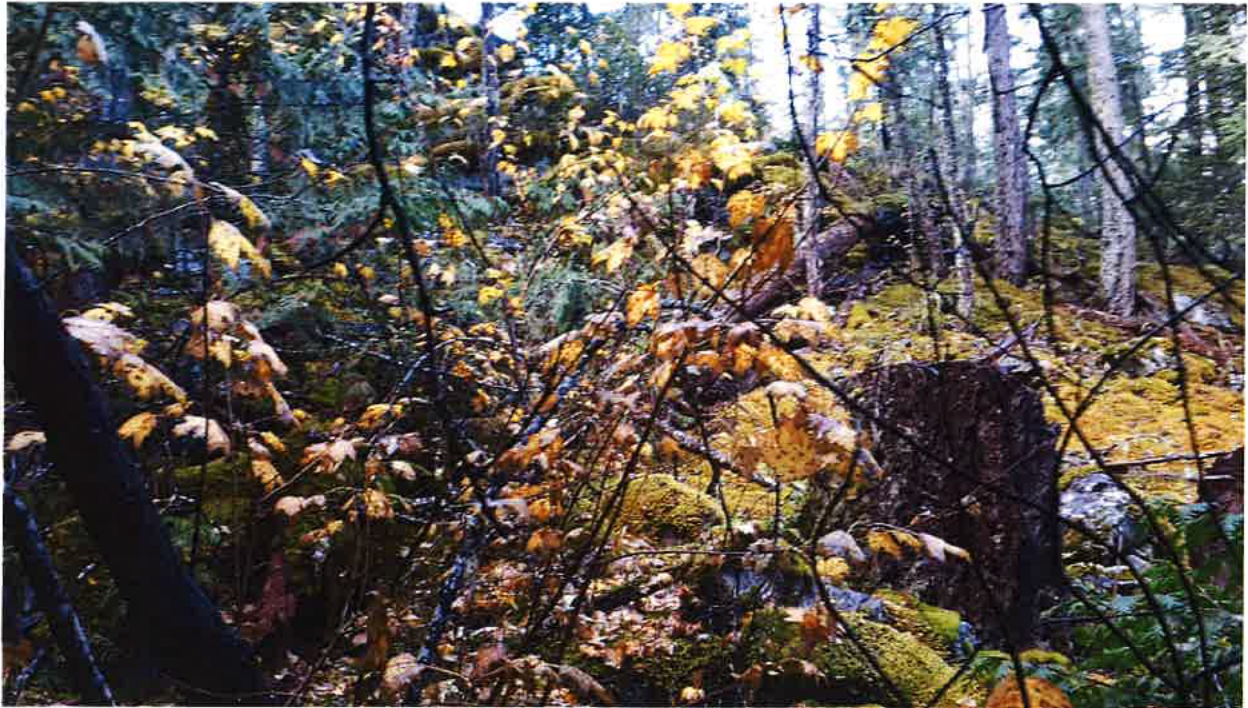
Photograph 7 – Mossy Talus Slope – P7

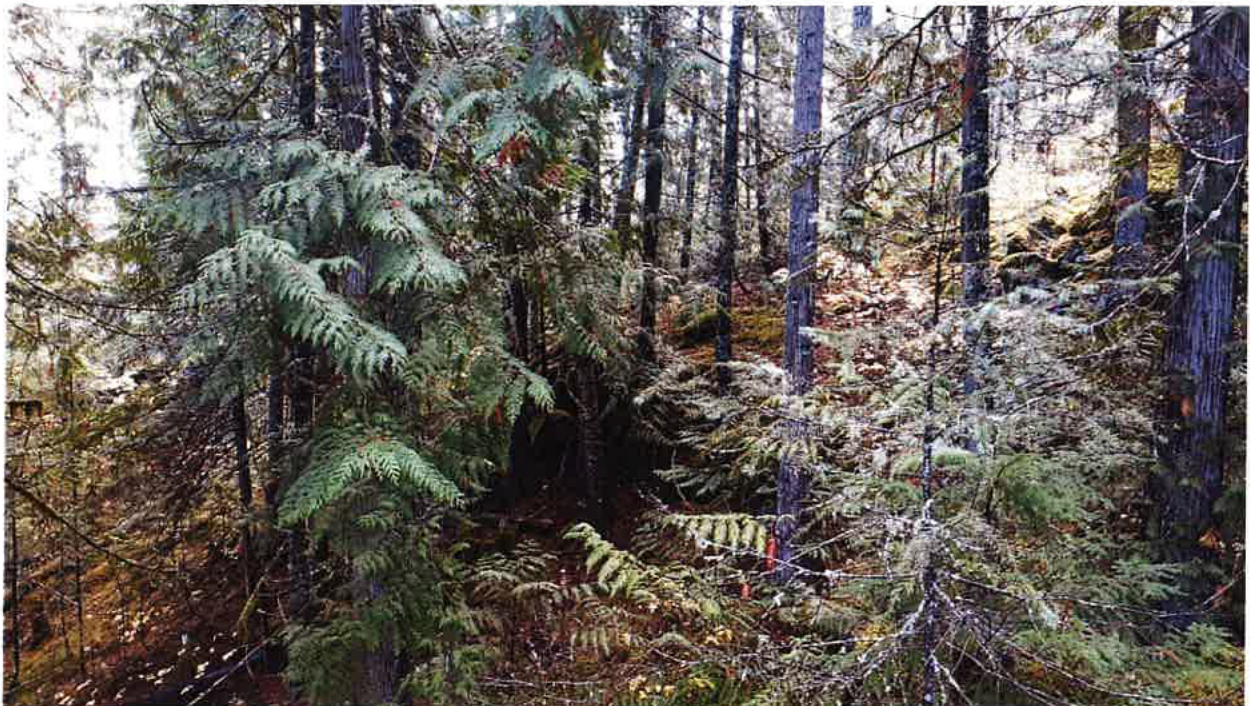
Photograph 8 – Mossy Talus Slope – P7

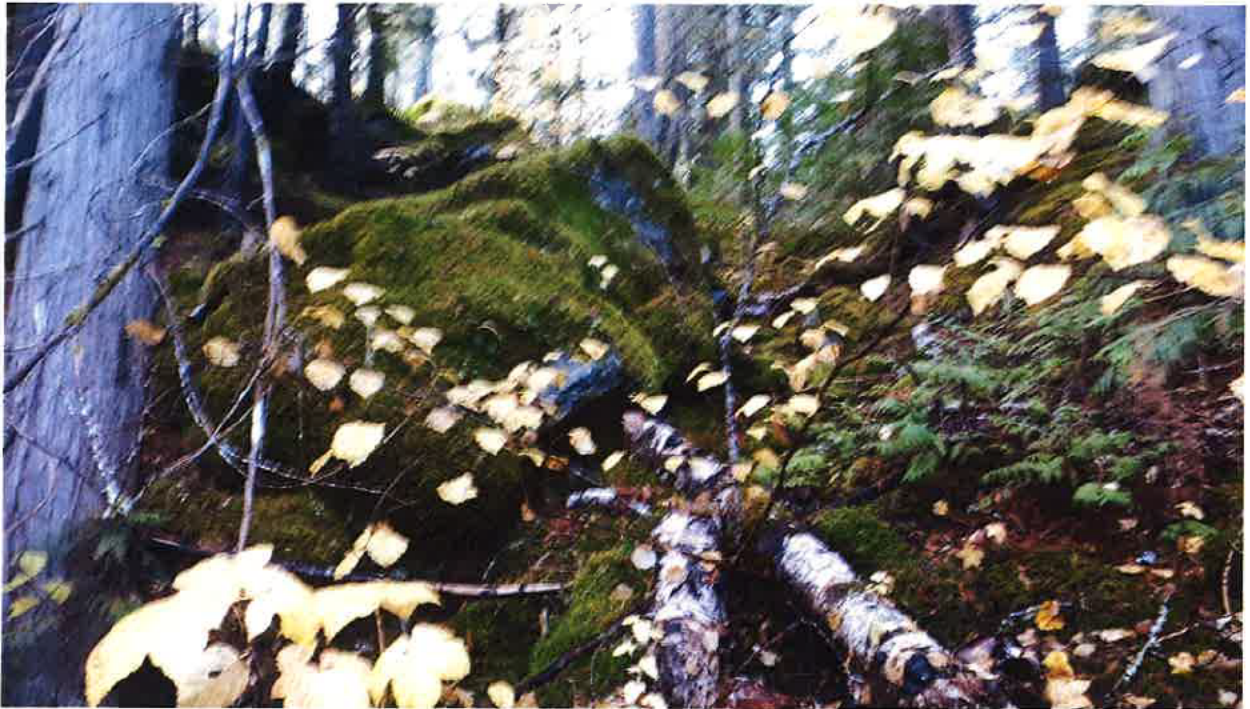
Photograph 9 – Loose Boulders – P8

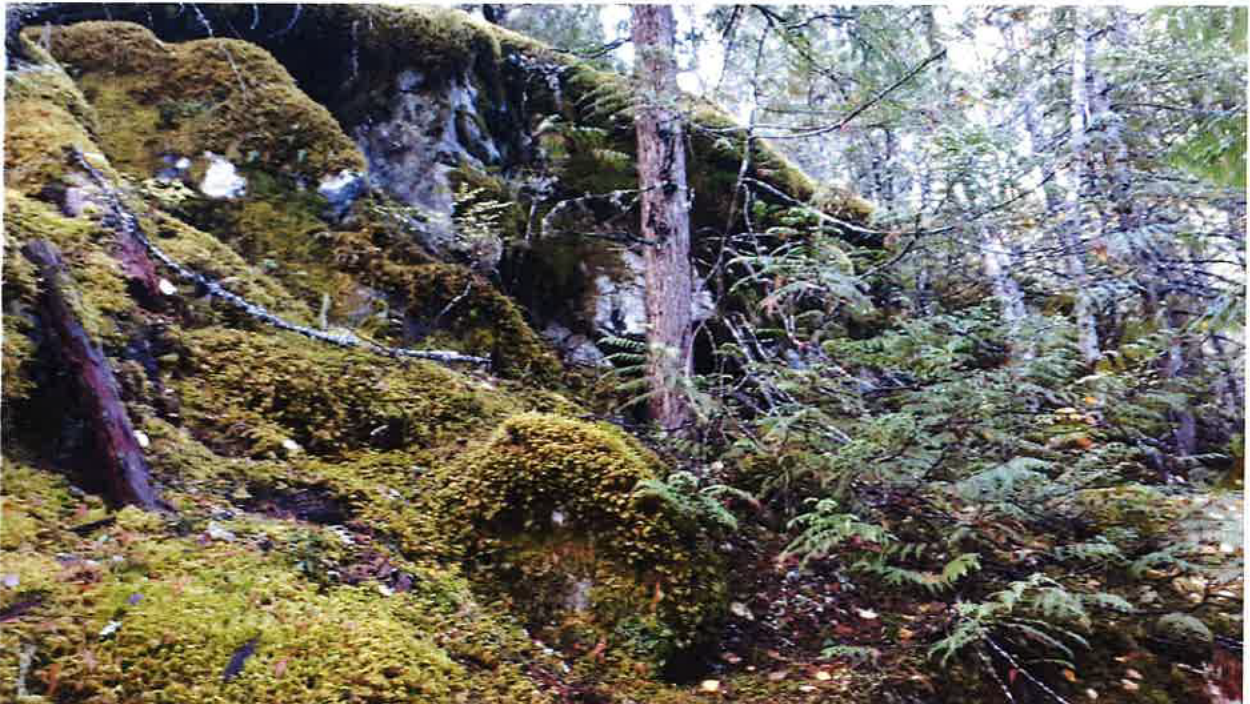
Photograph 12 – Bedrock Bluff Rockfall Source – P11

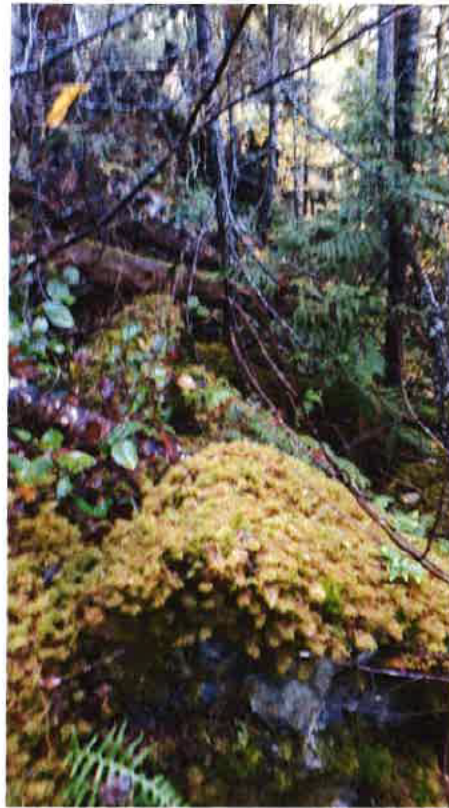
Photograph 13 – Large Loose Boulders – P13

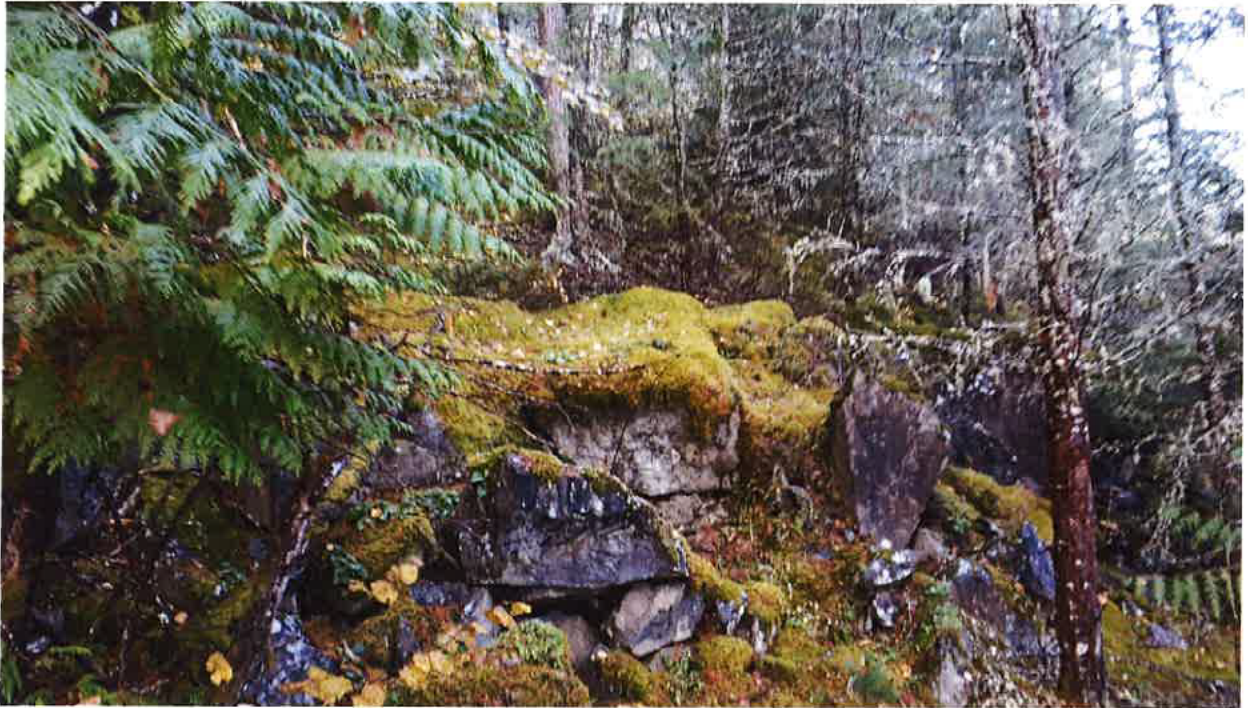
Photograph 15 – Loose Boulders Above Lower Access Road – P15

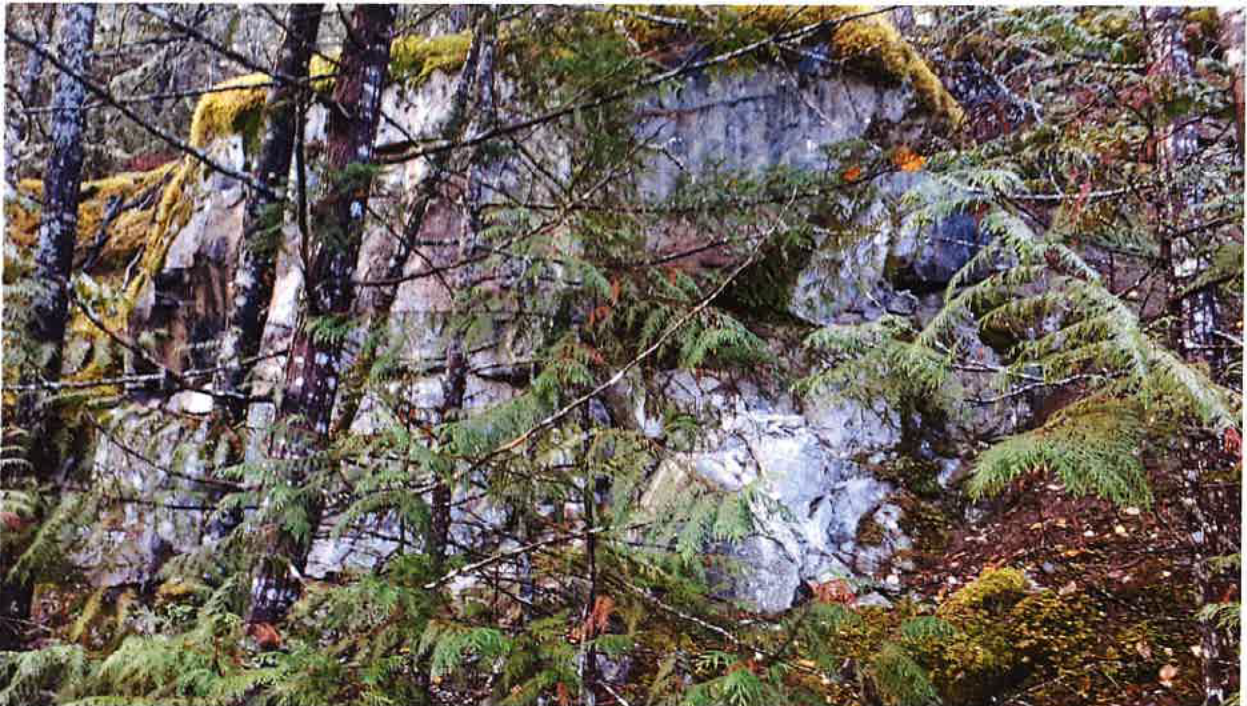
Photograph 16 – Bedrock Bluff Lower Access Road – P16

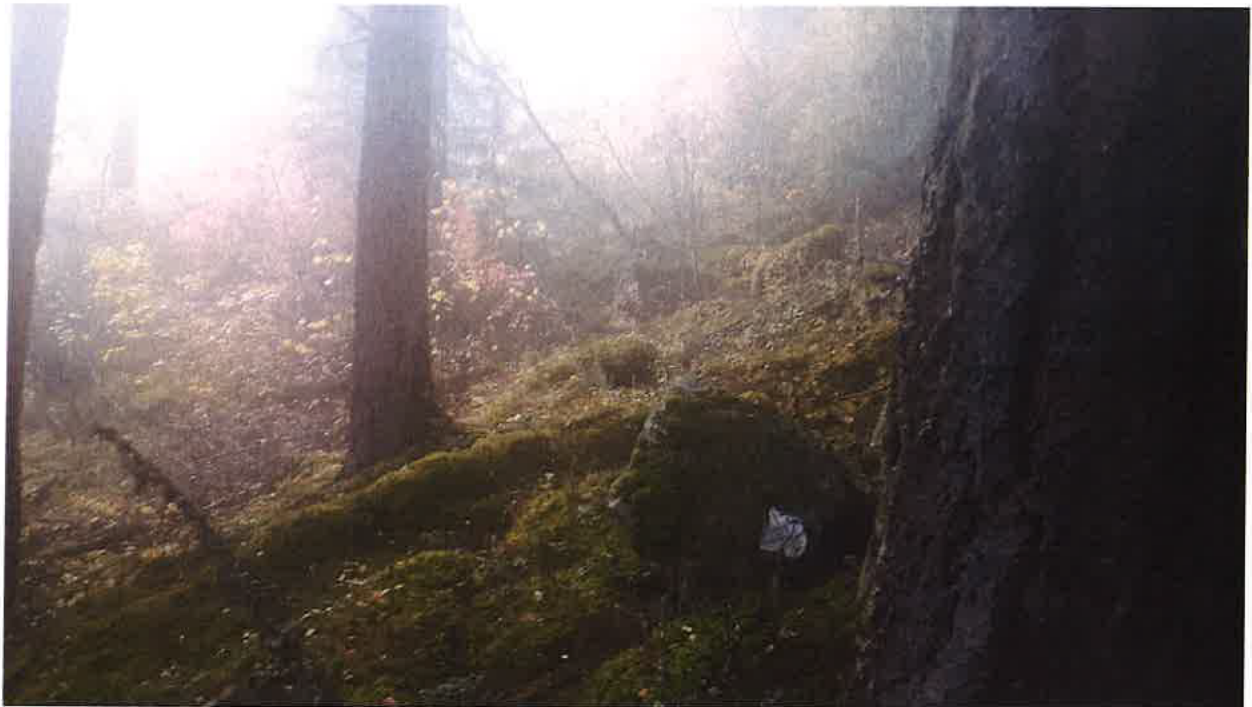
Photograph 20 – Loose Boulders – P26

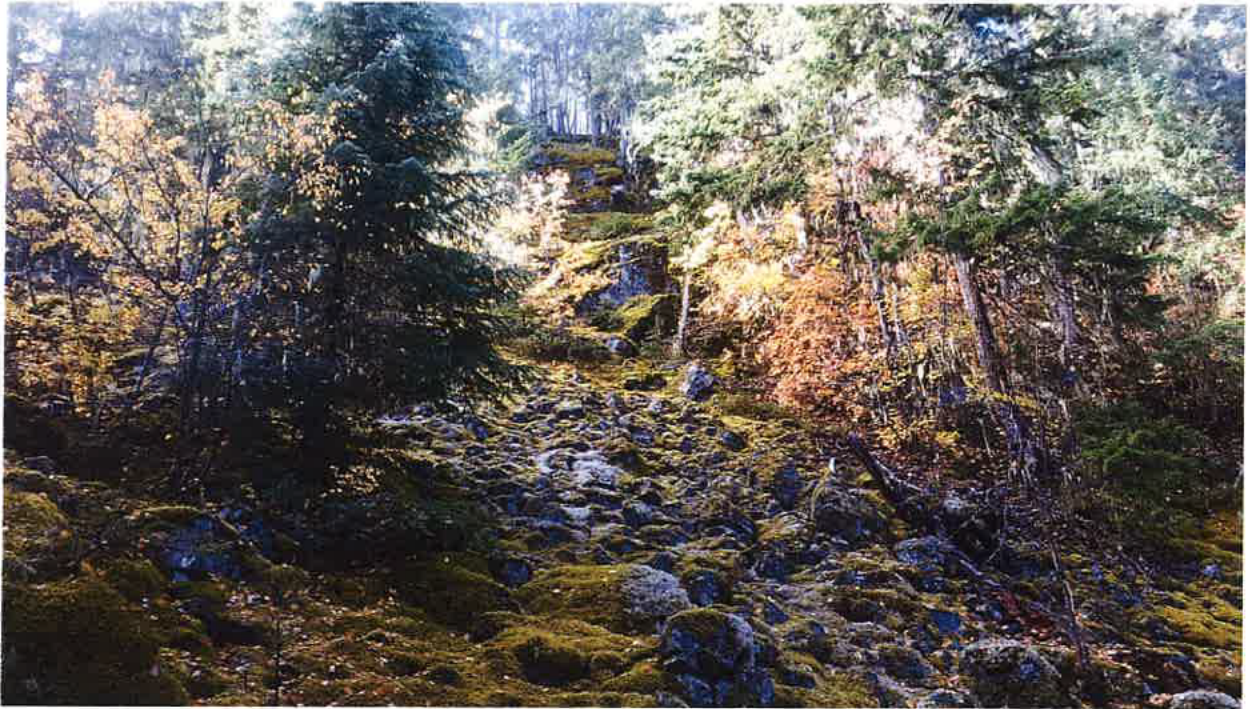
Photograph 21 – Talus Deposit – P27

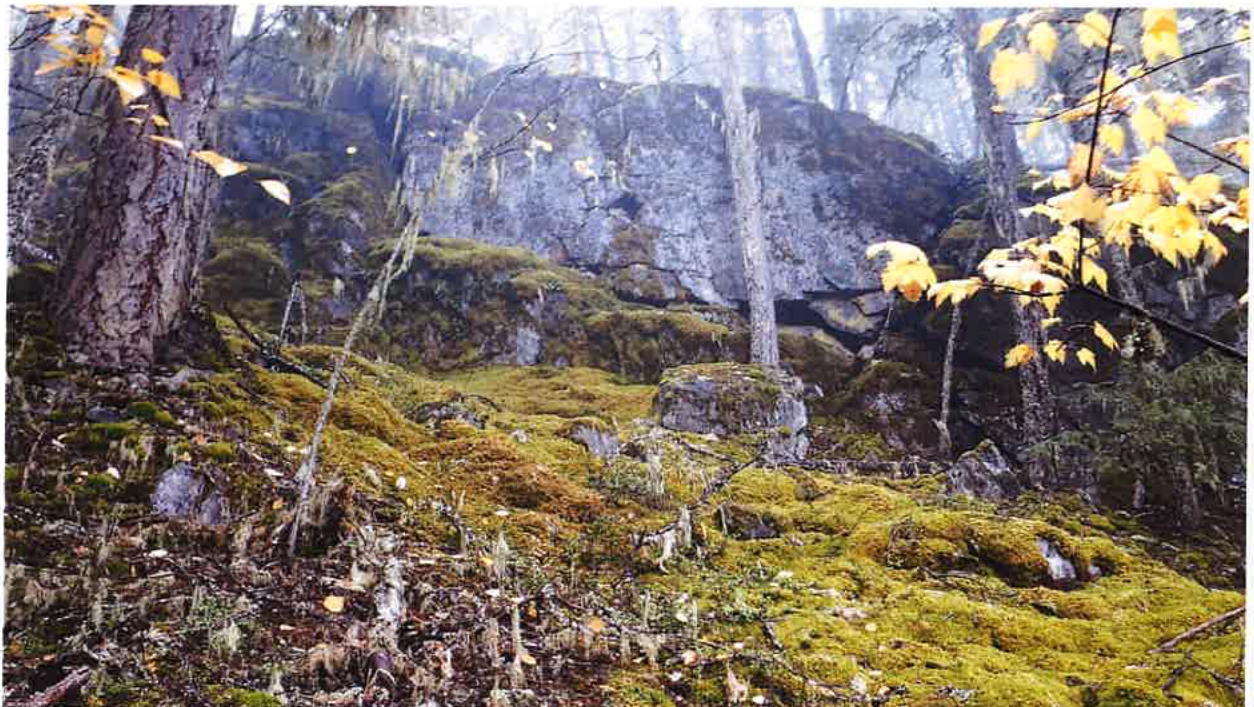
Photograph 22 – Bedrock Bluff, Talus Source – P27

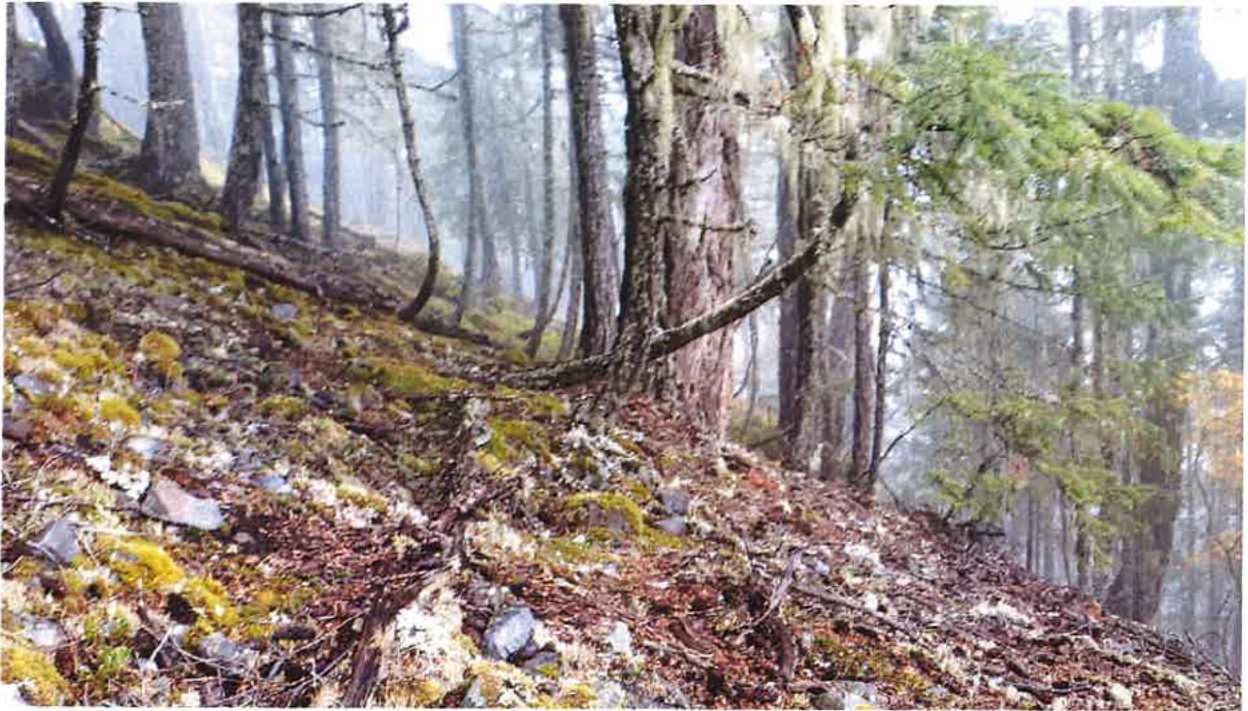
Photograph 23 – Bedrock with some Broken Rock on Slope Below Ridge – P28

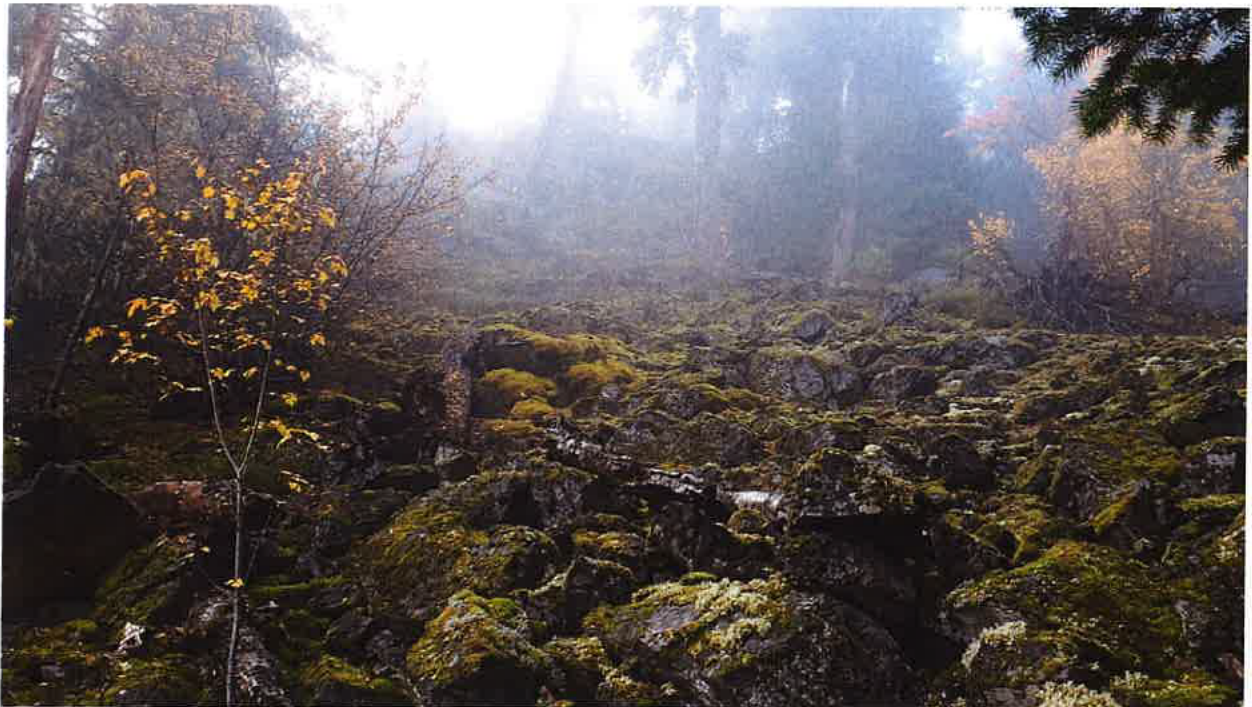
Photograph 24 – Talus Slope Below Ridge – P28

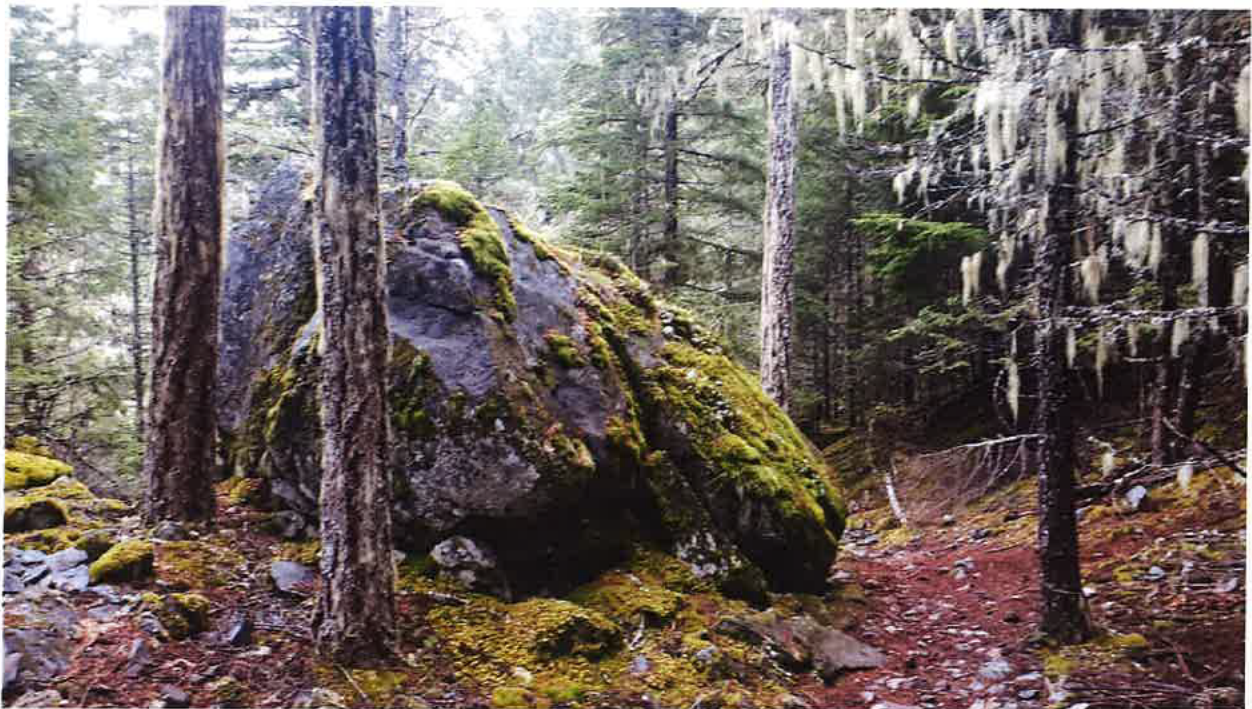
Photograph 26 – Large Boulder – P23

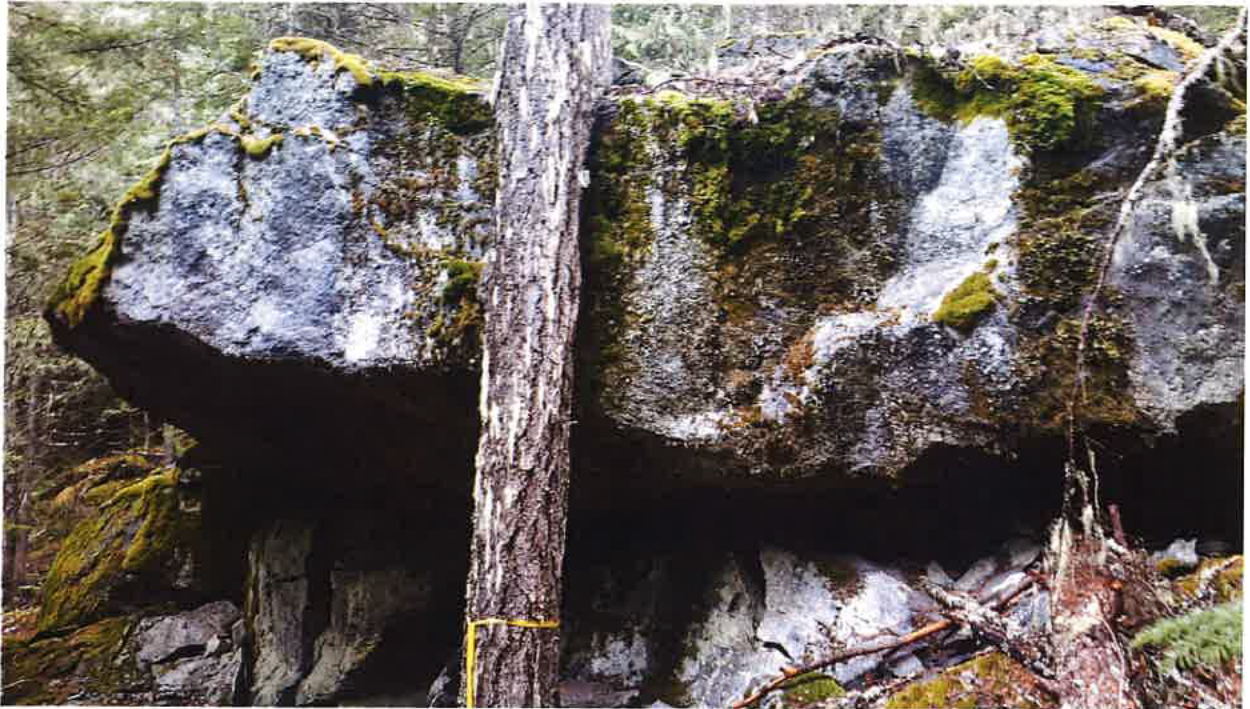
Photograph 27 – Large Boulder – P22

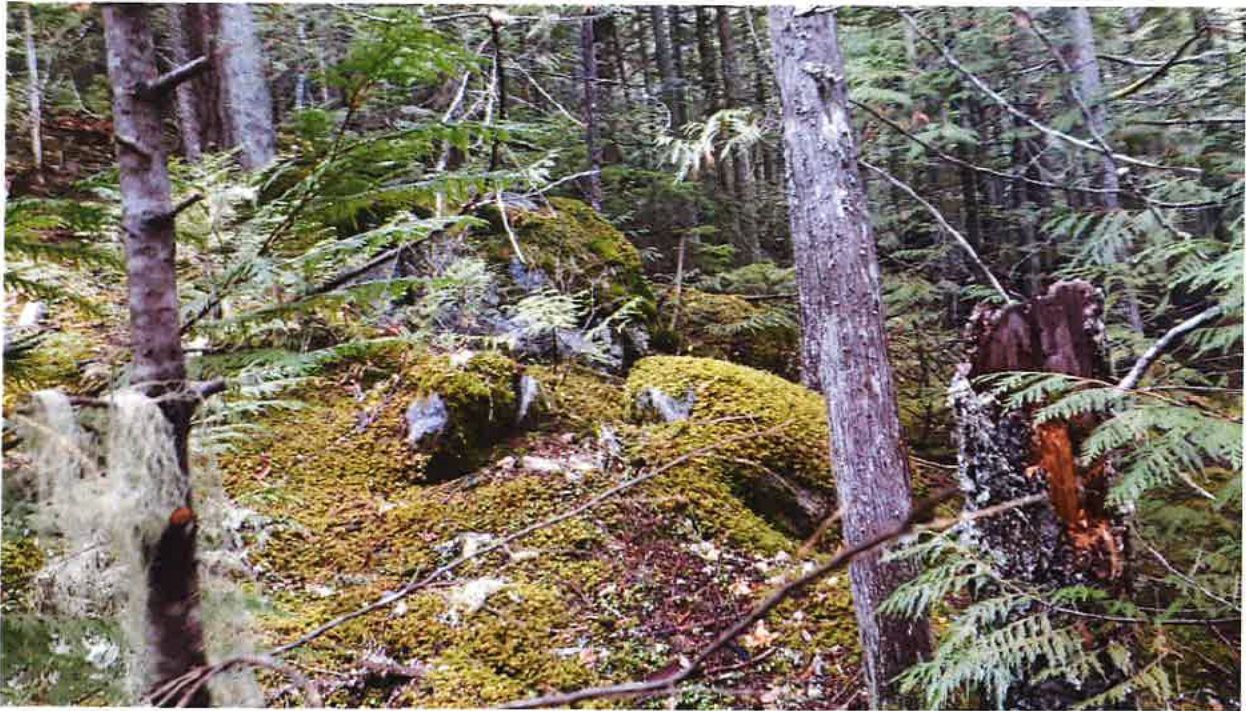
Photograph 29 – South End of Bounder Field Looking North – P24
