TREE MANAGEMENT PLAN

LOT 2 HARROW RD.
PEMBERTON, BC

CPA DEVELOPMENT
CONSULTANTS

Version 2.0

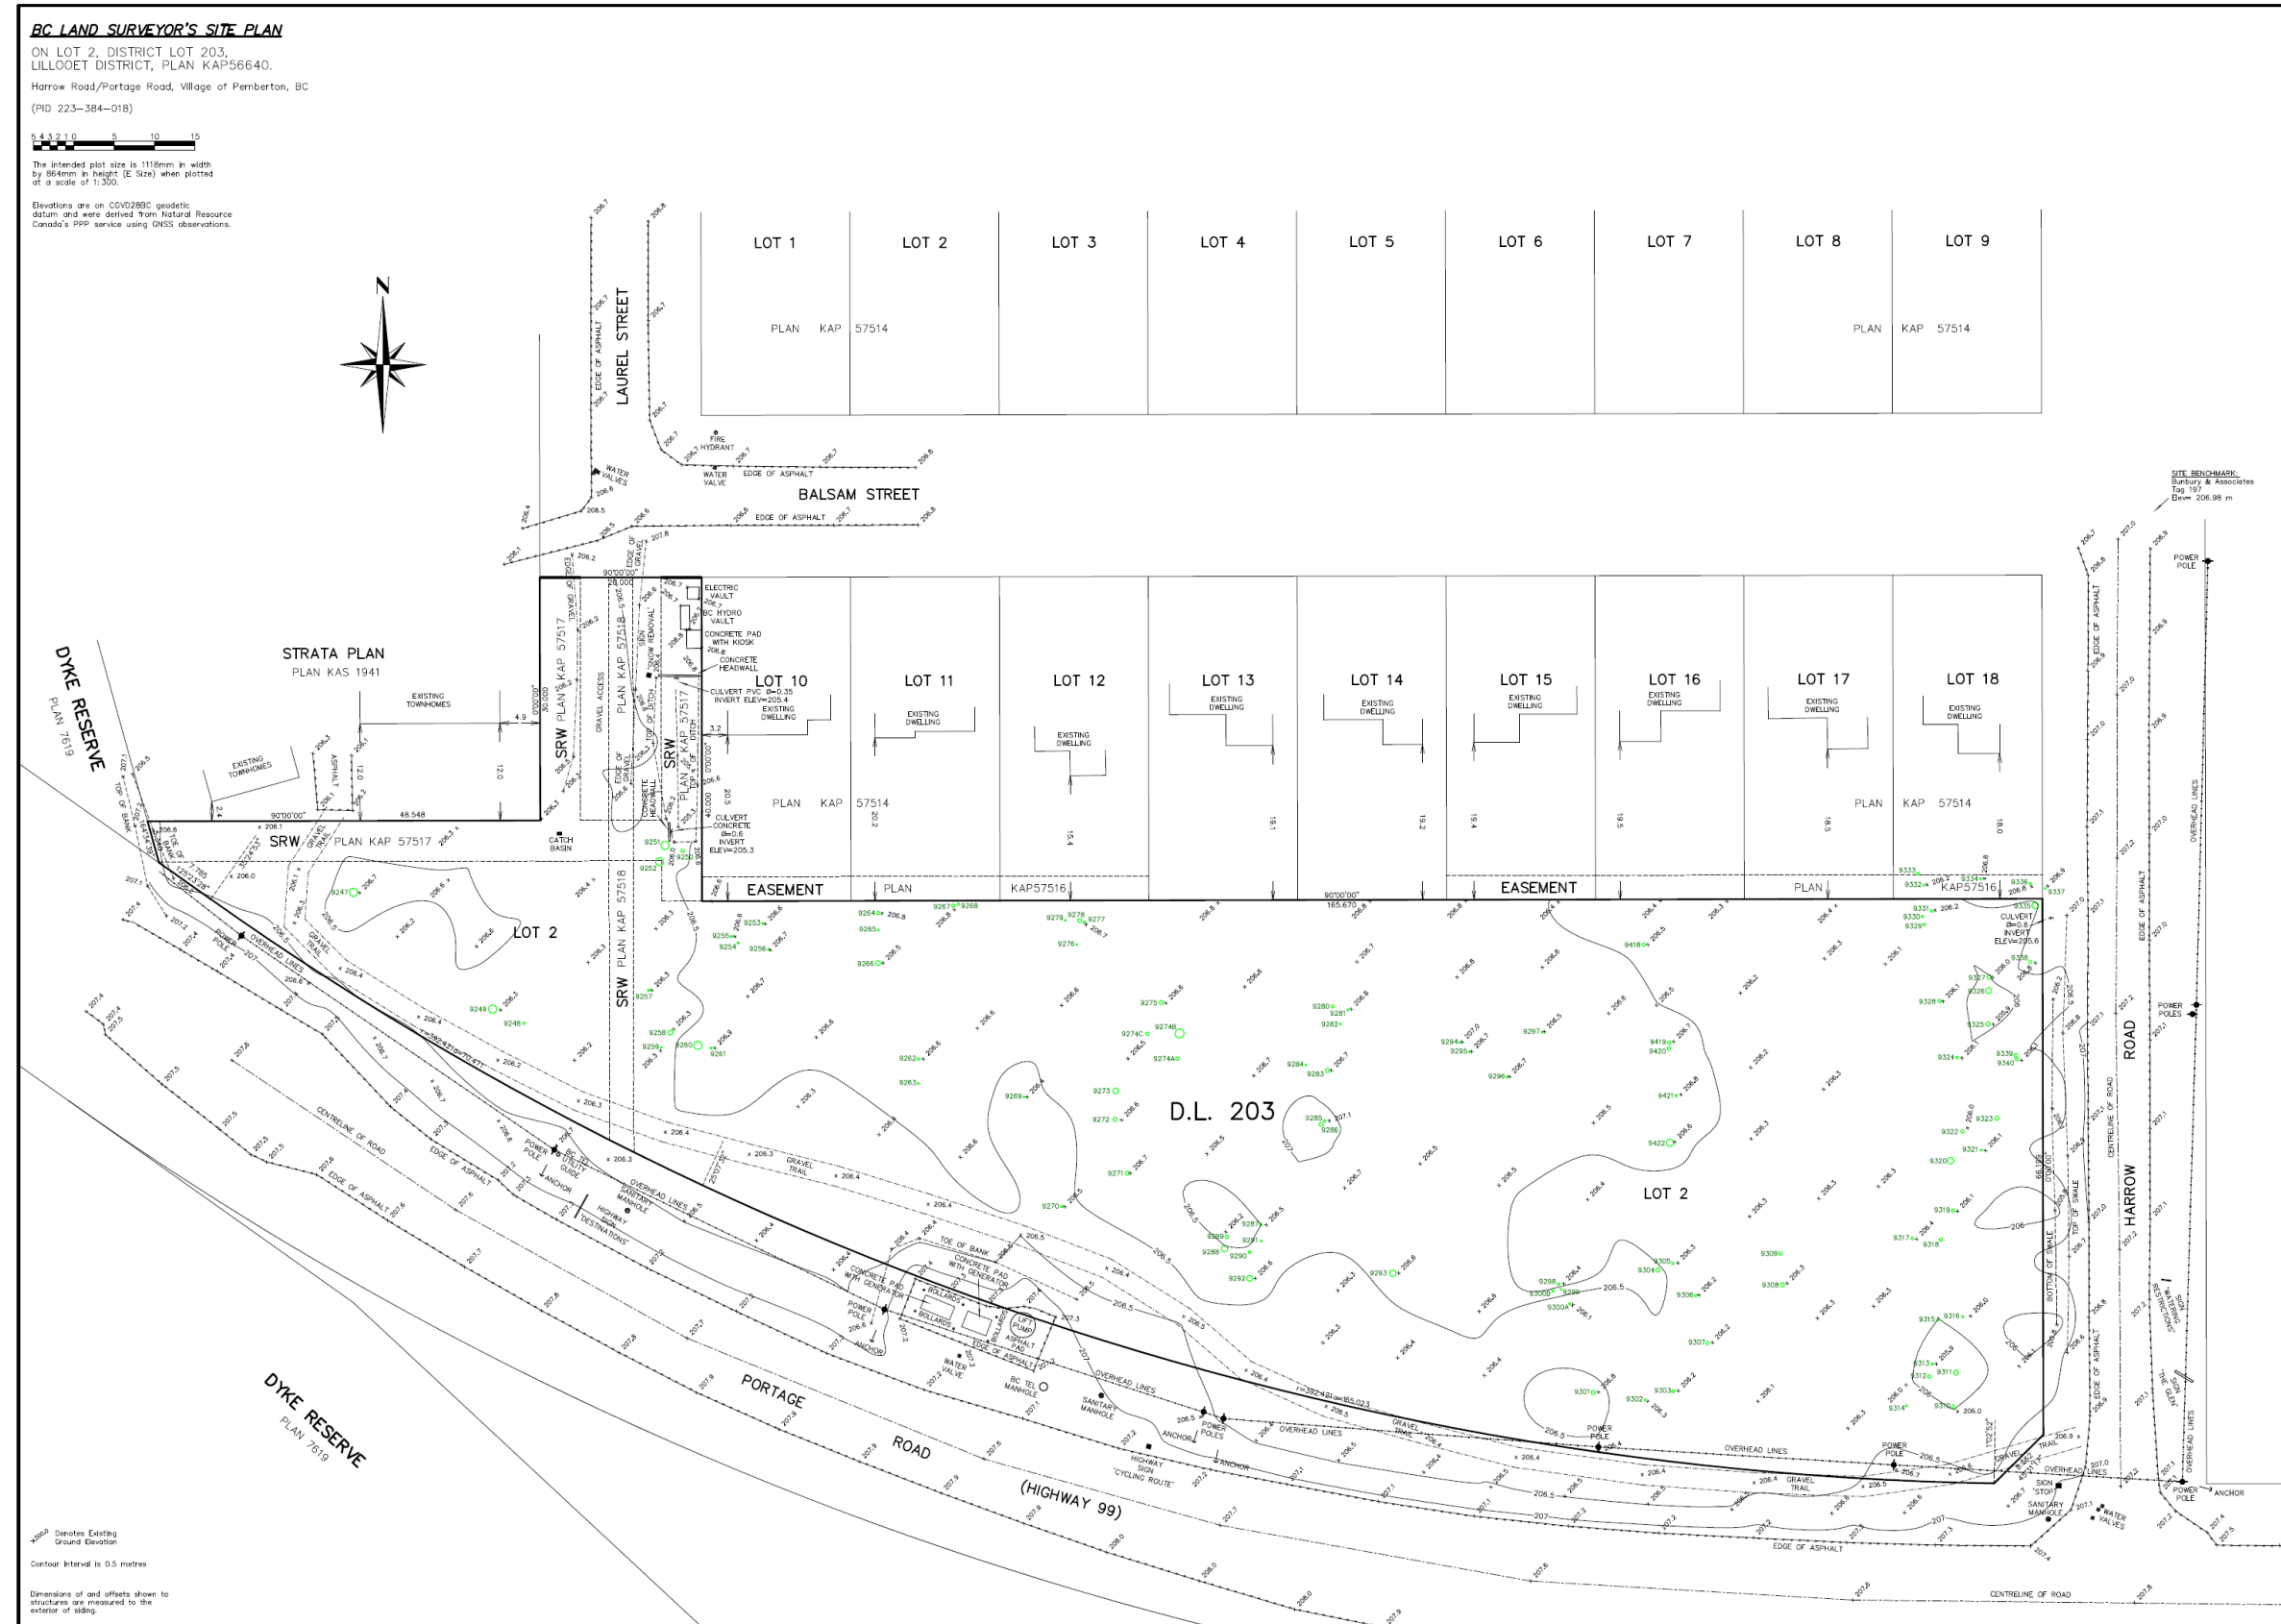
Figure 2. Site survey at Lot 2 Harrow Rd., Pemberton B.C.

The site survey is described in Figure 2 that includes identified trees highlighted in green. The proposed development will have 63 housing units for community members and ground floor commercial space and community services. Associated parking and playground area are also proposed (Figure 3).

The survey (Figure 2) identified four trees located on the neighbouring northwestern property, 1490 Balsam Street (Table 1). The trees are identified as 9333, 9332, 9334, and 9336 (Figure 4). All trees with the exception of 9332 are in fair condition. The trees are adjacent to the development where the proposed carpark is to be built.

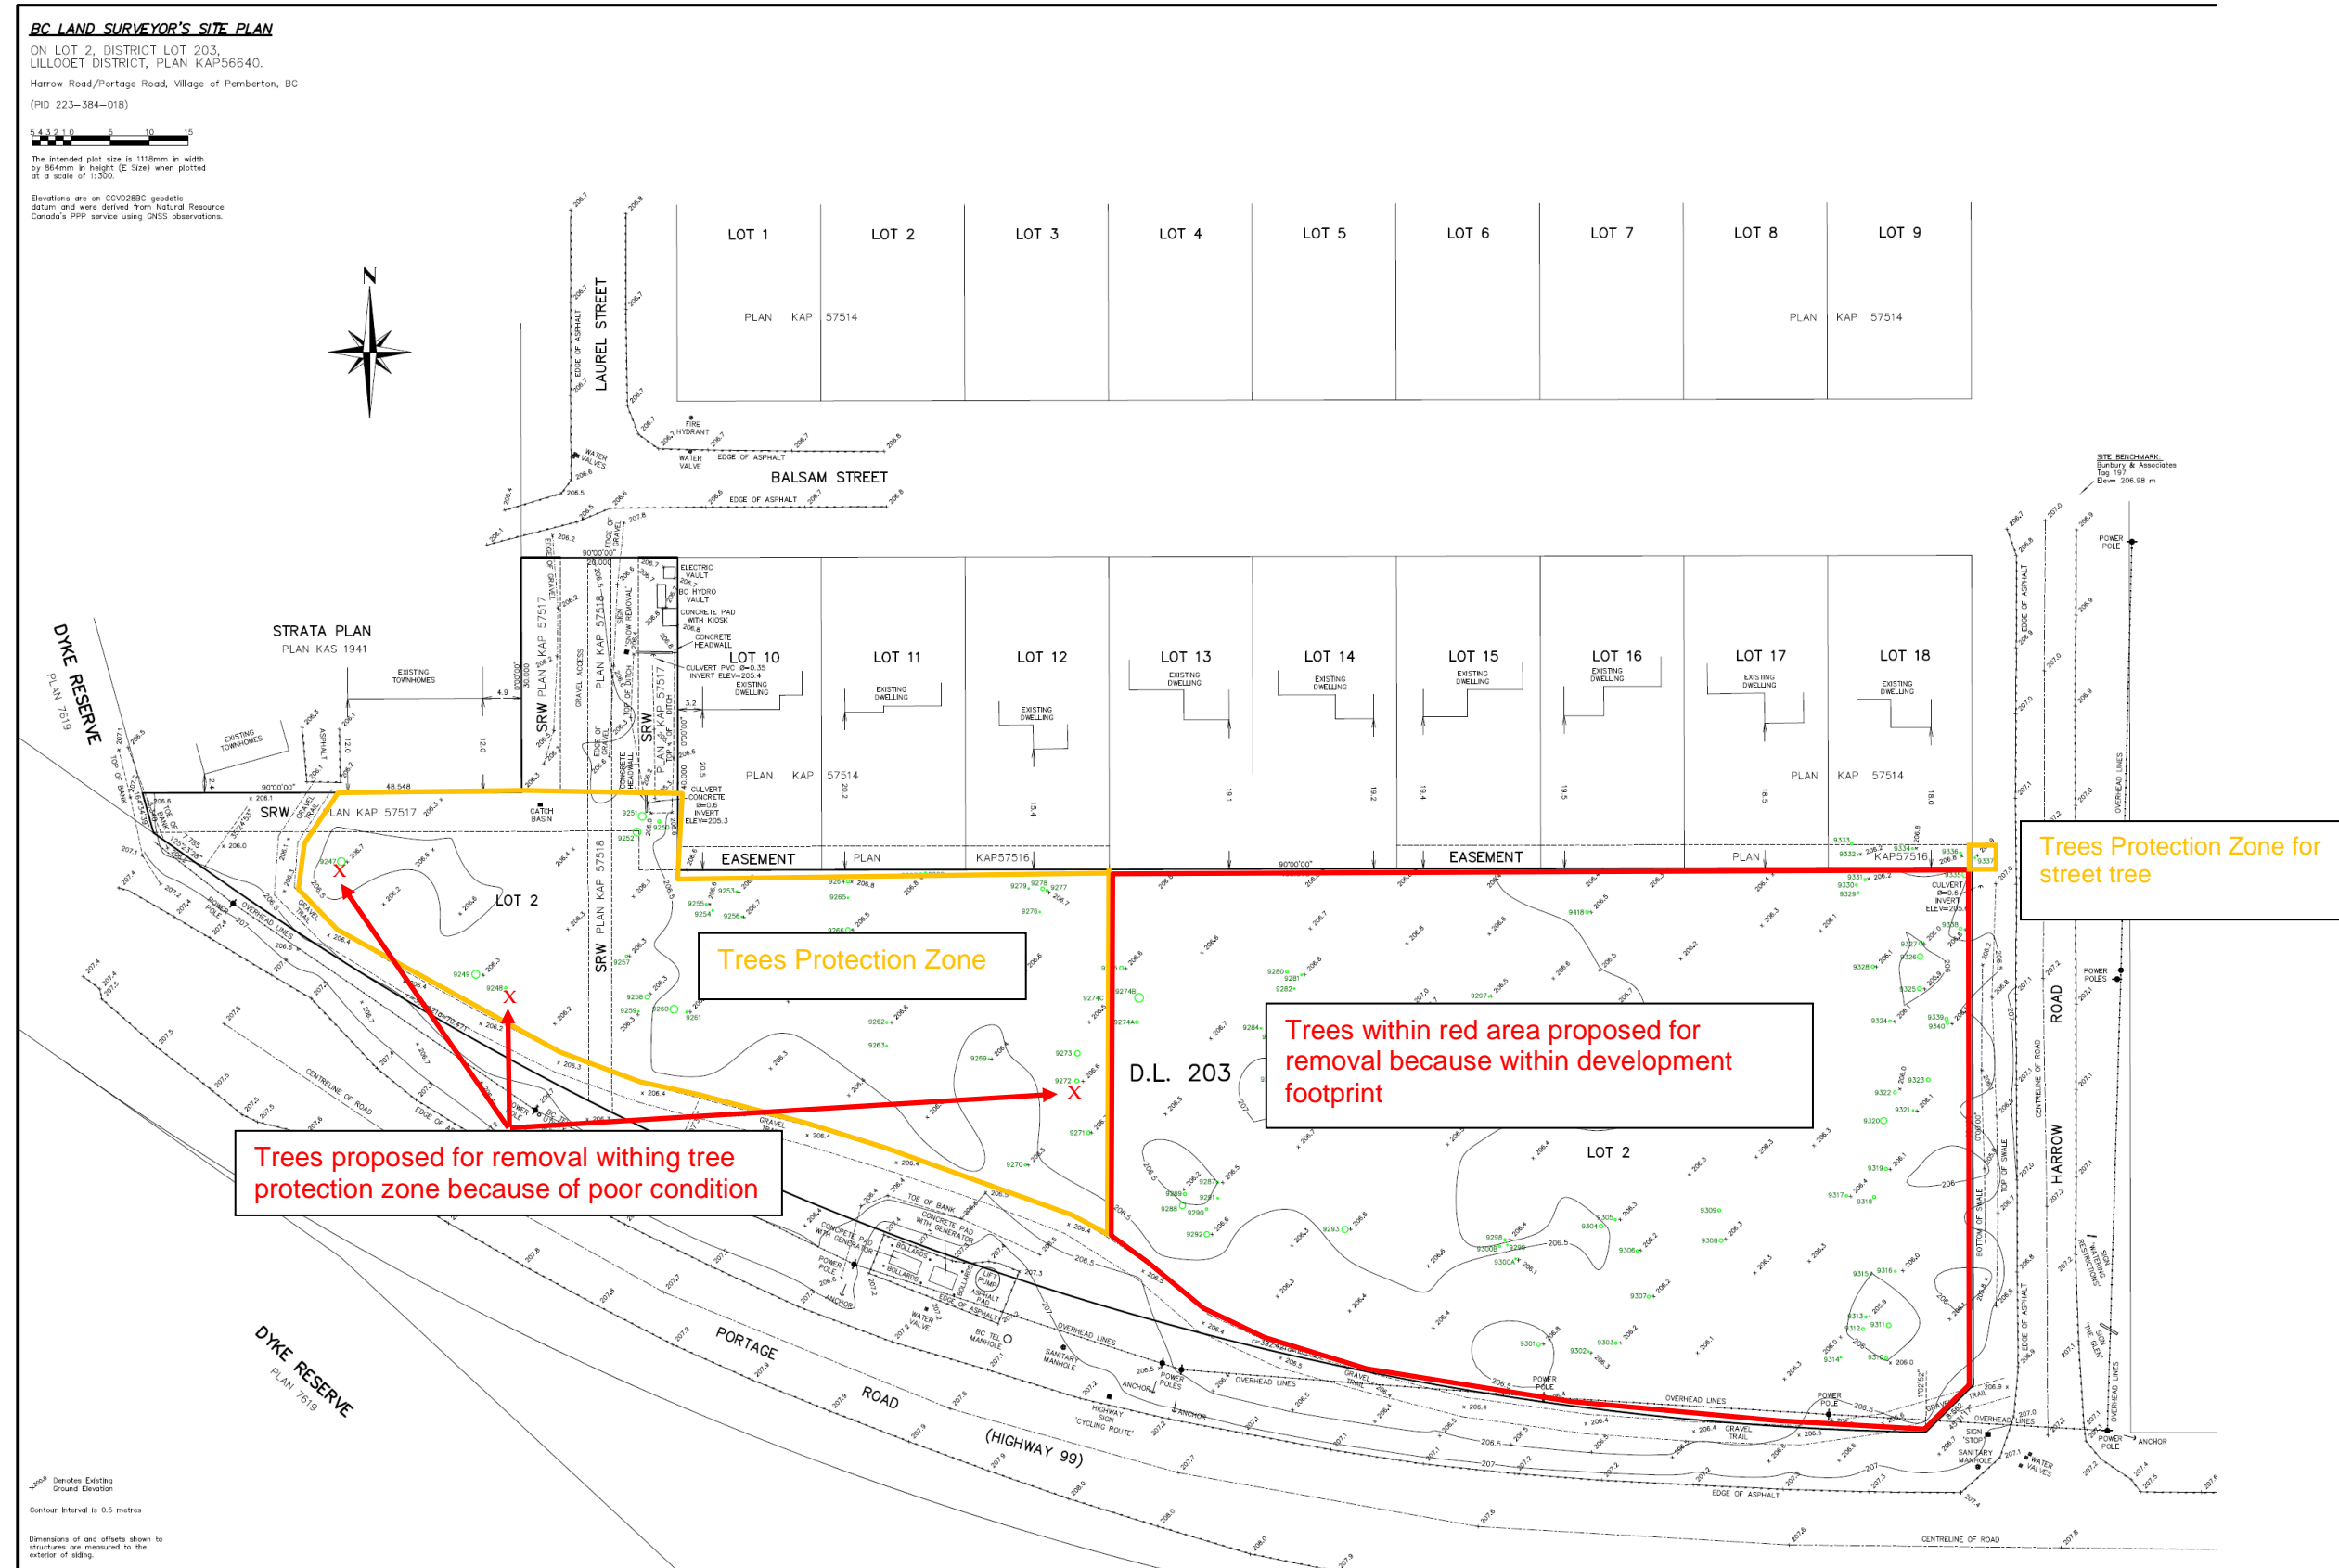
Figure 4. Tree protection zone(s) and trees recommended for removal

The survey (Figure 2) identified, one street tree, a Cottonwood (Tag ID 9337) present within the vicinity of the project (Table 1). The tree is in fair condition and is located in the northwest corner between Harrow Road and the neighbouring northwestern property (Figure 4). The tree is on municipal land and must not be harmed during construction.

The survey identified a total of 97 property trees (Figure 2) on the project site. Of those, 68 trees are recommended for removal because they are within the development footprint. The remainder are outside of the development footprint. Of the remaining trees, 26 trees are recommended for retention because they are in fair condition and 3 trees are in poor condition and subsequently recommended for removal. A number of Cottonwood trees in poor condition were identified to have suffered borer infestation, possibly Cottonwood Borer (*Plectrodera scalator*). The majority of these trees were within the development footprint and are requested for removal.

- The TPZ must be well marked and have a tree protection barrier placed 1.2m from the base of the tree to the south, east and north. Orange plastic fencing is recommended as the barrier for its high visibility and size. No material storage or construction equipment storage should occur within the TPZ of the tree. The barrier should be at least 1.4m in height and re-enforced to last throughout the construction time frame.

- Restrict both foot and mechanized traffic over the TPZ of trees. TPZ sizes are contained in Table 1 and Figure 4. The property line fence is sufficient to act as a barrier for the development and to avoid impacting the trees. If a fence is not present then a barrier must be constructed along the property line. Orange plastic fencing is recommended as the barrier for its high visibility and size. The barrier should be at least 1.4m in height and re-enforced to last throughout the construction time frame.

Arborist recommendations: Subject to receiving permission from the Village of Pemberton, remove 68 trees because they are within the development footprint as depicted in Figure 4. Subject to receiving permission from the Village of Pemberton, remove a further 3 poorly rated trees due to being assessed in poor condition (Figure 4). A summary is provided in Table 2.

- Prior to construction, protect retained trees in the western portion of the subject property by establishing a TPZ that borders the proposed wood fence along the western carpark and urban agriculture boxes in a north to south direction as depicted in Figure 4. Restrict both foot and mechanized traffic over the TPZs of the trees by using protective fencing around the area. The TPZ must be well marked and be sufficient enough to deter all foot traffic during the entire duration of the development project. Orange plastic fencing is recommended as the barrier for its high visibility and size. No material storage or construction equipment storage should occur within the TPZ of the trees. The barrier should be at least 1.4m in height and re-enforced to last throughout the construction time frame.
