SQUAMISH-LILLOOET REGIONAL DISTRICT

MOUNT CURRIE LANDSLIDE RISK ASSESSMENT

PROJECT NO.: 1358004

DATE: January 16, 2018

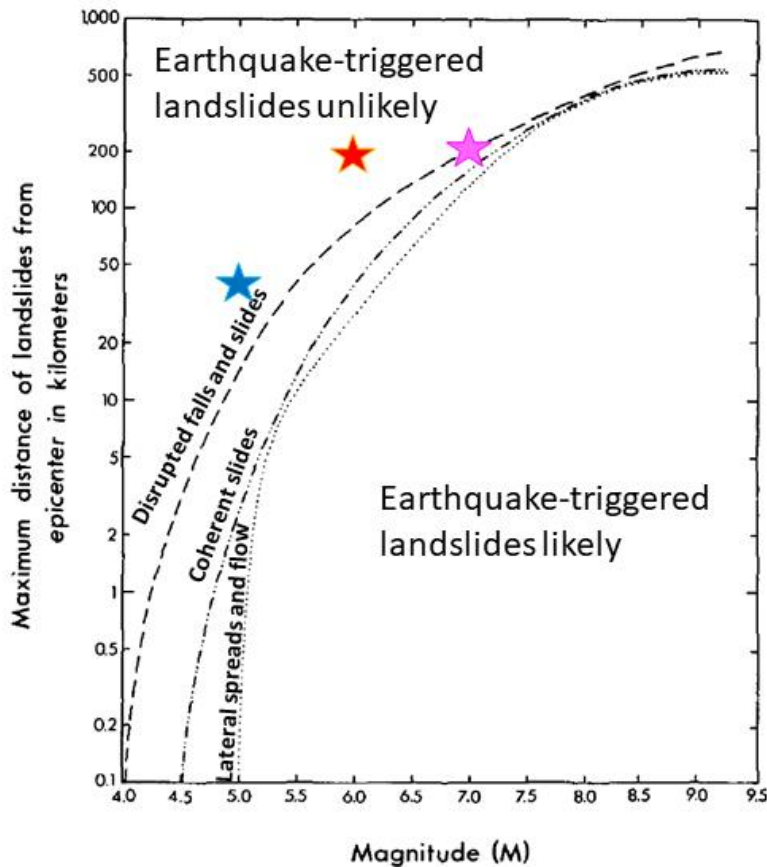
B)
 Figure 2-6. A) Earthquakes in Natural Resource Canada database (Halchuk et al., 2015) for southwestern British Columbia. Estimated distance to the nearest M5 (blue), M6 (red), and M7 (magenta) earthquakes are shown. B) Empirical relationship of earthquake magnitude and distance at which landslides were seismically triggered and the magnitude of the earthquake (Keefer, 1984). The three nearest major earthquakes from A are shown using the same colours.

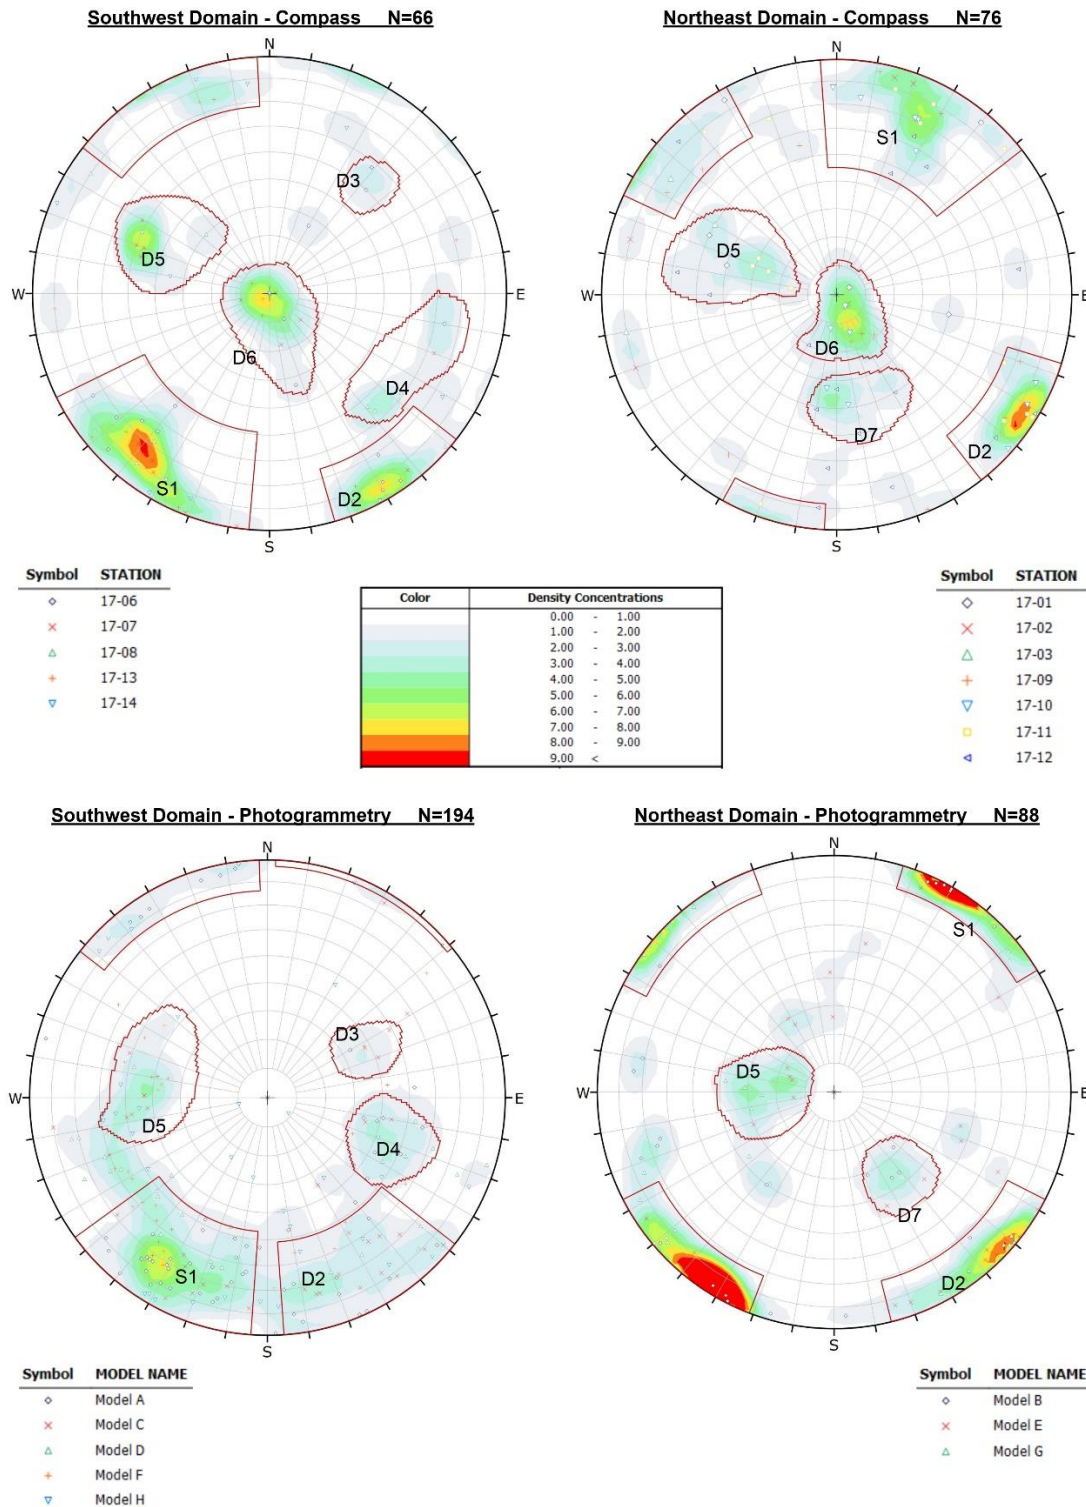
Figure 3-4. Stereonets of the two structural domains for both compass and photogrammetry measurements. The stereonet shows lower hemisphere equal area projections, and the contours symbolize the percentage of total pole measurements per 1% area. The symbols refer to the field station and model name for compass and photogrammetry measurements, respectively.

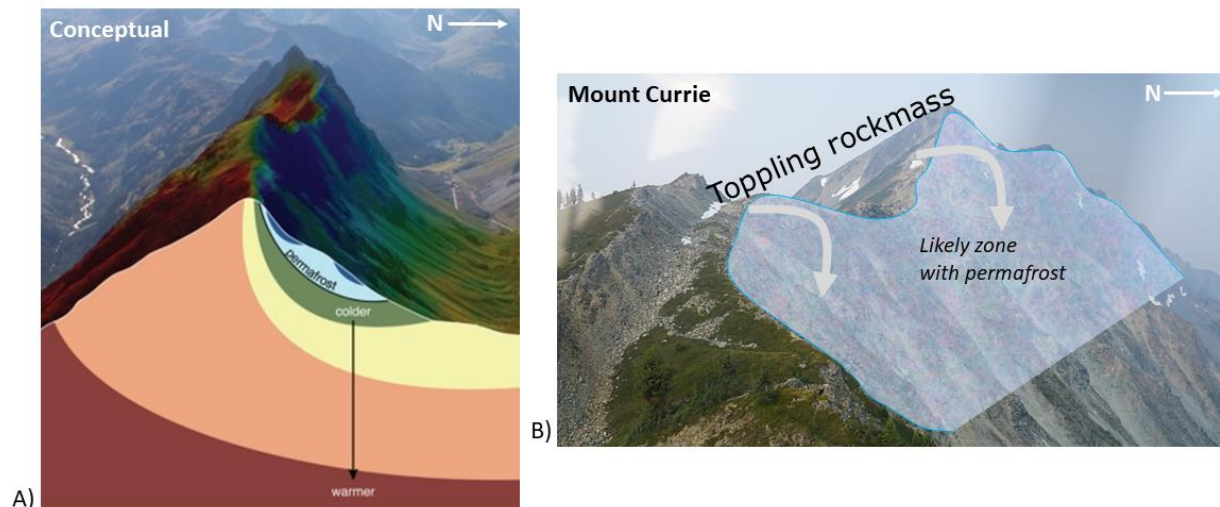
Figure 3-6. Schematic of permafrost distribution on Mount Currie. A) shows the conceptual distribution of permafrost on the north face and progressive warming with depth (image from Global Greenhouse, 2017). B) shows the summit ridge and North Face of Mount Currie with an approximation of permafrost limits (note these are schematic and not currently based on real data).

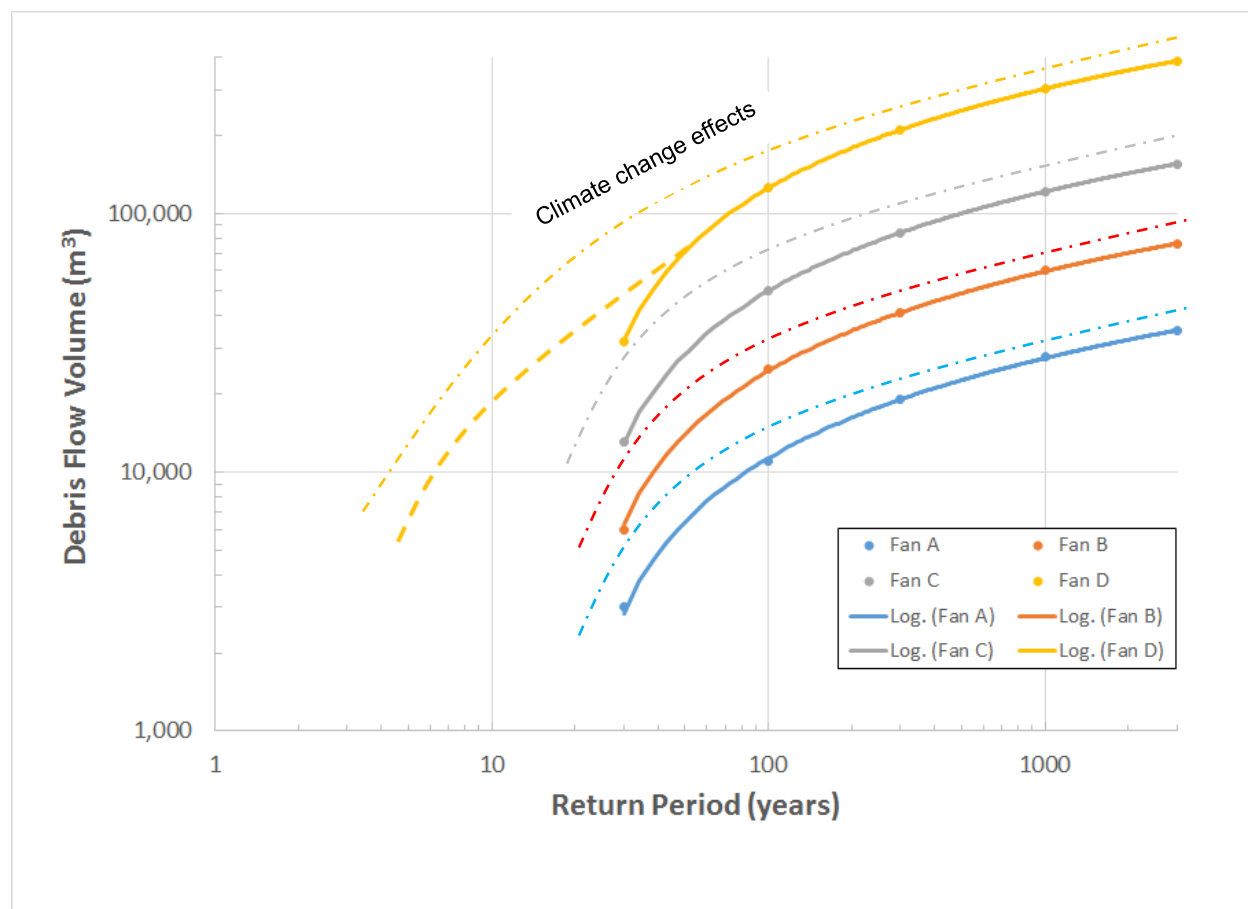
Figure 3-7. Debris-flow frequency-volume estimates for major creeks draining the North Face of Mount Currie based on regional analysis. The frequency-magnitude curve for Fan D was manually adjusted based on detailed investigations by Jakob (1996). A similar adjustment may be appropriate for Fan B and C, but without detailed field investigations is not warranted. Dashed lines show conceptually the effect of climate change.

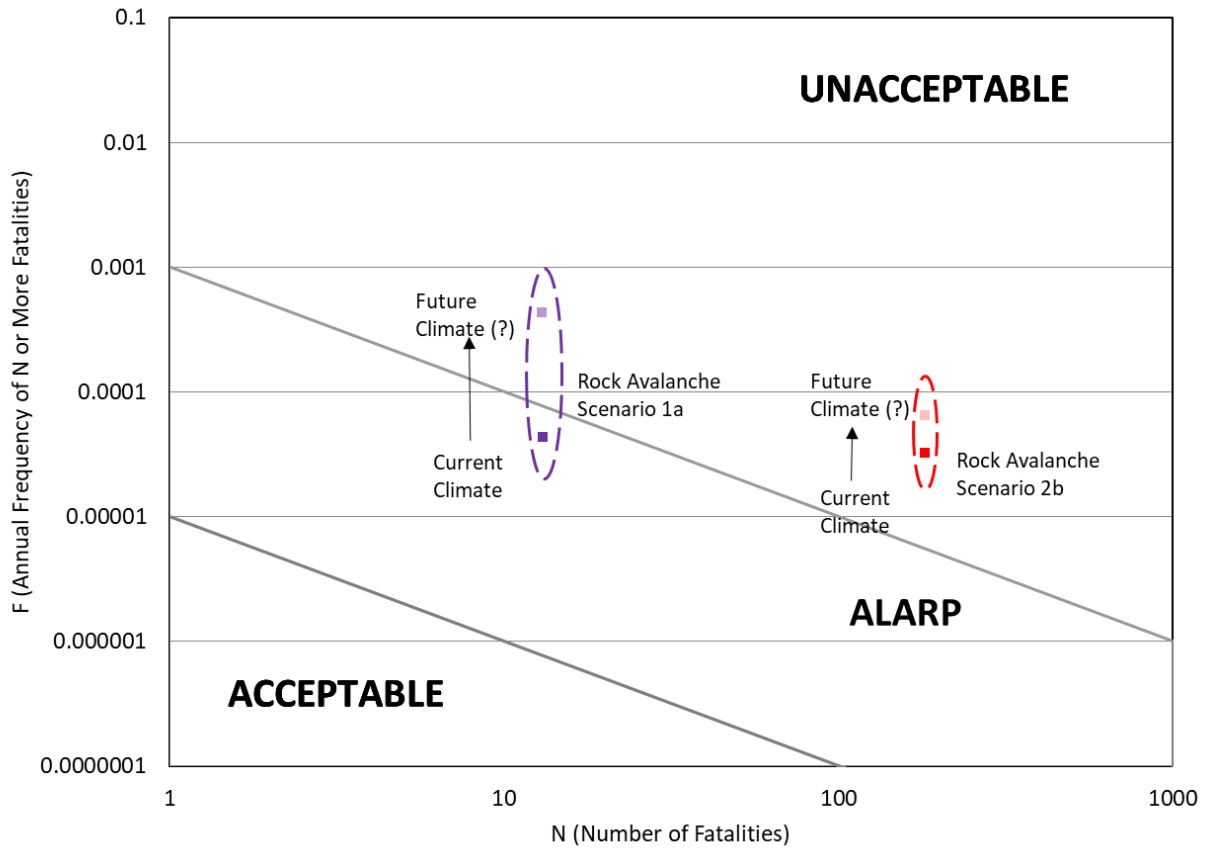
Figure 5-3. F-N curve showing the range of group risk analysis results for Scenarios 1a (purple dots) and 2b (red dots) in the current climate and projected future climate conditions. Note that the latter are associated with substantial uncertainty and are based entirely on judgement. The frequency ranges represented by the ellipses are not based on quantitative analysis, but illustrate subjective ranges in uncertainty in the rock avalanche probability estimates.

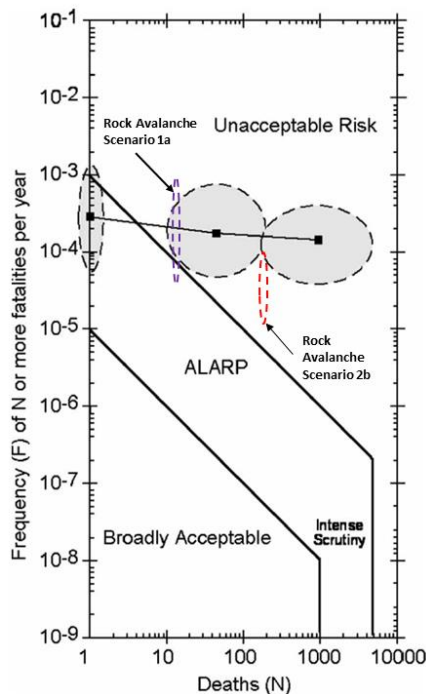
Figure 5-4. F-N plot for group risk for debris flows from Mount Meager (gray shaded ovals represent different debris flow volumes considered in Friele et. al. 2008) with Rock Avalanche Scenario 1a and 2b group risk results from the current study shown for comparison (purple and red ovals). The results of both studies are shown as shaded ovals to indicate uncertainty.

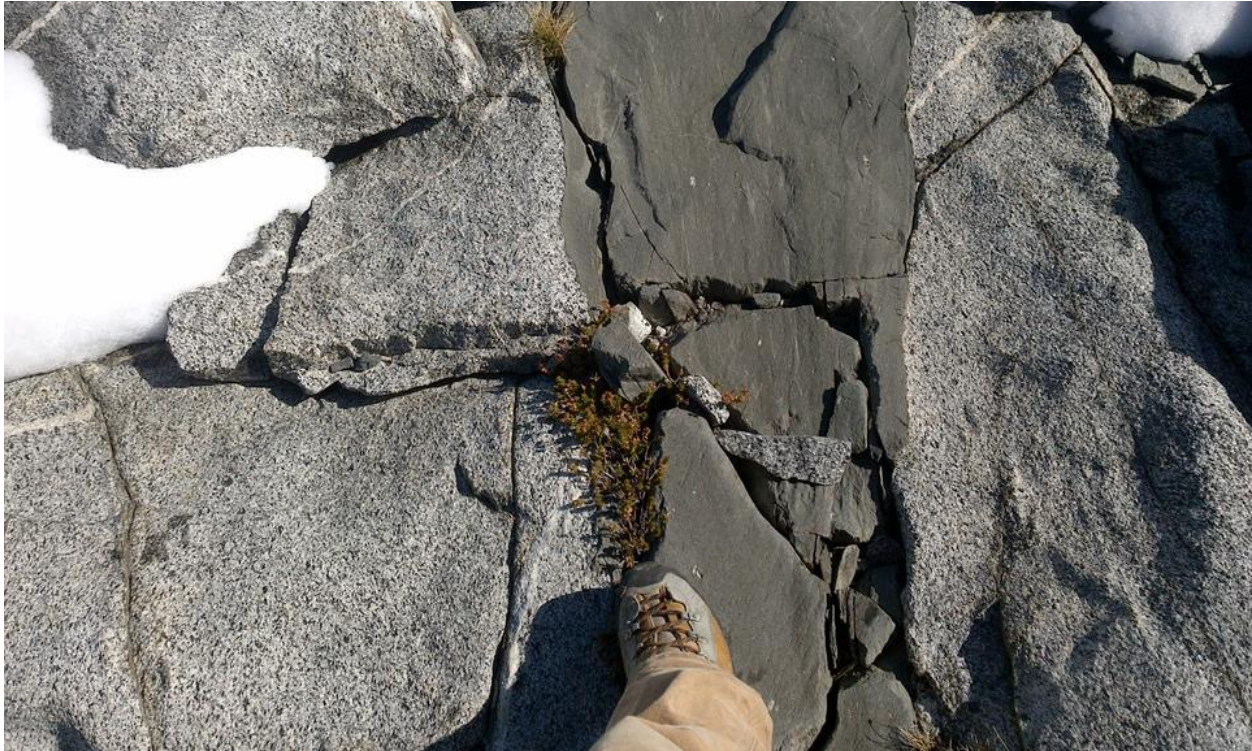
Photograph 1 Diorite intruded by a basaltic dyke.

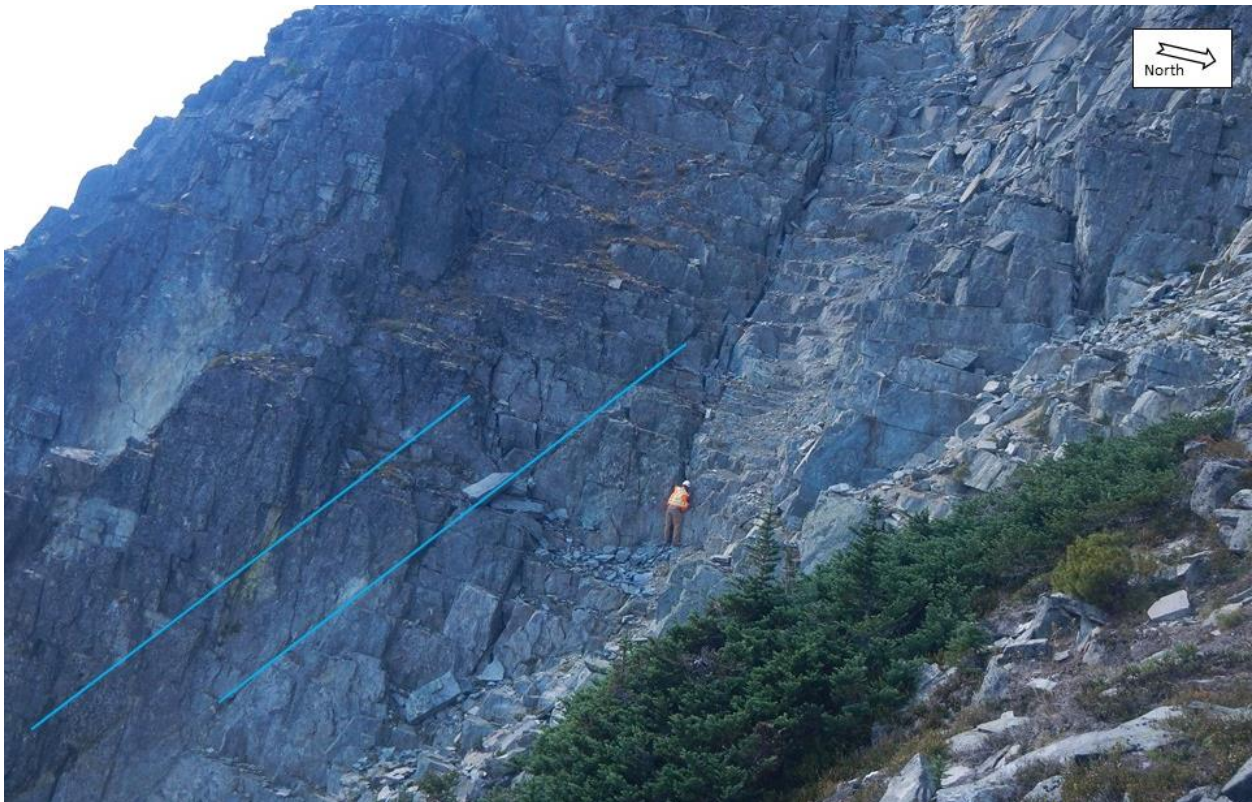
Photograph 2 D5 discontinuities on the southeast slopes, just downslope from the Mt Currie ridgeline.

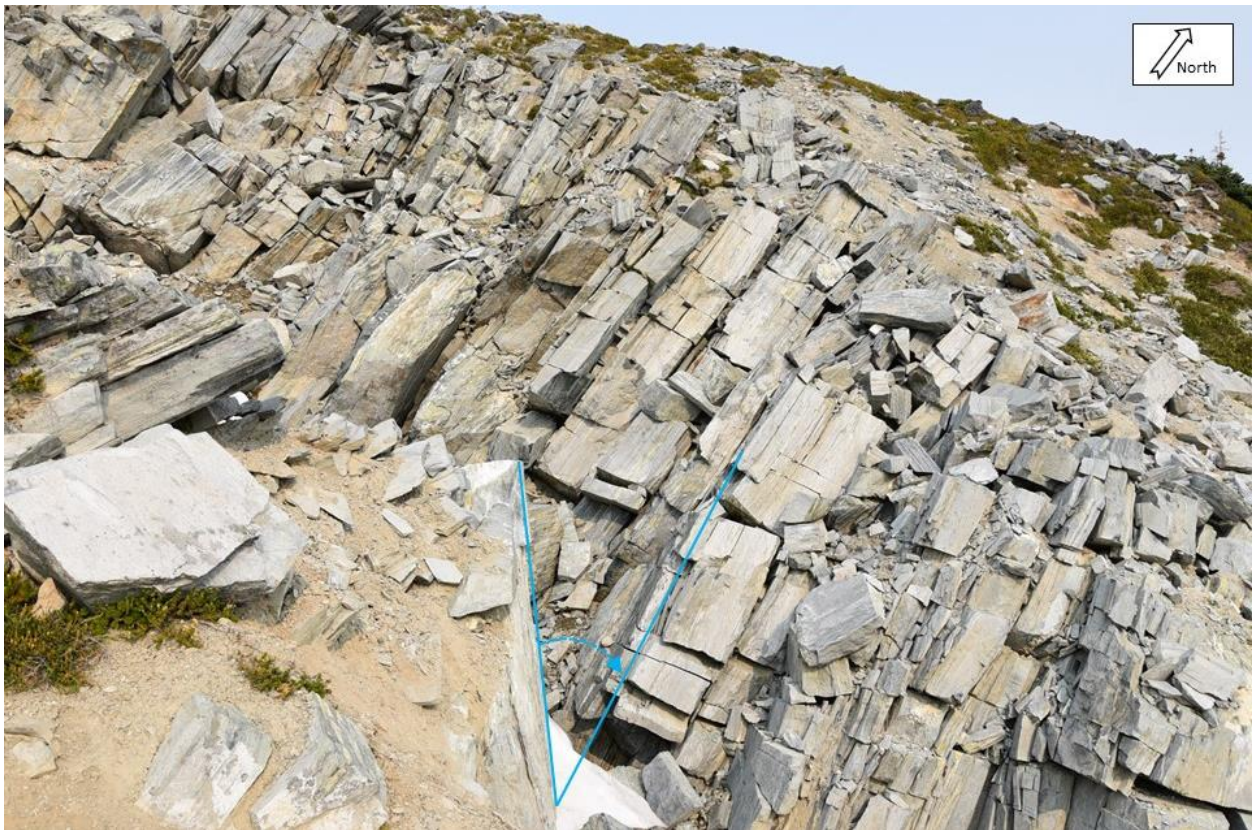
Photograph 6 Disturbed and dilated rock mass (Source ID 1a) with tilted blocks along foliation.

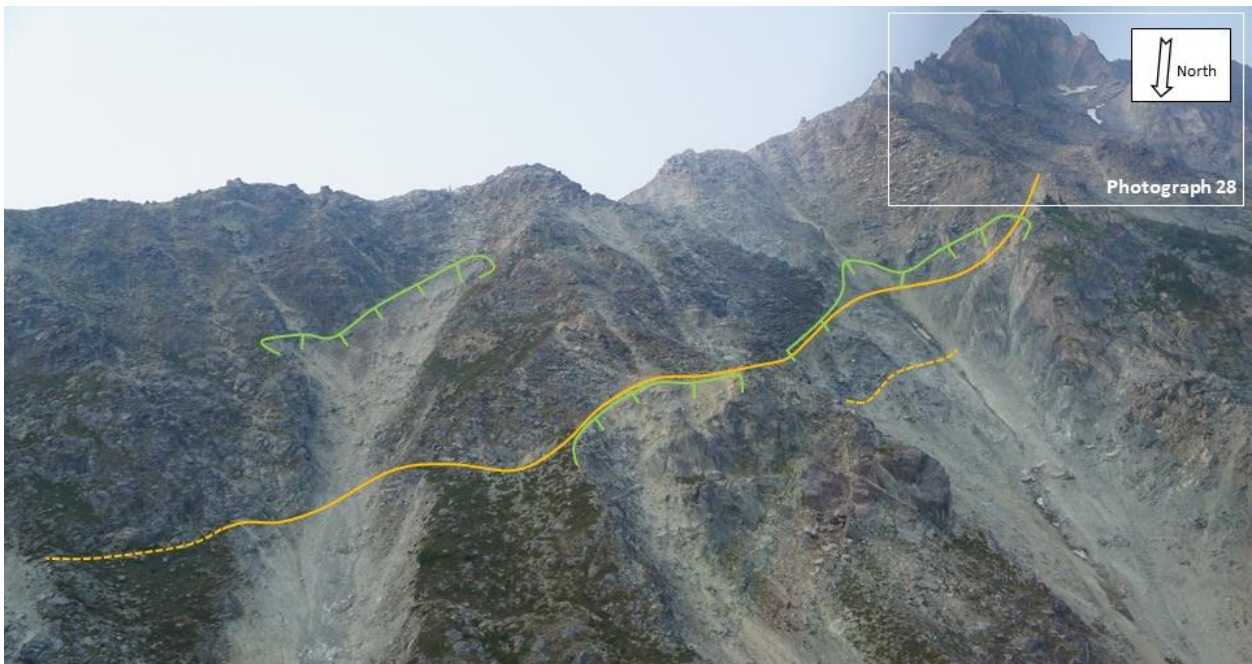
Photograph 7 Scars (green lines) of small landslides initiating on the edge of the disturbed mass (Source ID 1a) and interpreted basal sliding surfaces (orange dashed line) of the disturbed mass.

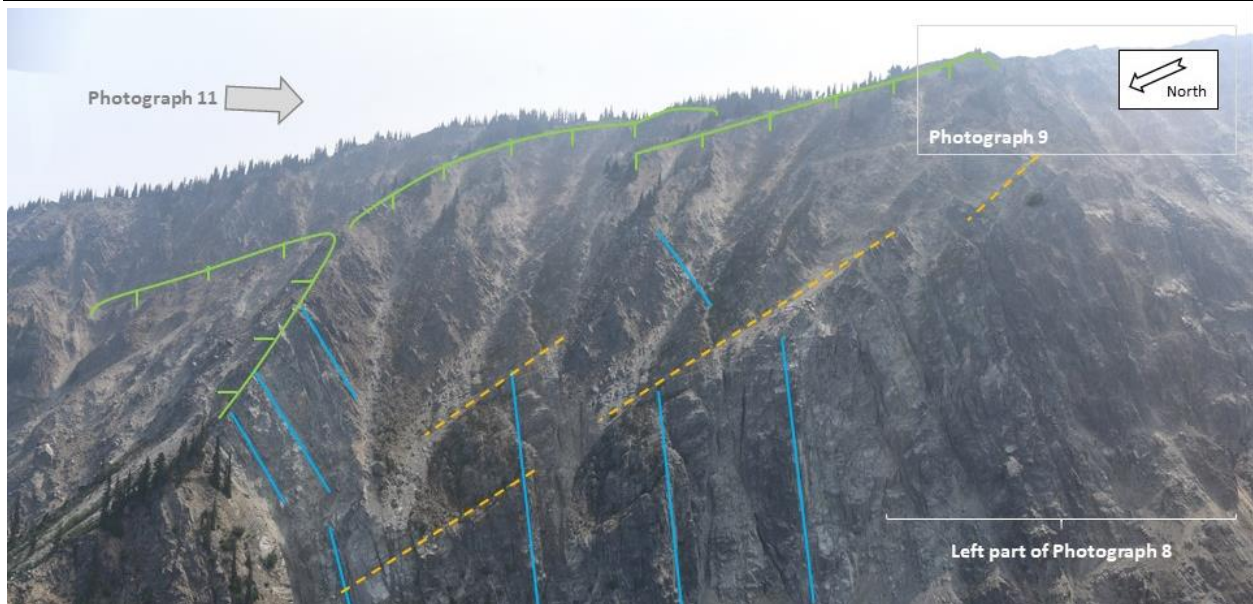
Photograph 10 Disturbed mass (Source ID 1b) with interpreted basal sliding surfaces (orange dashed line) constrained by the location where undisturbed foliation planes become tilted (blue lines). Green lines show scars of small landslides initiating on the edge of the mass.

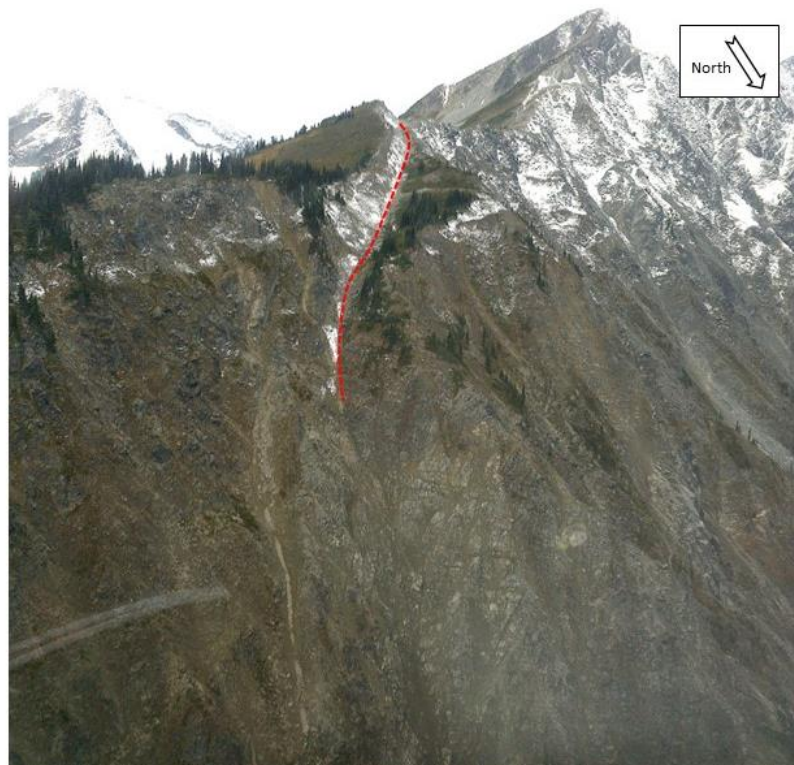
Photograph 11 Looking southwest at Source ID 1b and the counter-slope scarp marking its upper extent (red dashed line).

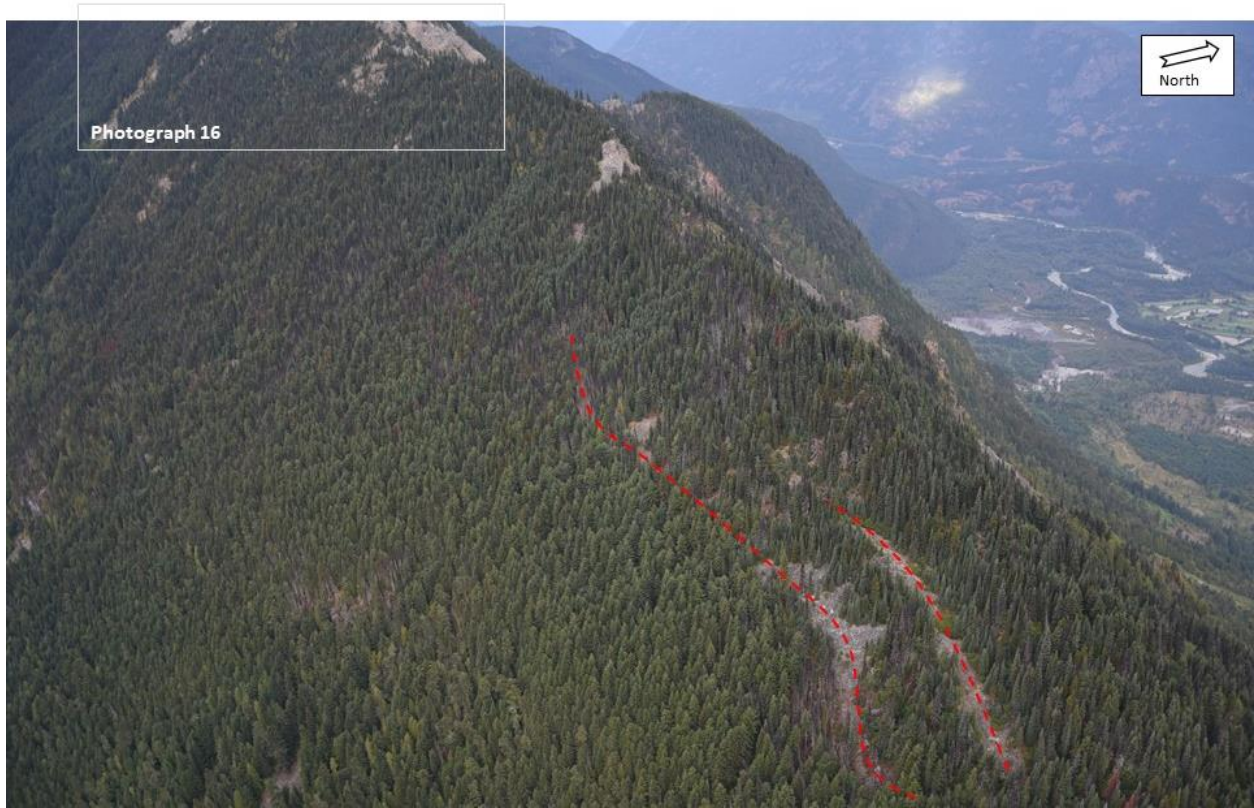
Photograph 12 Tension cracks (red dashed lines) subparallel to the ridge at Source ID 2c.

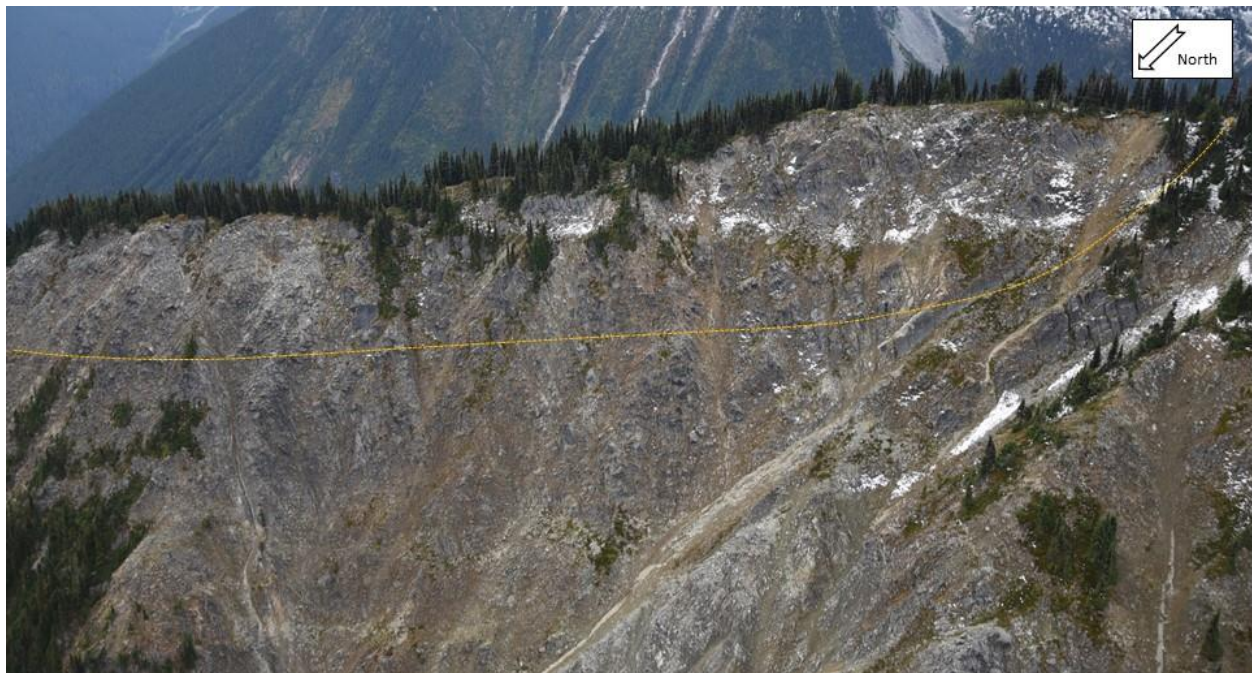
Photograph 14 Source ID 2a and the inferred location of its basal sliding surface (orange dashed line).

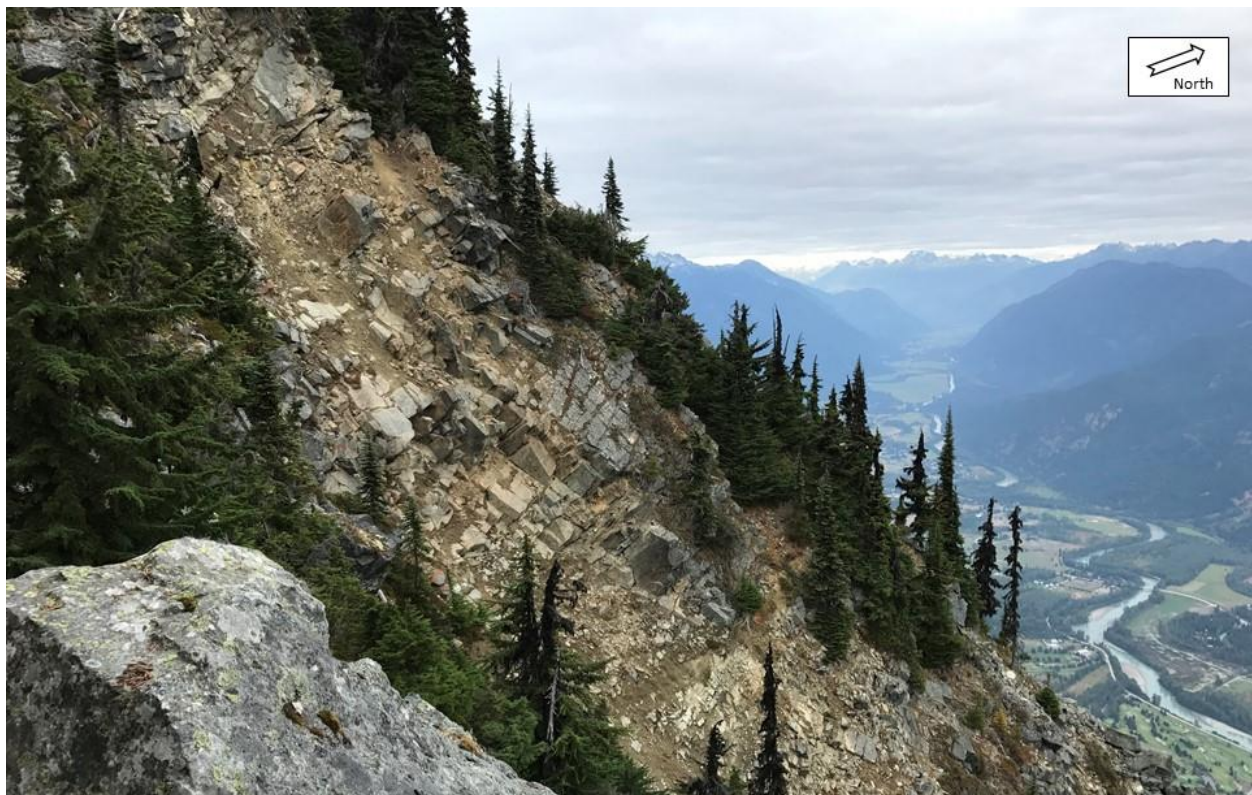
Photograph 15 Upper part of a section of Source ID 2b showing a disturbed rock mass and moderately dipping discontinuities.

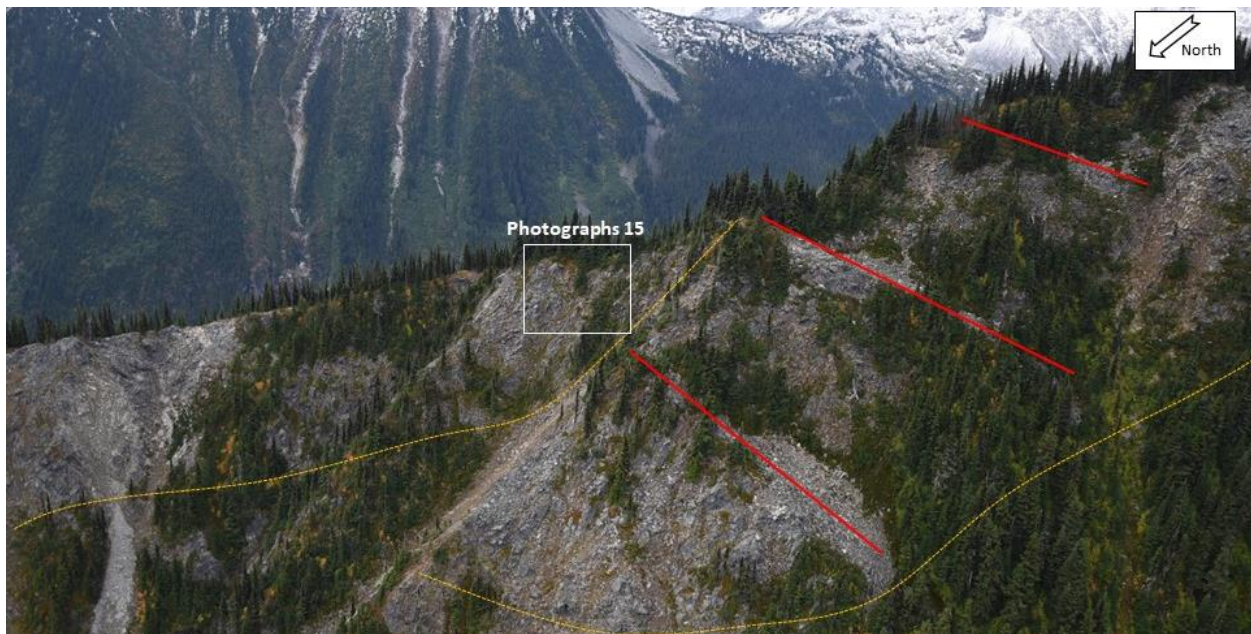
Photograph 17 Right: northeast side of Source ID 2a, showing lineaments (red lines) and associated slope deformation parallel to foliation, and inferred basal sliding surface (orange dashed line). Left: southwest side of Source ID 2b and inferred basal sliding surface (orange dashed line).

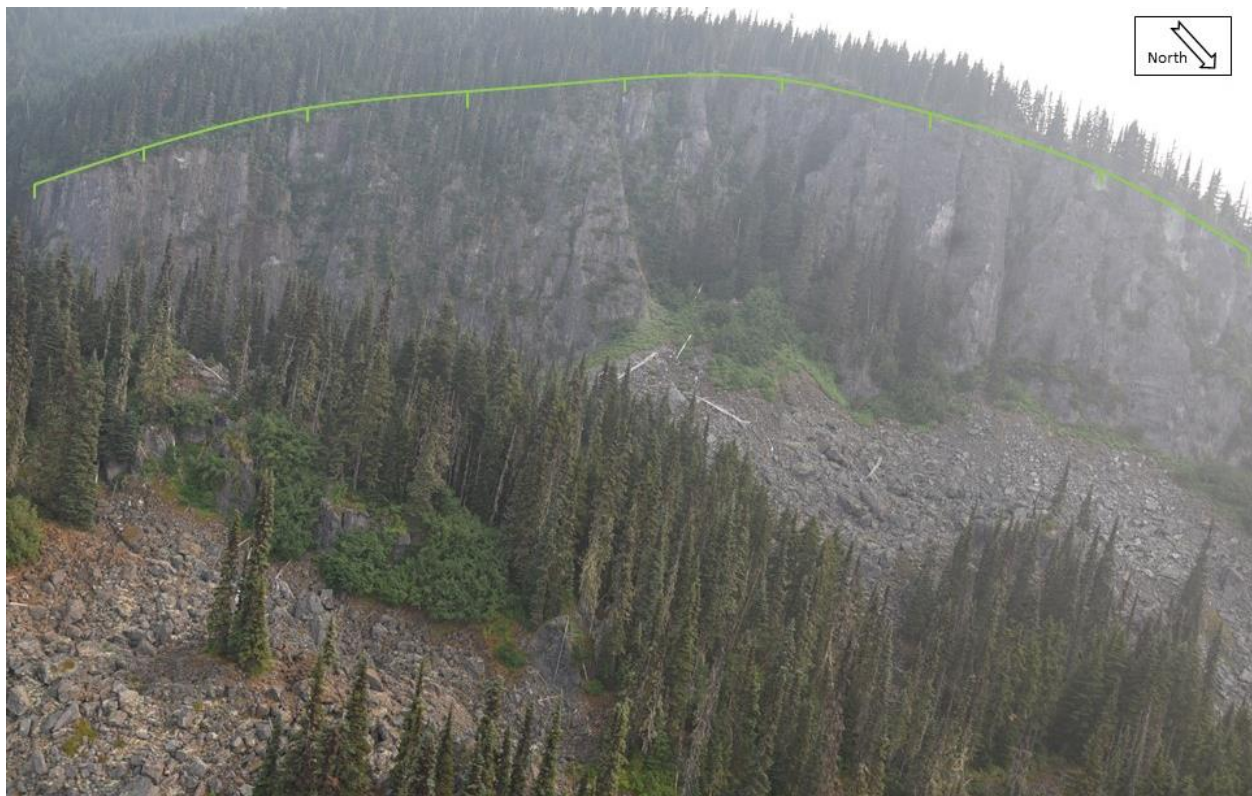
Photograph 18 Source ID 3 showing the upper scar (green line) of a DSGSD and talus covered with lichen and some vegetation.

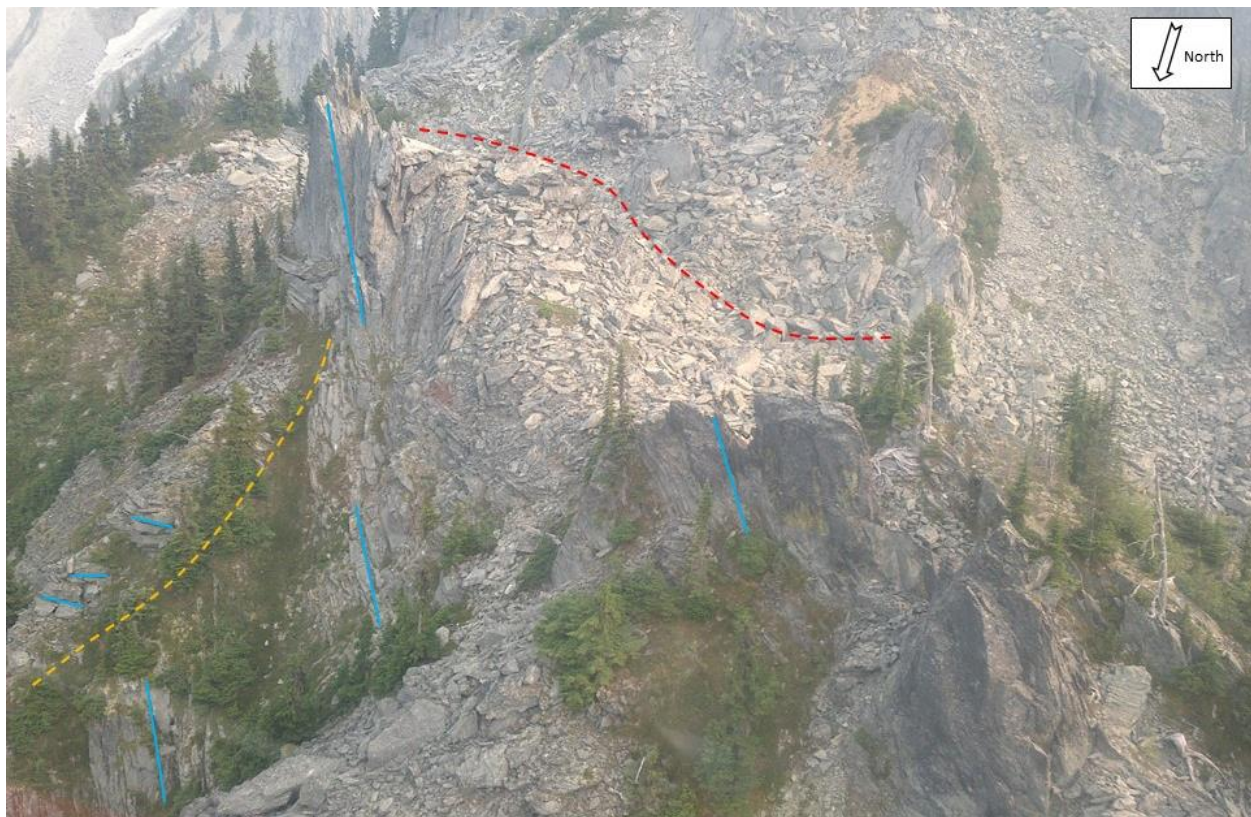
Photograph 21 Bare, unvegetated rock debris at the base of the cliff described in Photograph 19 and Photograph 20. Toppling was identified on the left where undisturbed foliation planes become tilted (blue lines) forming a basal sliding surface (orange dashed line). The red dashed line appears to show a depression within the rock debris, suggesting that further instability (Source ID 16) is possible.

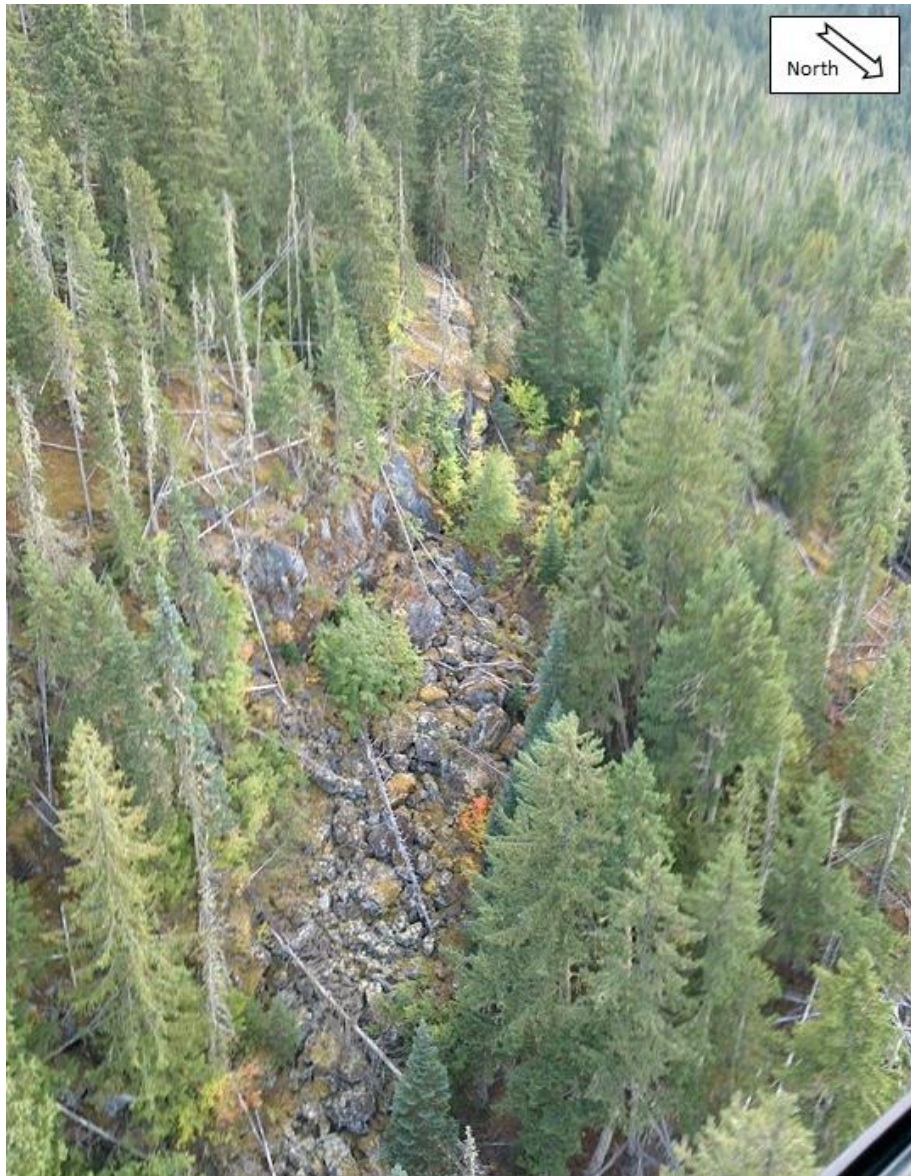
Photograph 23 Wide northeast trending tension crack filled with rock blocks and vegetation, and marking the upper limit of potential Source ID 13. The surface of the blocks is weathered and appears to be covered with lichen.

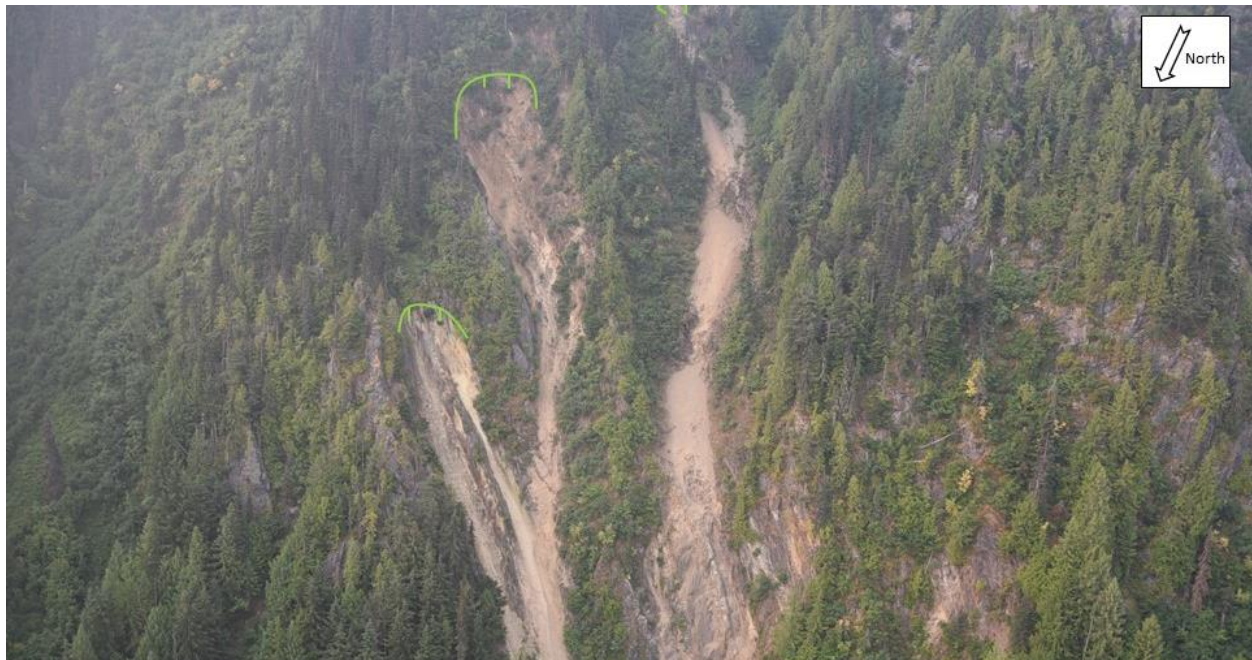
Photograph 25 Rock and debris slides in the easternmost watershed. The green lines highlight the scars.

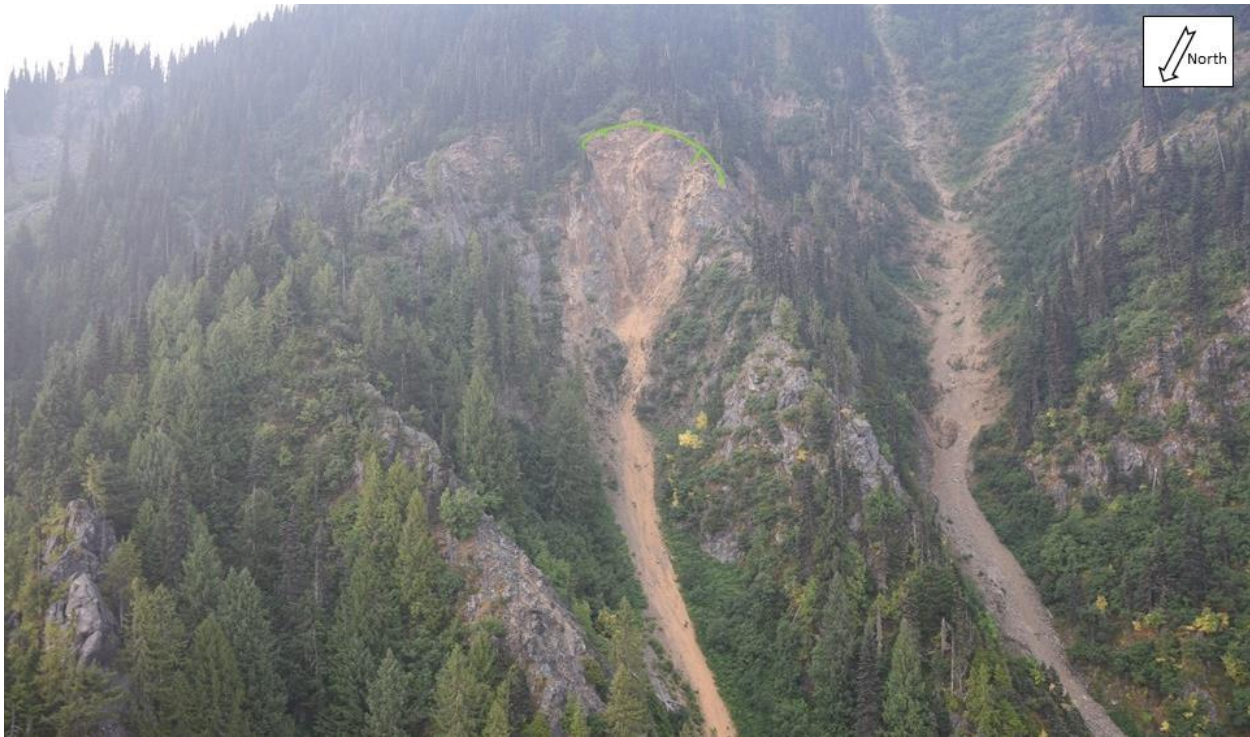
Photograph 26 Rock and debris slides in the easternmost watershed. The green line highlights the scar.

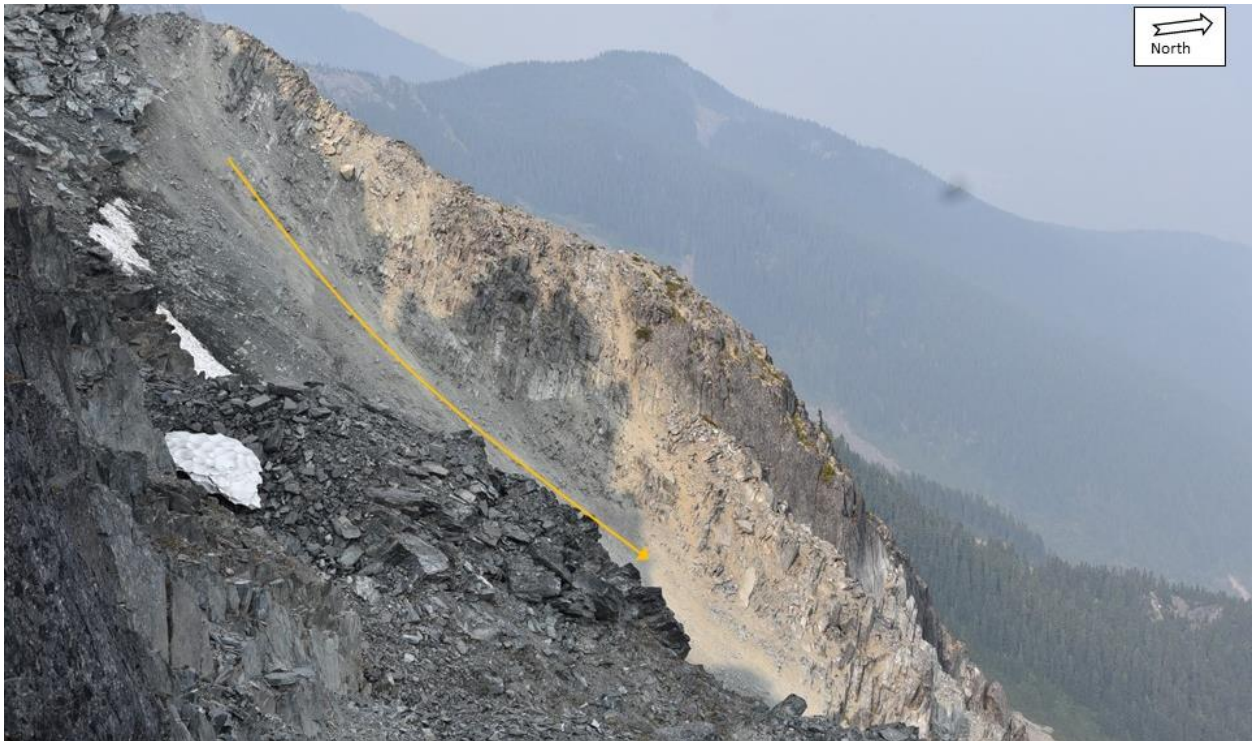
Photograph 29 Scar of the small disturbed mass, whose failure is assumed to have been triggered by a rock fall event, as explained in Photograph 28.

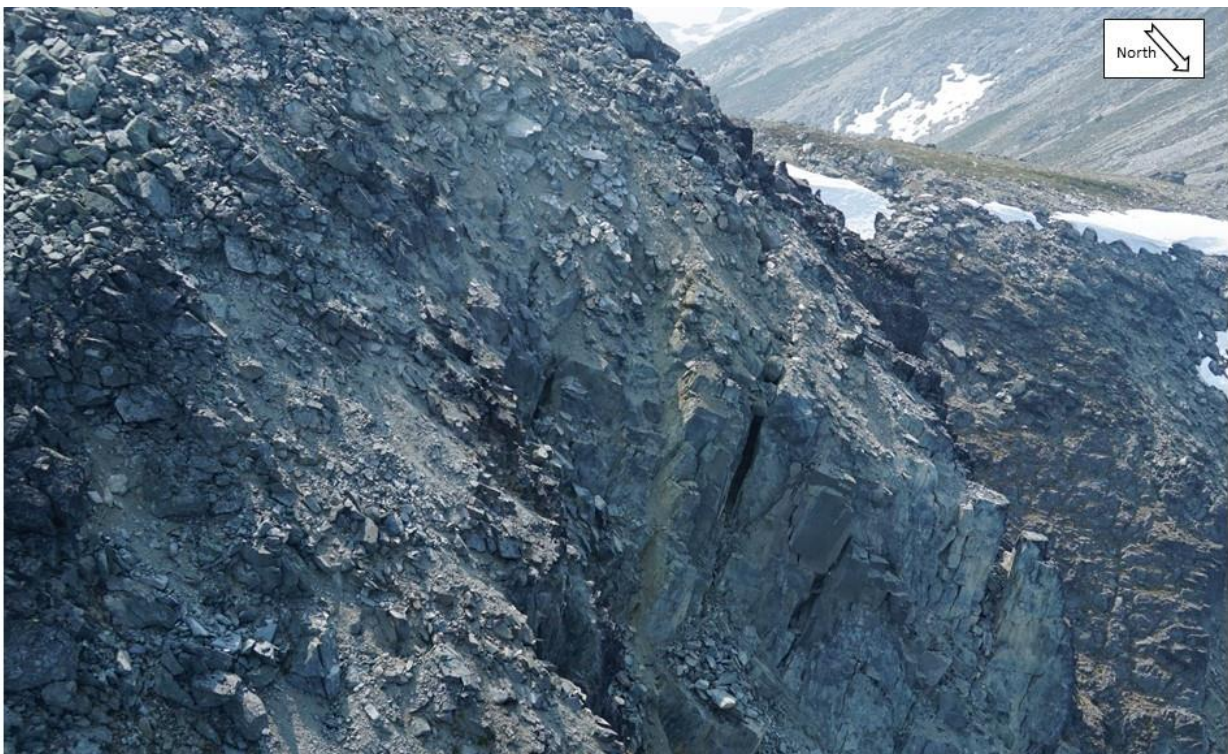
Photograph 30 Upper scar of rock fall event described in Photograph 28 showing dilation and open cracks corresponding to Source ID 7.
