SQUAMISH-LILLOOET REGIONAL DISTRICT

MOUNT CURRIE LANDSLIDE RISK ASSESSMENT

PROJECT NO.: 1358004

DATE: January 16, 2018

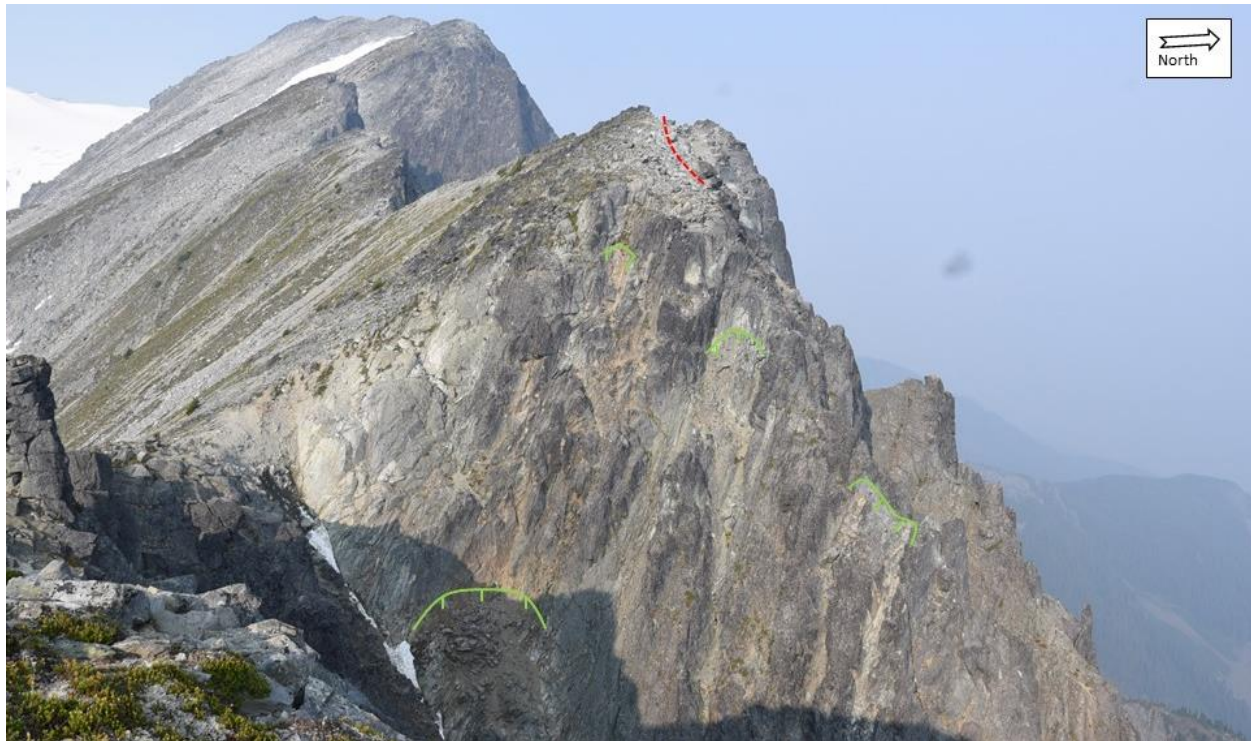
Photograph 31 Minor rock fall scars (green lines); and tension crack (red dashed line) defining a potential instability (Source ID 12).

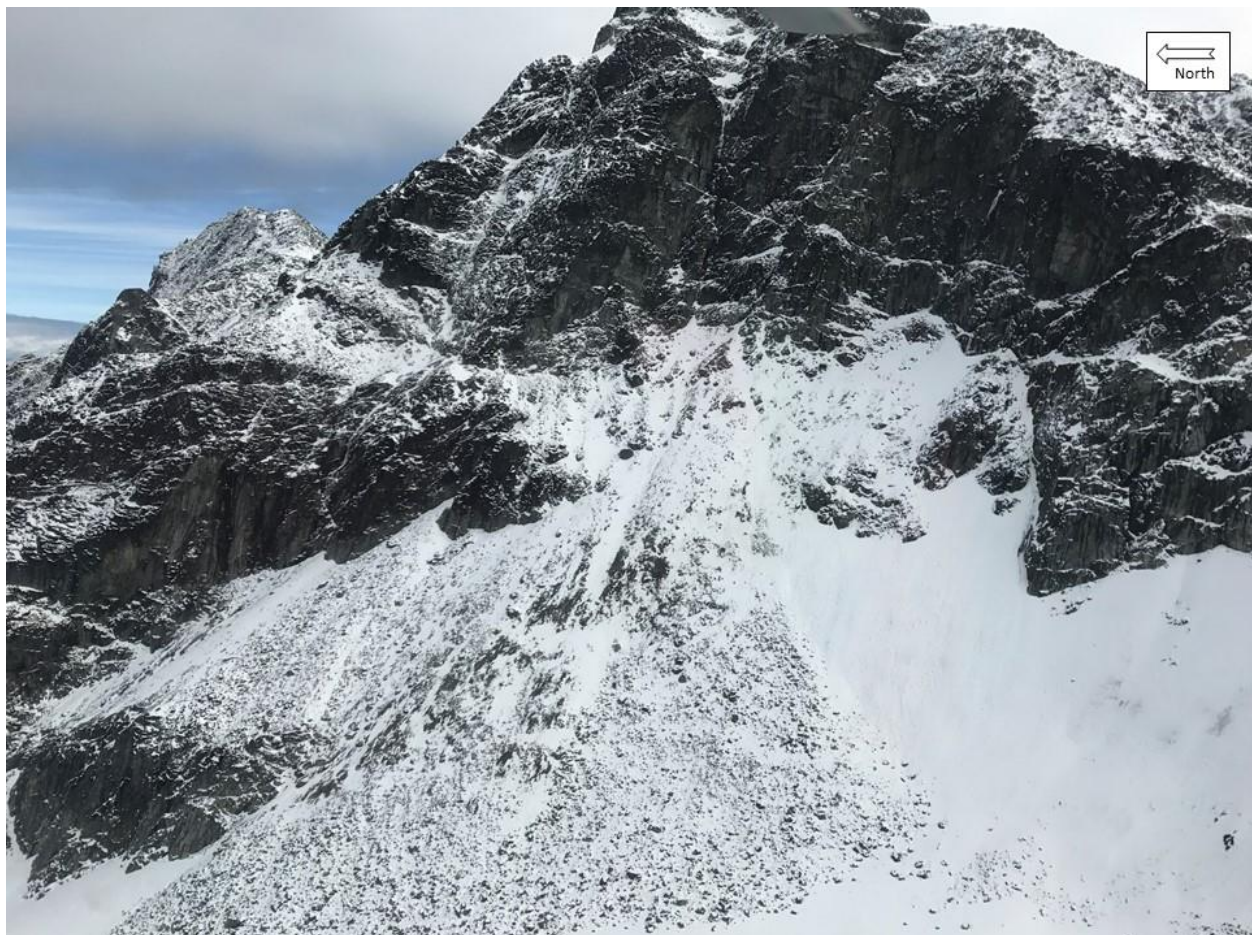
Photograph 32 Inferred location of reported June 29, 2015 rock fall events and location of potential further instability (Source ID 10).

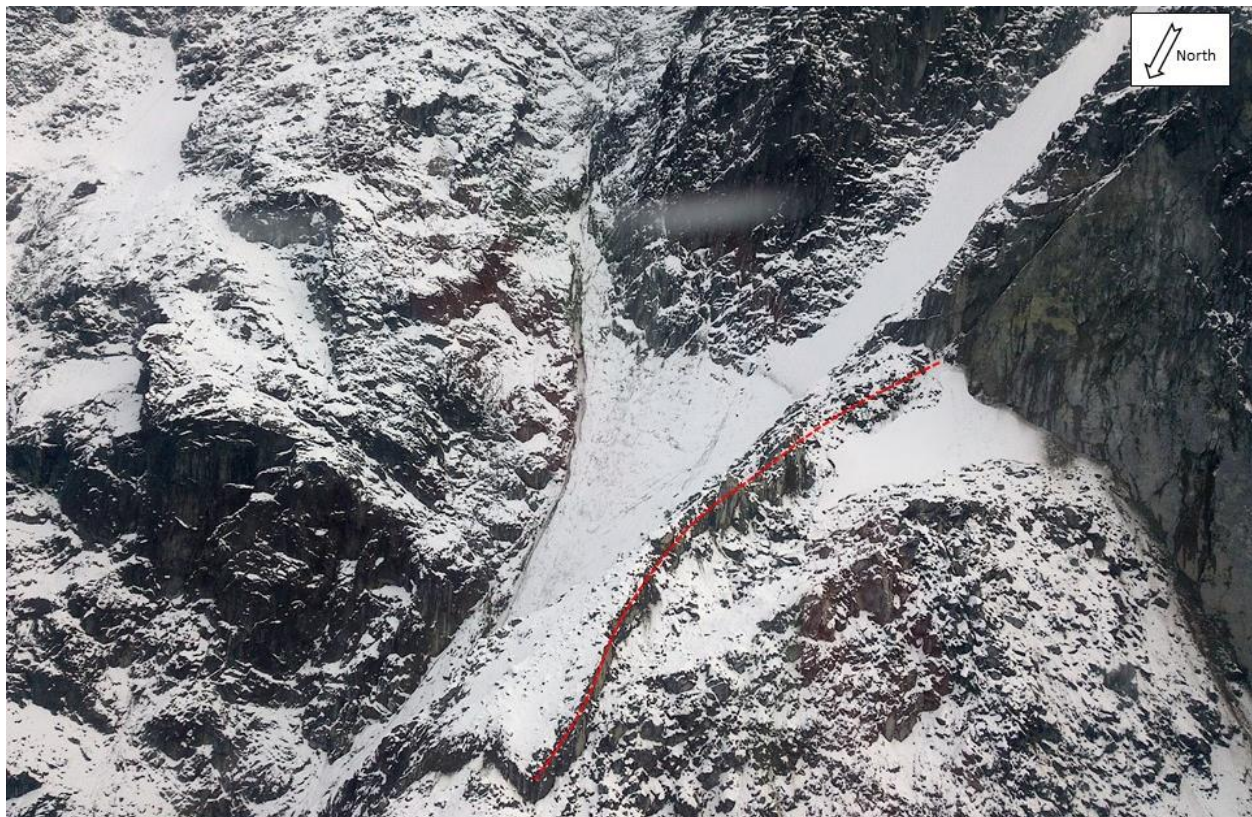
Photograph 34 Upper counter-slope scarp (red dashed line) of the July and September 2016 rock slide events.

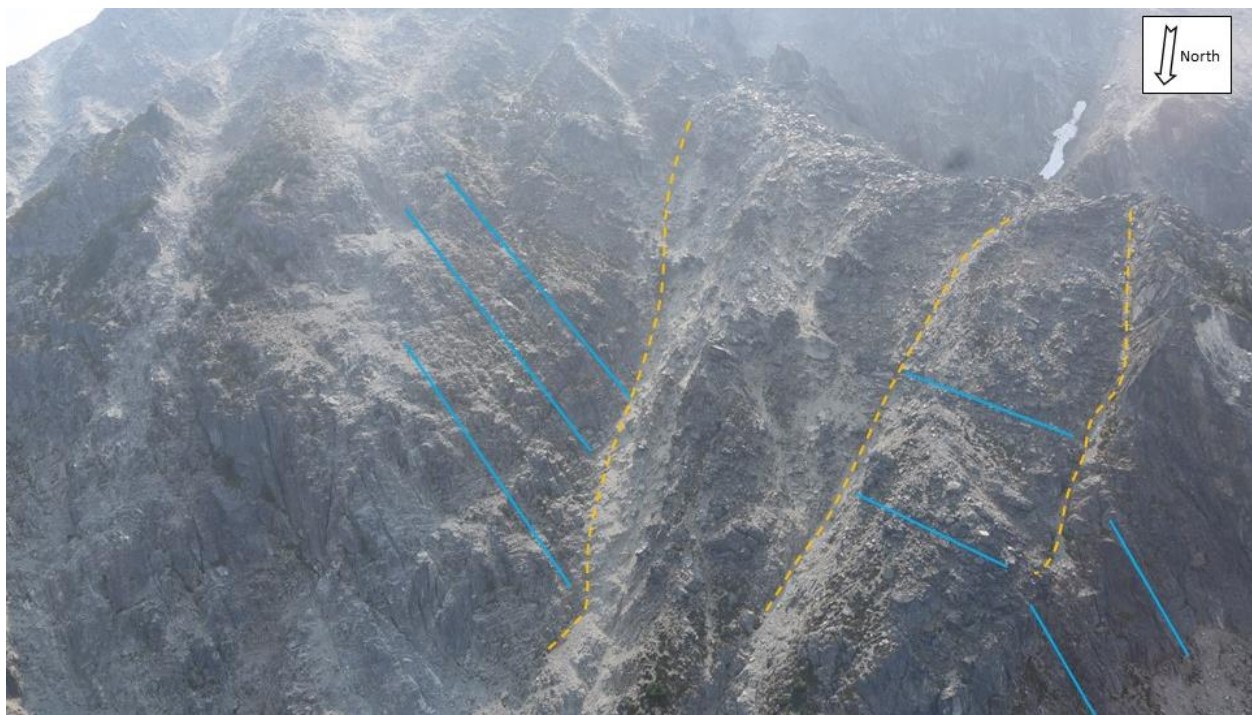
Photograph 36 Disturbed mass along the crest separating Watershed C and D. The orange dashed line shows interpreted basal sliding surfaces constrained by the location where undisturbed foliation planes are tilted (blue lines).

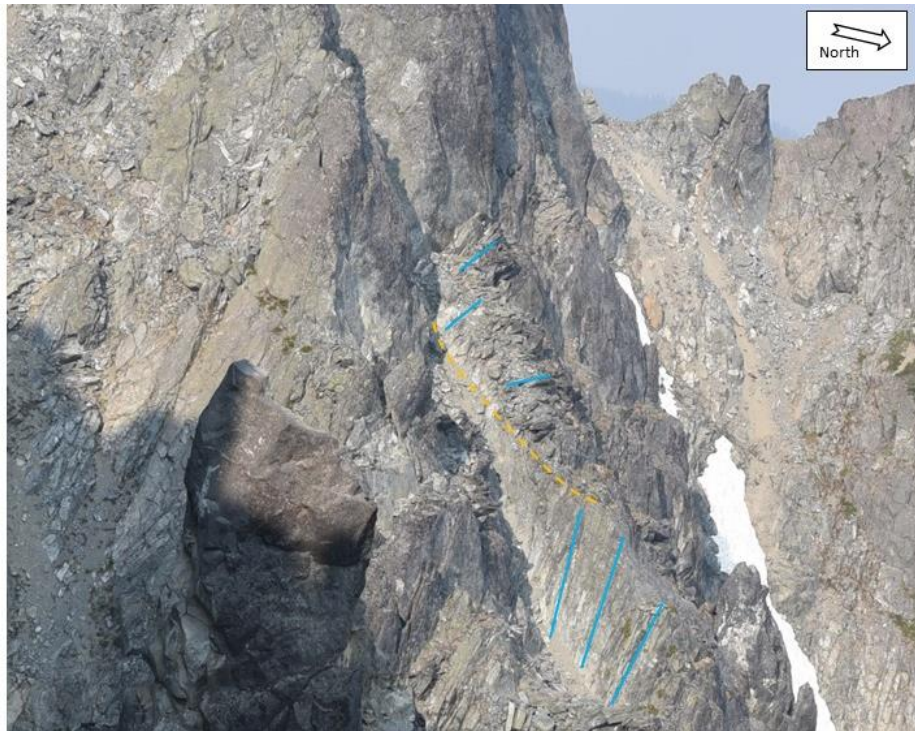
Photograph 37 Toppling mechanism generating a disturbed mass whose interpreted basal sliding surface (orange dashed line) corresponds to the location where undisturbed foliation planes (blue lines) become tilted.

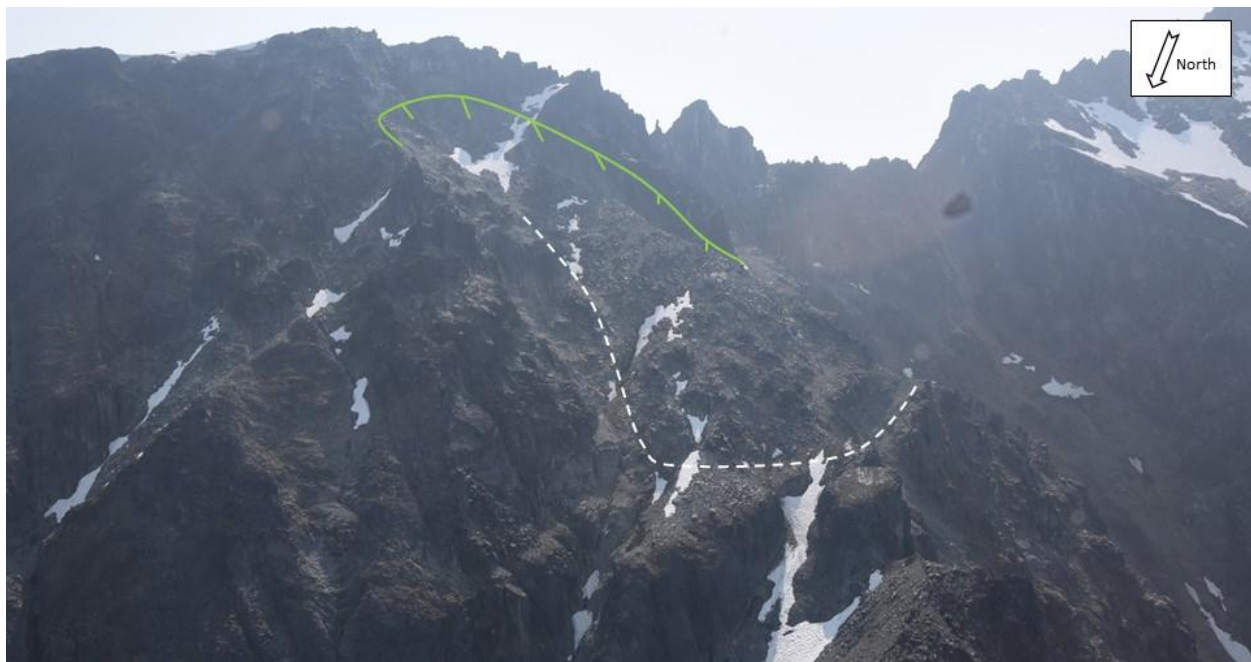
Photograph 38 Debris of a rock slide with its scar (green line) and lower extent (white dashed line). Re-mobilization of the debris corresponds to Source ID 6.

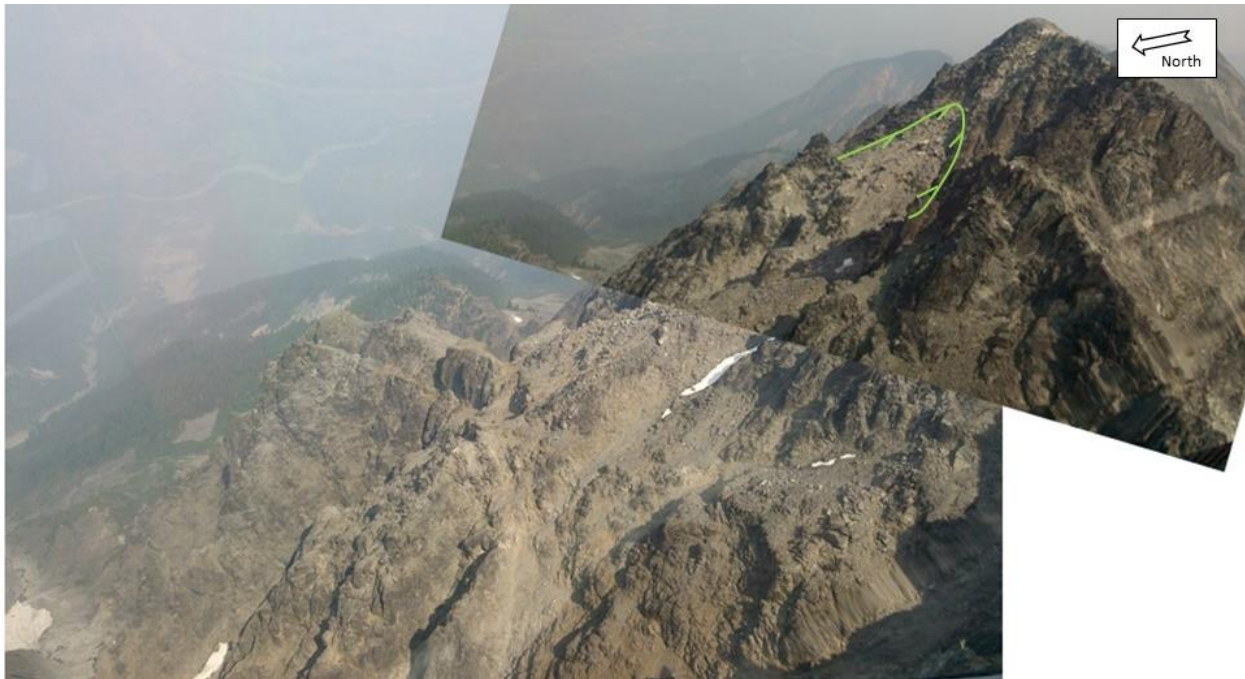
Photograph 39 Debris of a rock slide and its scar (green line). Re-mobilization of the debris corresponds to Source ID 6.

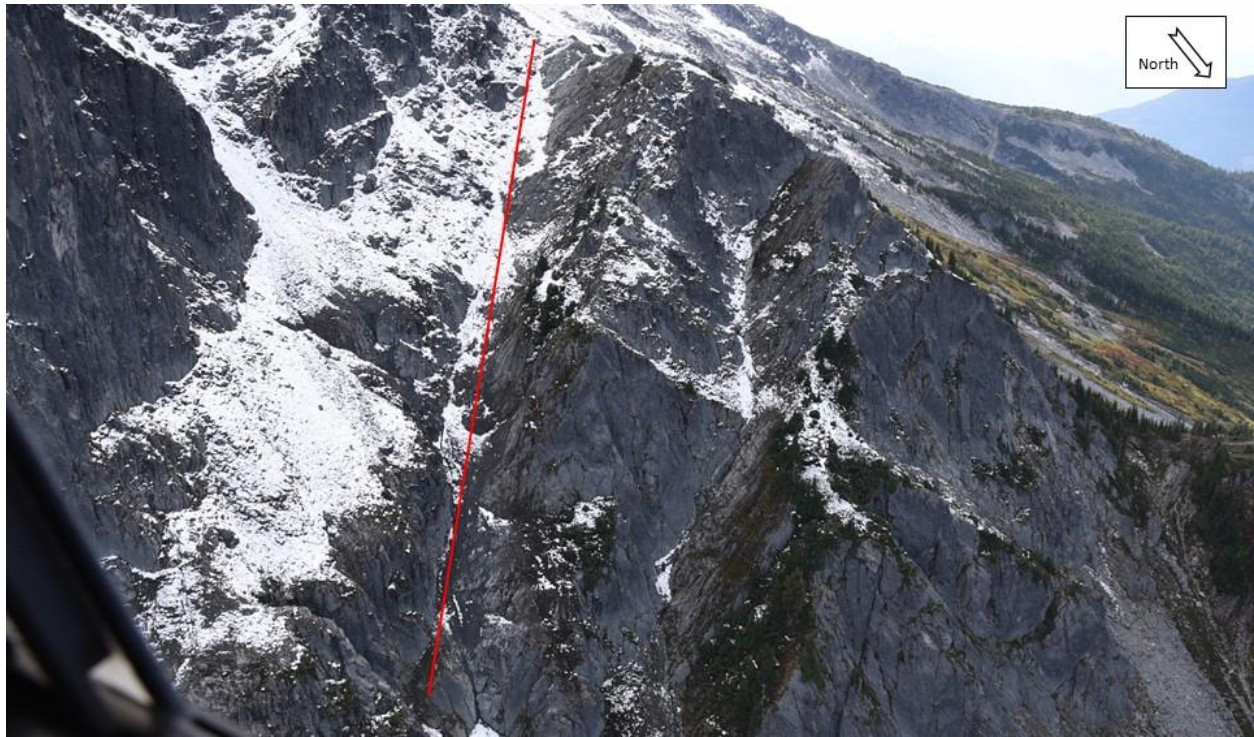
Photograph 41 Lineament (red line) marking the lateral extent of potential Source ID 14.

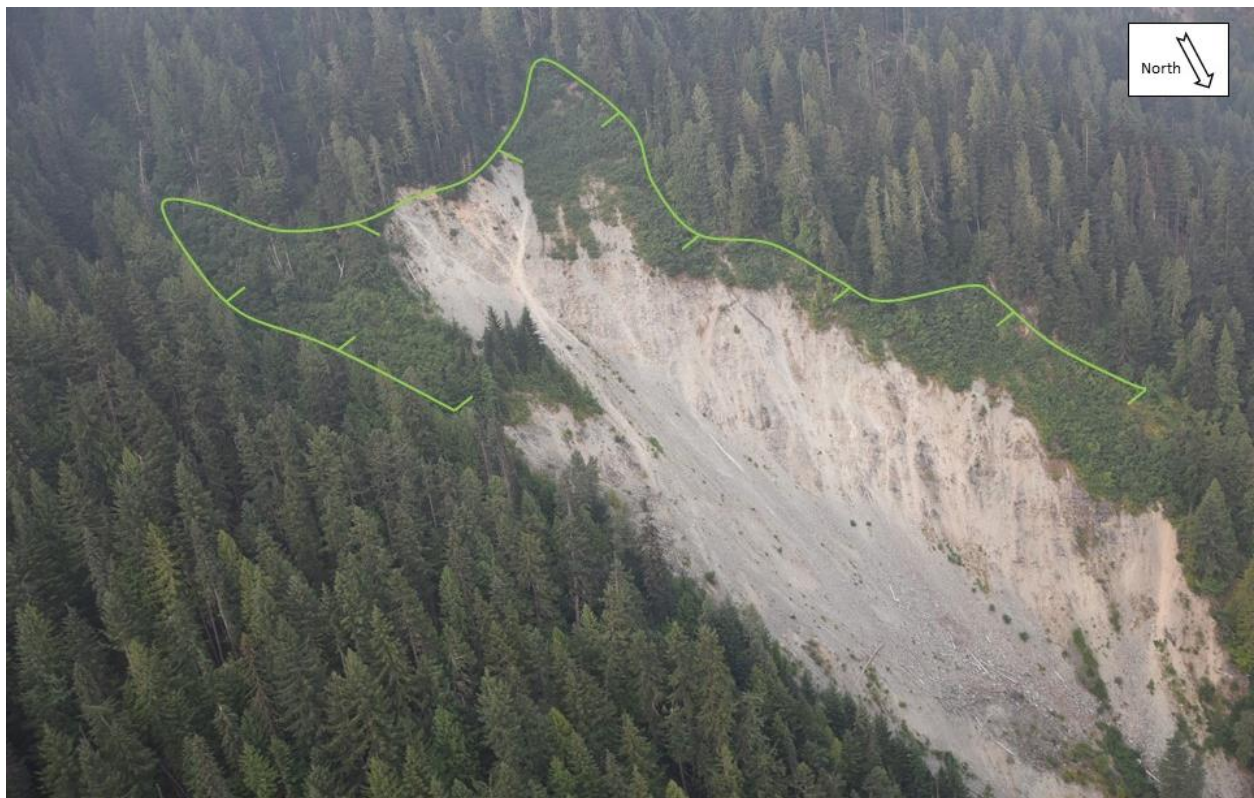
Photograph 42 Rock and debris slide showing re-vegetation of the scar of the event which occurred between 1948 and 1969. Possible retrogression of this landslide represents Source ID 5.

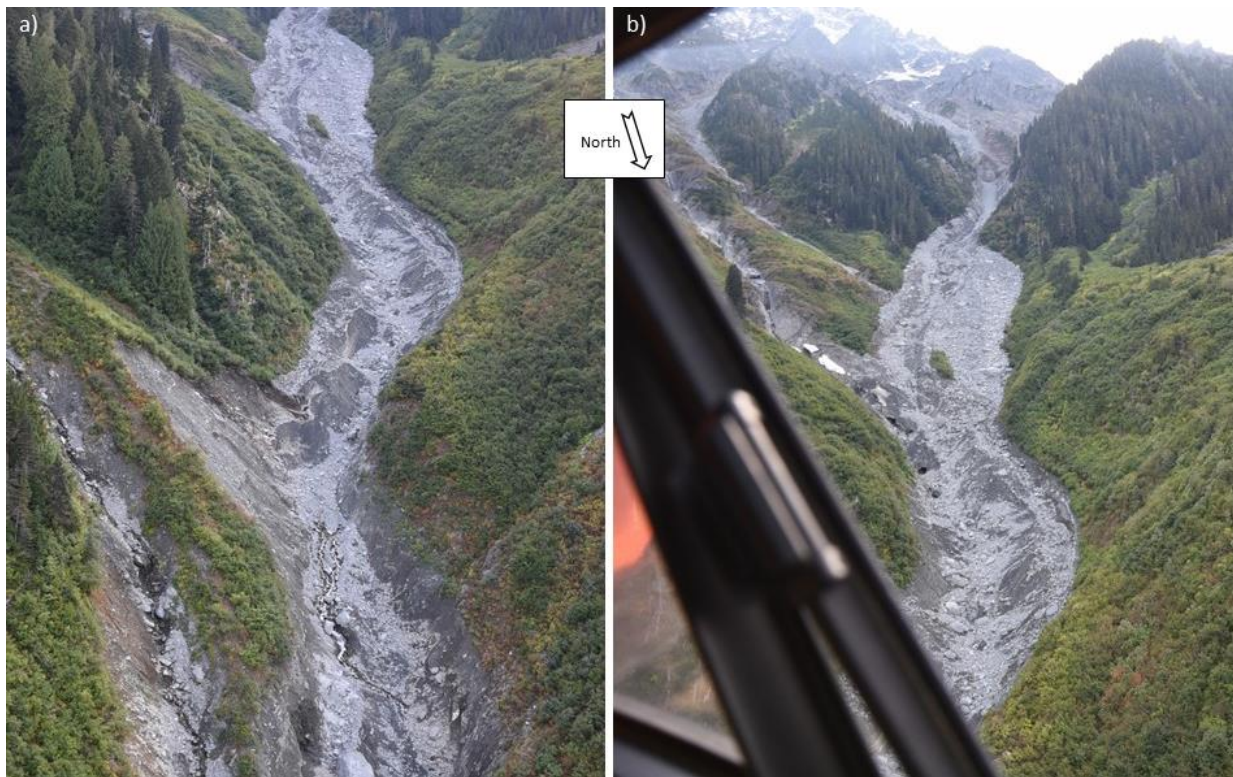
Photograph 43 Main debris flow path of Watershed B. Some remaining snow patches are visible in picture b.

Four main debris flow paths (along watersheds A, B, C and D on Drawing 04) were identified on the north face of Mount Currie. Deeply incised flow paths (Photographs 43 and 44) and fans (Drawing 01 and Photographs 45 to 48) are the main landforms associated with these processes. Active rock falls and rock / debris slides on the upper sections of the north face of Mount Currie provide the debris supply to the channels which can be subsequently remobilized as debris flows.

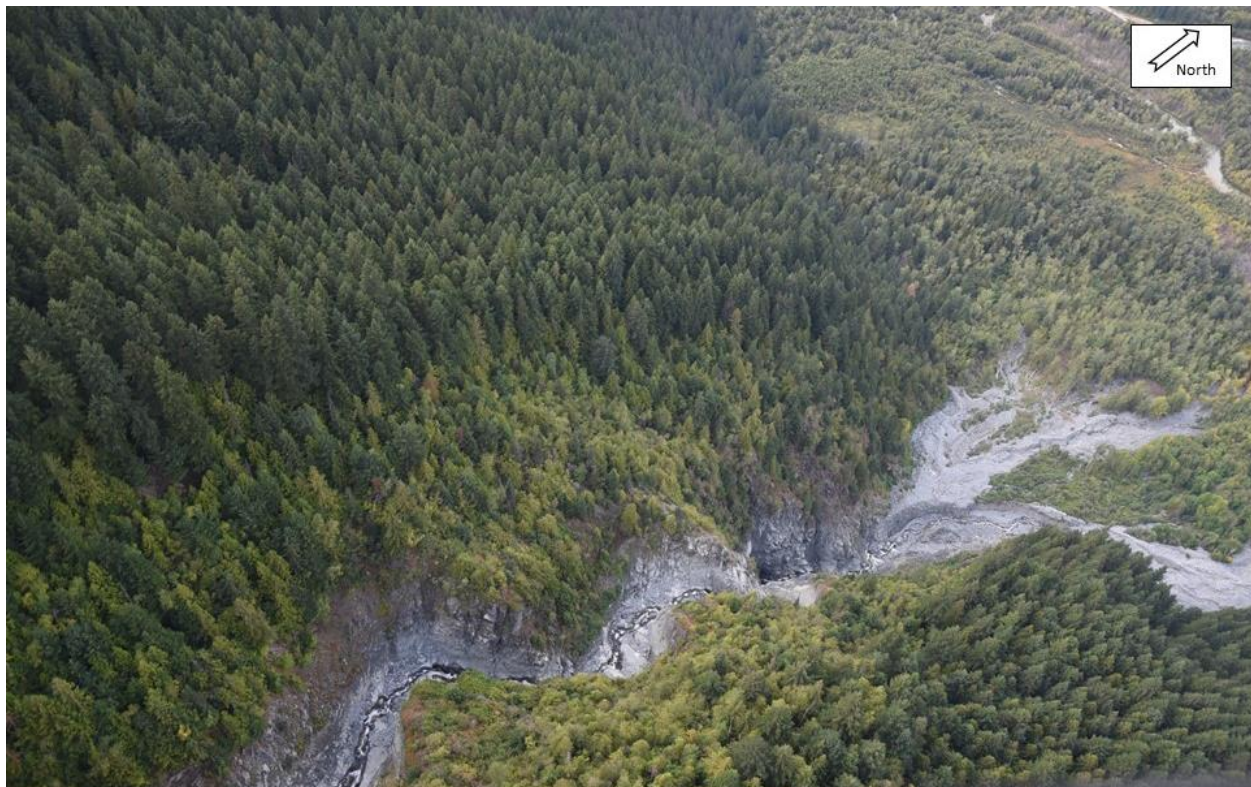
Photograph 44 Deeply incised gully on the lower part of the debris flow path of Watershed B.

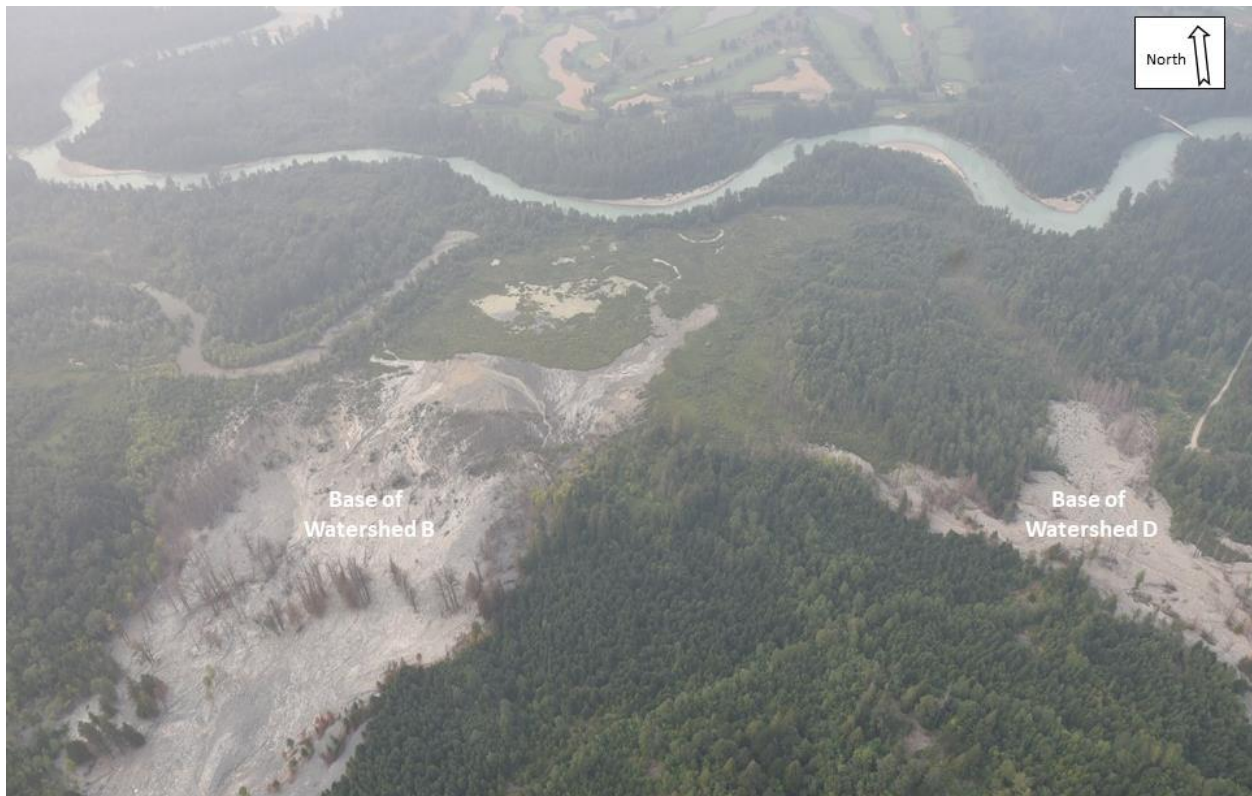
Photograph 45 View of the debris flow fans at the base of Watersheds B and D.

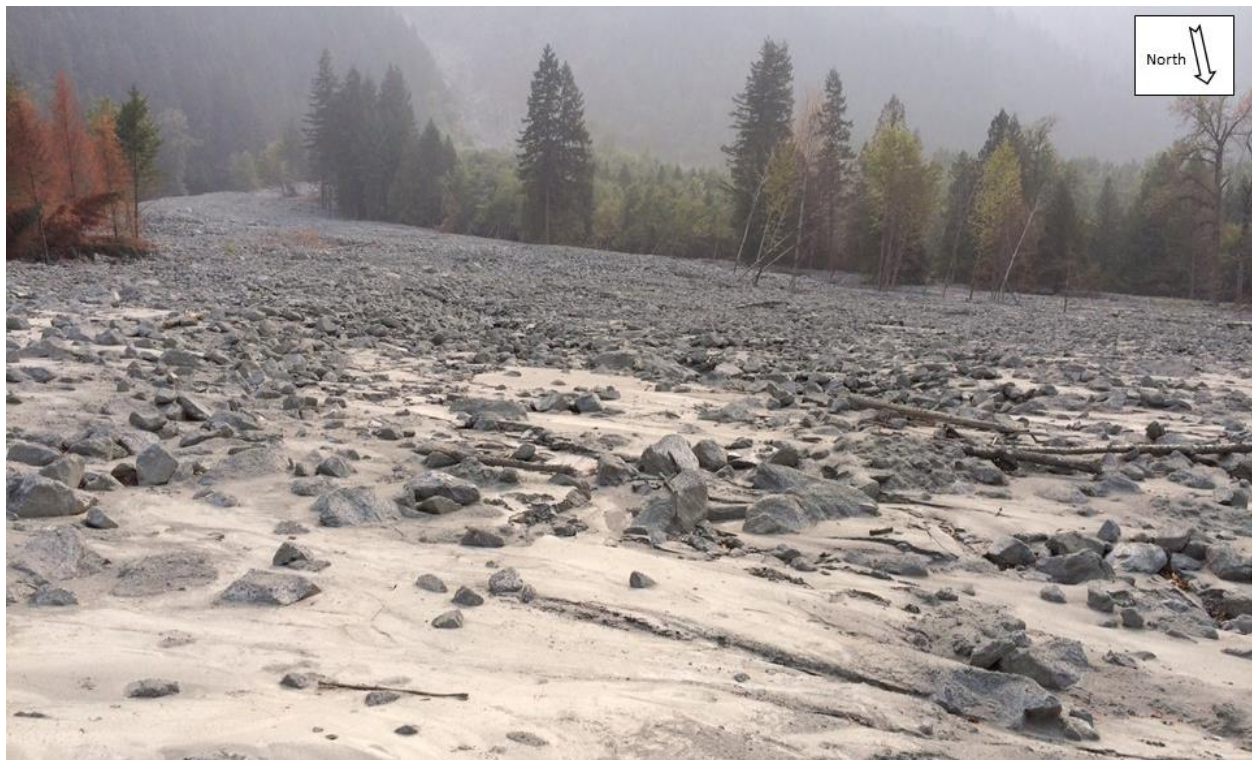
Photograph 46 Debris flow fan at the base of Watershed B.

Debris flow activity in the watershed that experienced the recent rock falls has increase as a response of the much higher sediment recruitment in the upper watershed. Now the debris flow deposits are extending well beyond its former limit into the Green River floodplain (Photographs 45 to 48).

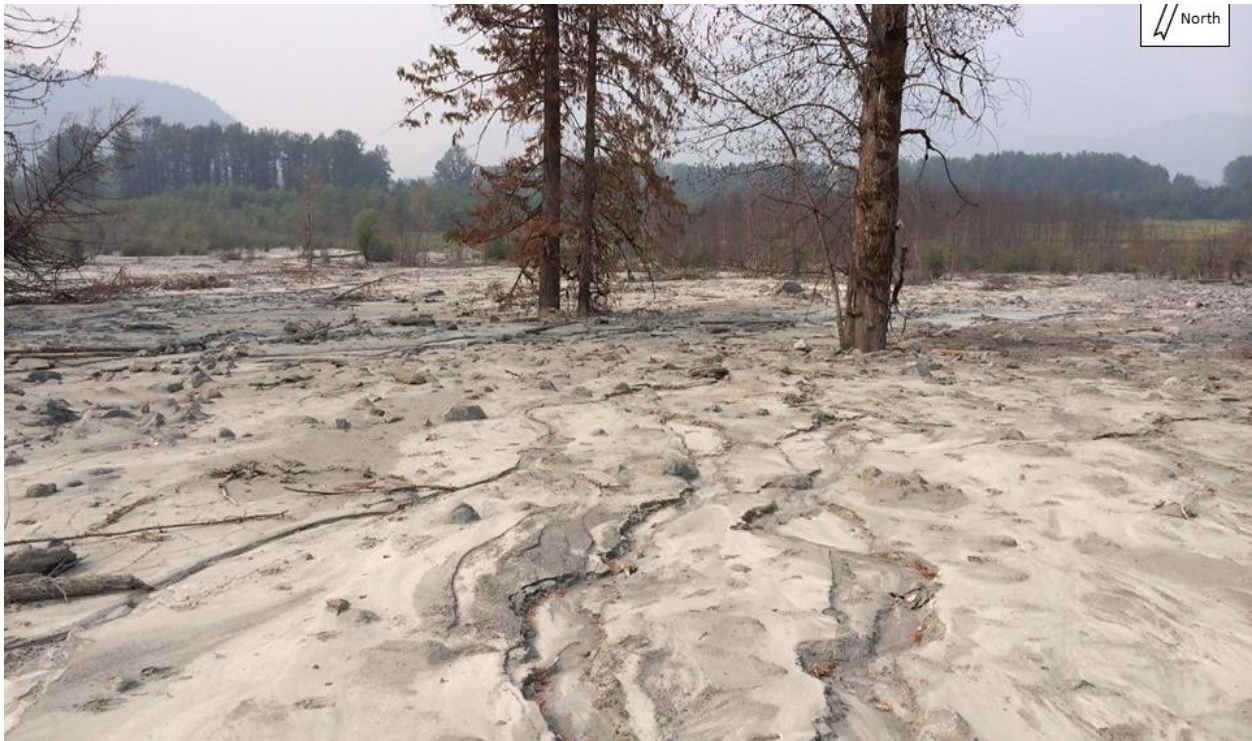
Photograph 47 Debris flow fan at the base of Watershed B.

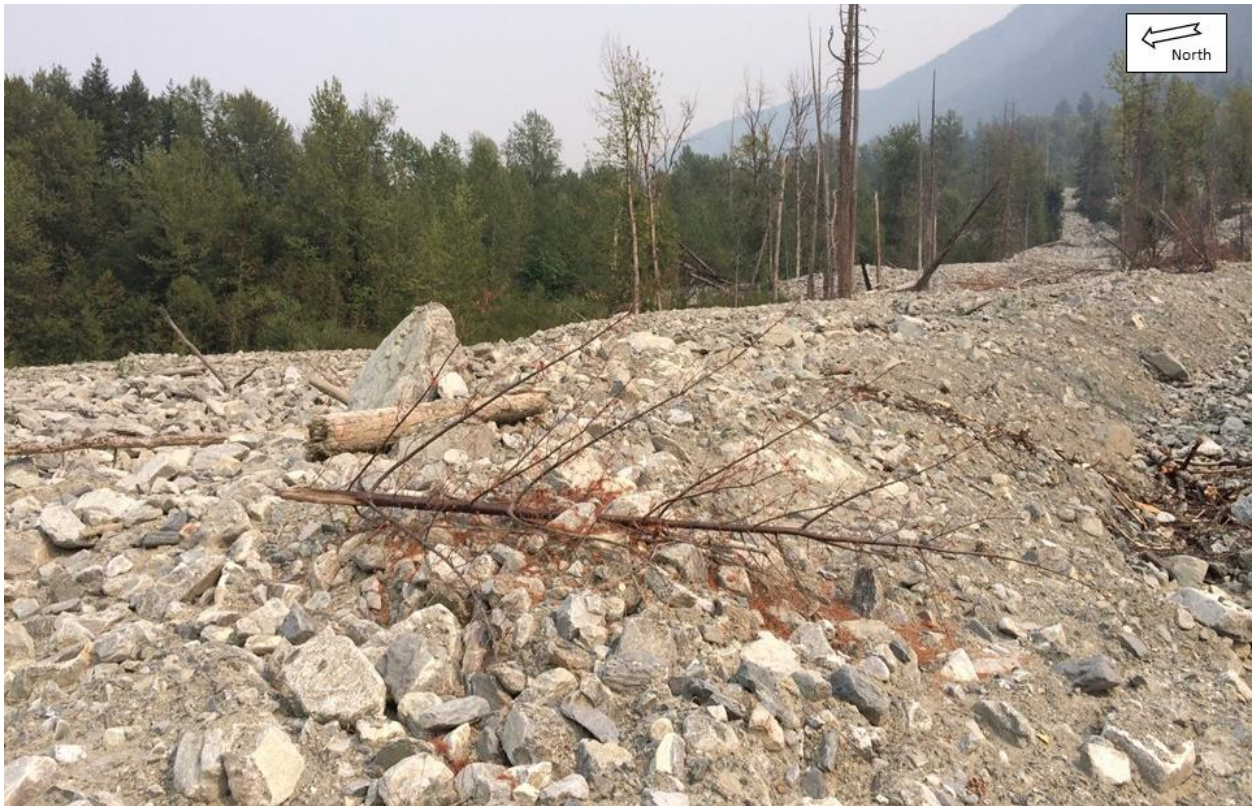
Photograph 48 Debris flow fan at the base of Watershed D.

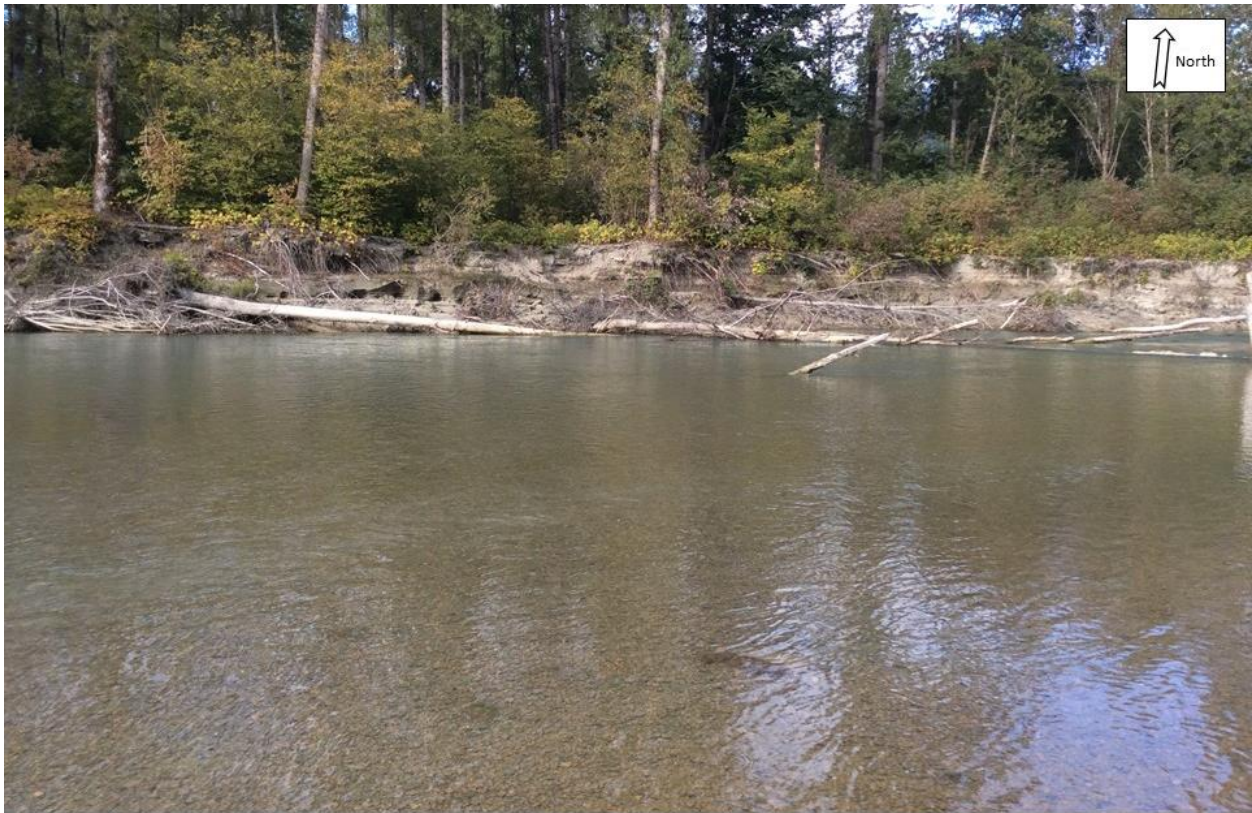
Photograph 49 Green River bank at the base of the north side of Mount Currie showing mostly fine-grained fluvial sediments, and no evidence of past rock avalanche debris.

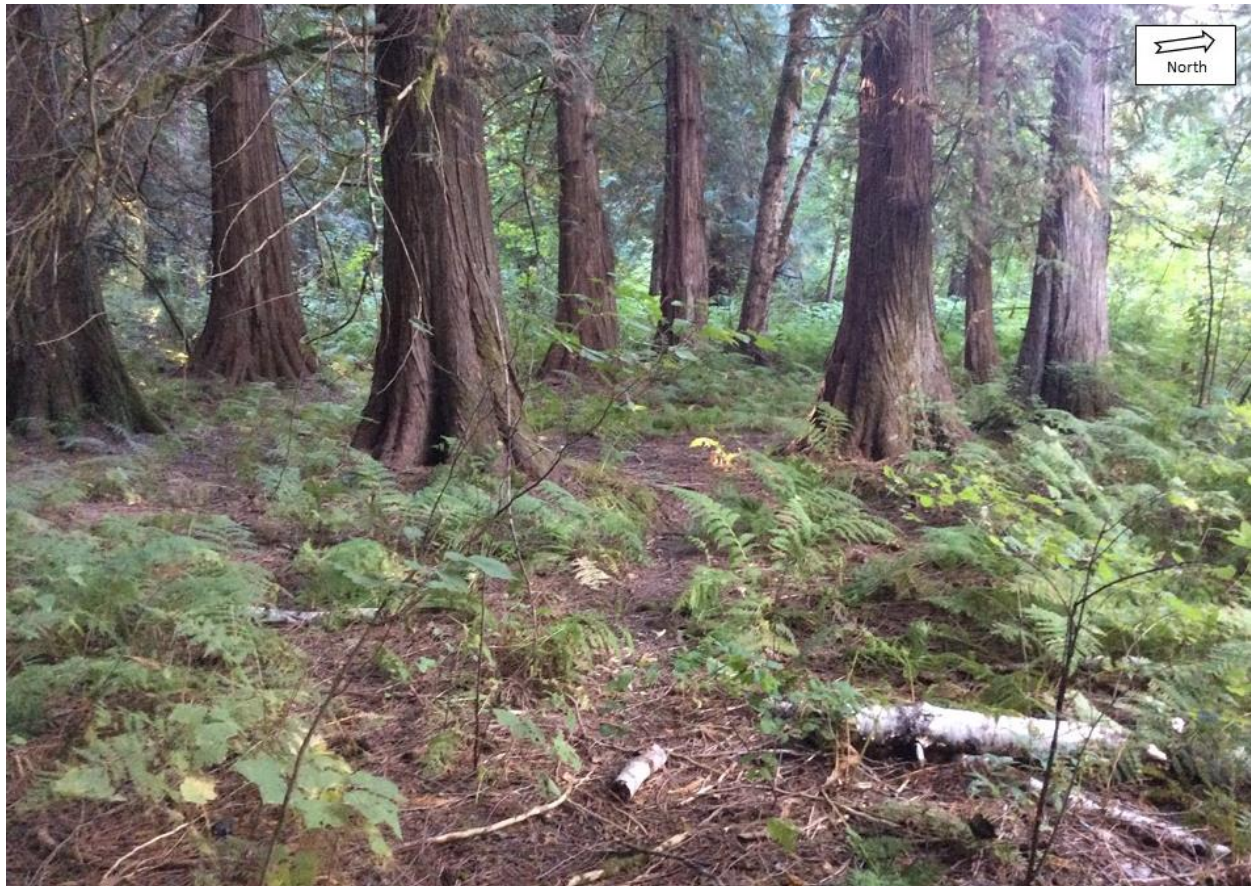
Photograph 50 Old growth forest on the north side of Highway 99 showing no evidence of past rock avalanche debris.

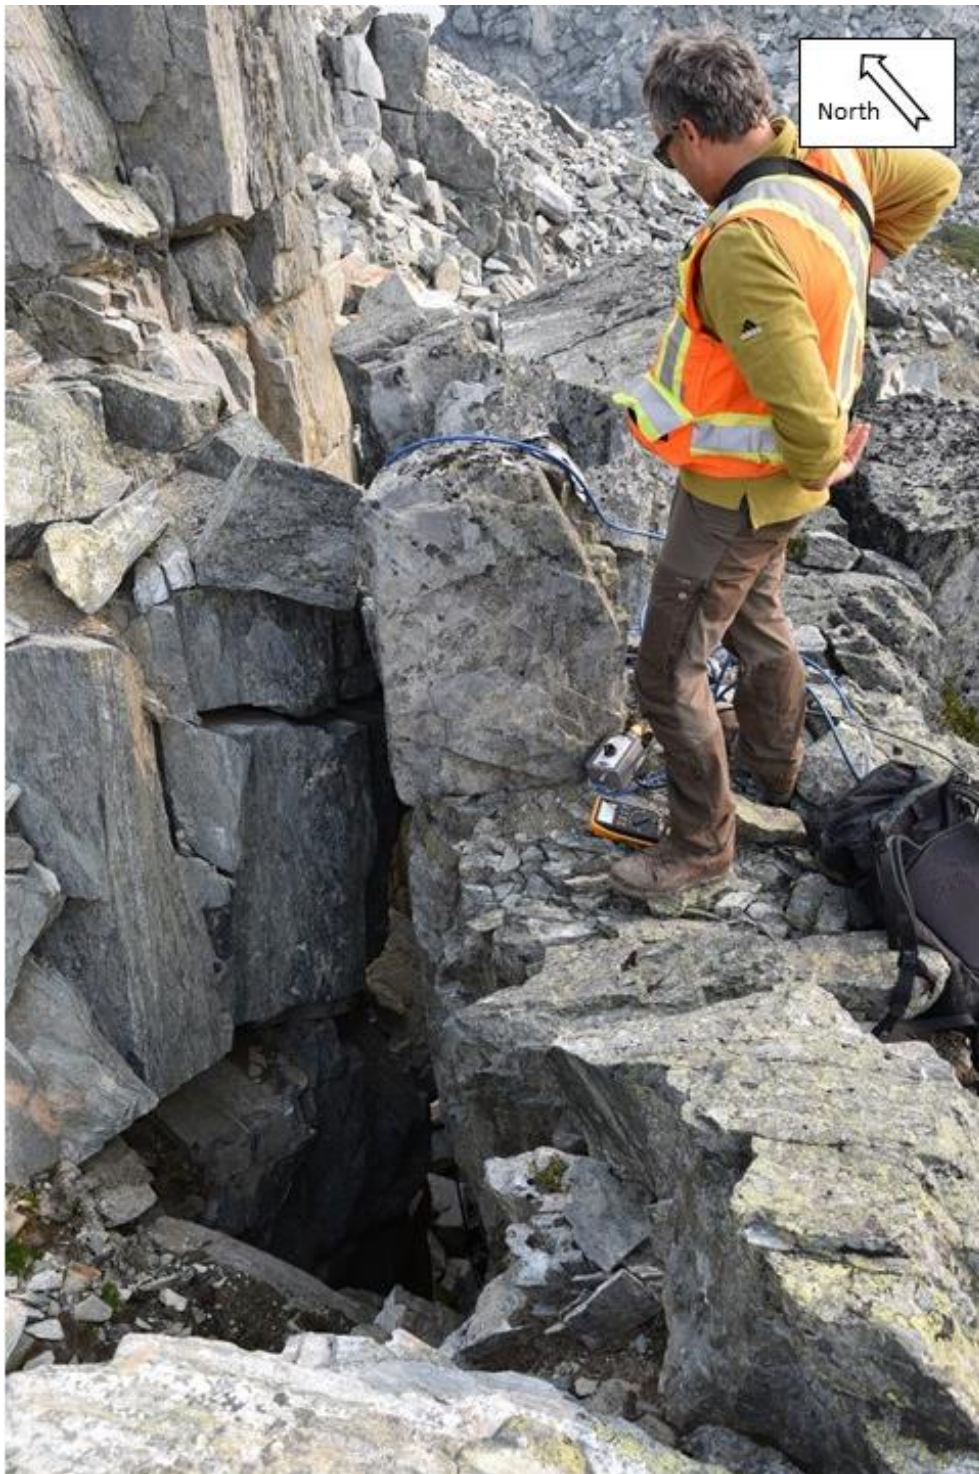
Photograph 51 Crack at Station 17-01 where the thermistor was used to generate a temperature profile.

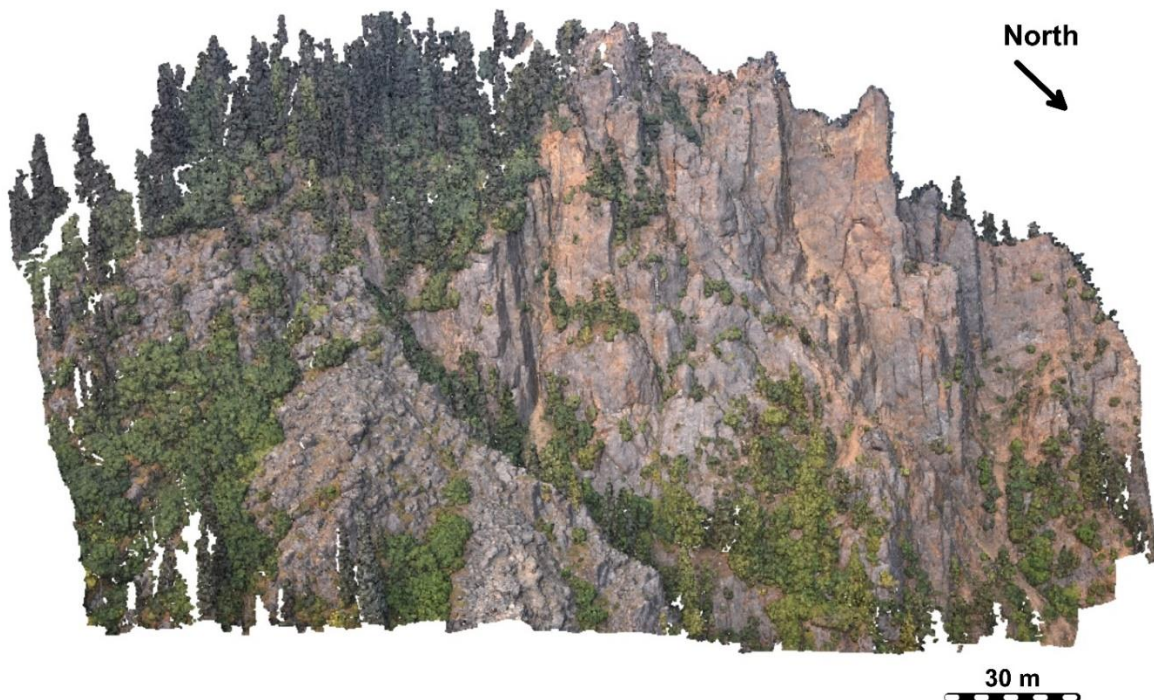
Figure B-1 3D model of a rock slope on the north face of Mount Currie

In this project, 3D models were generated with the software PhotoScan (Agisoft, 2017). PhotoScan uses Structure-from-Motion photogrammetry to build 3D models on a large number of photographs of a scene/object taken from many viewpoints. This technique allows calculation of camera positions and orientations, together with the location of object points in 3D space. Figure B-1 shows an example of dense point cloud generated using helicopter-based photographs on Mount Currie.

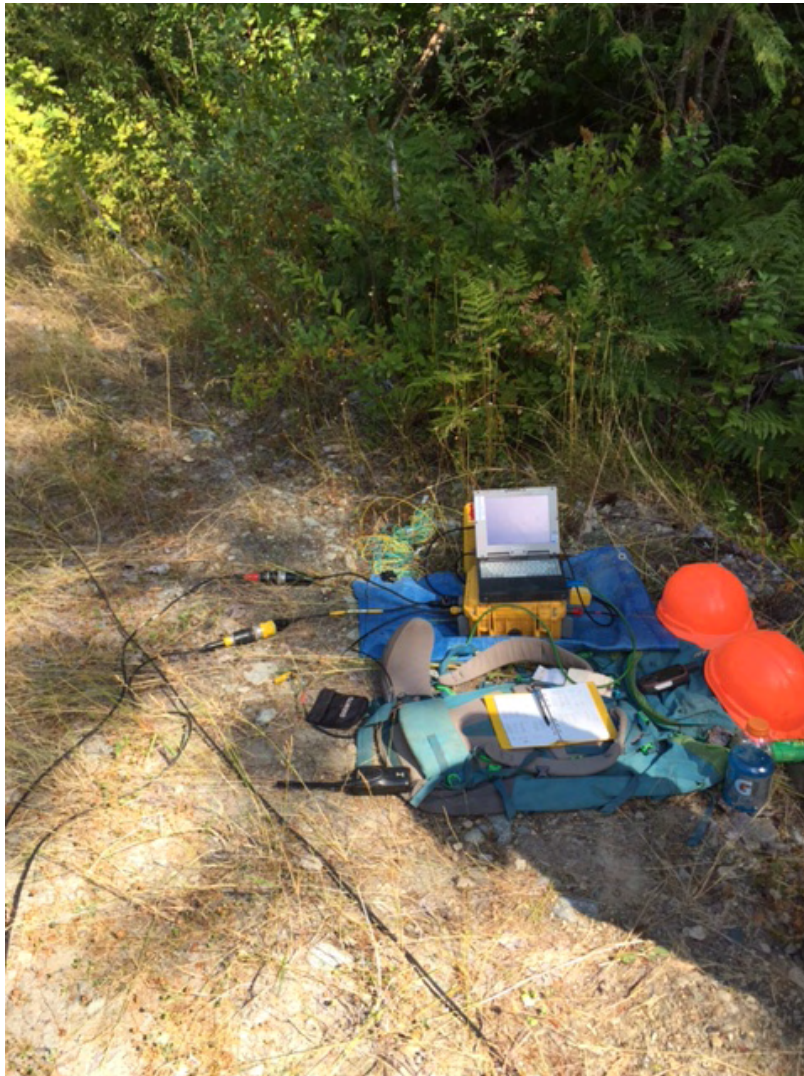
Seismograph setup

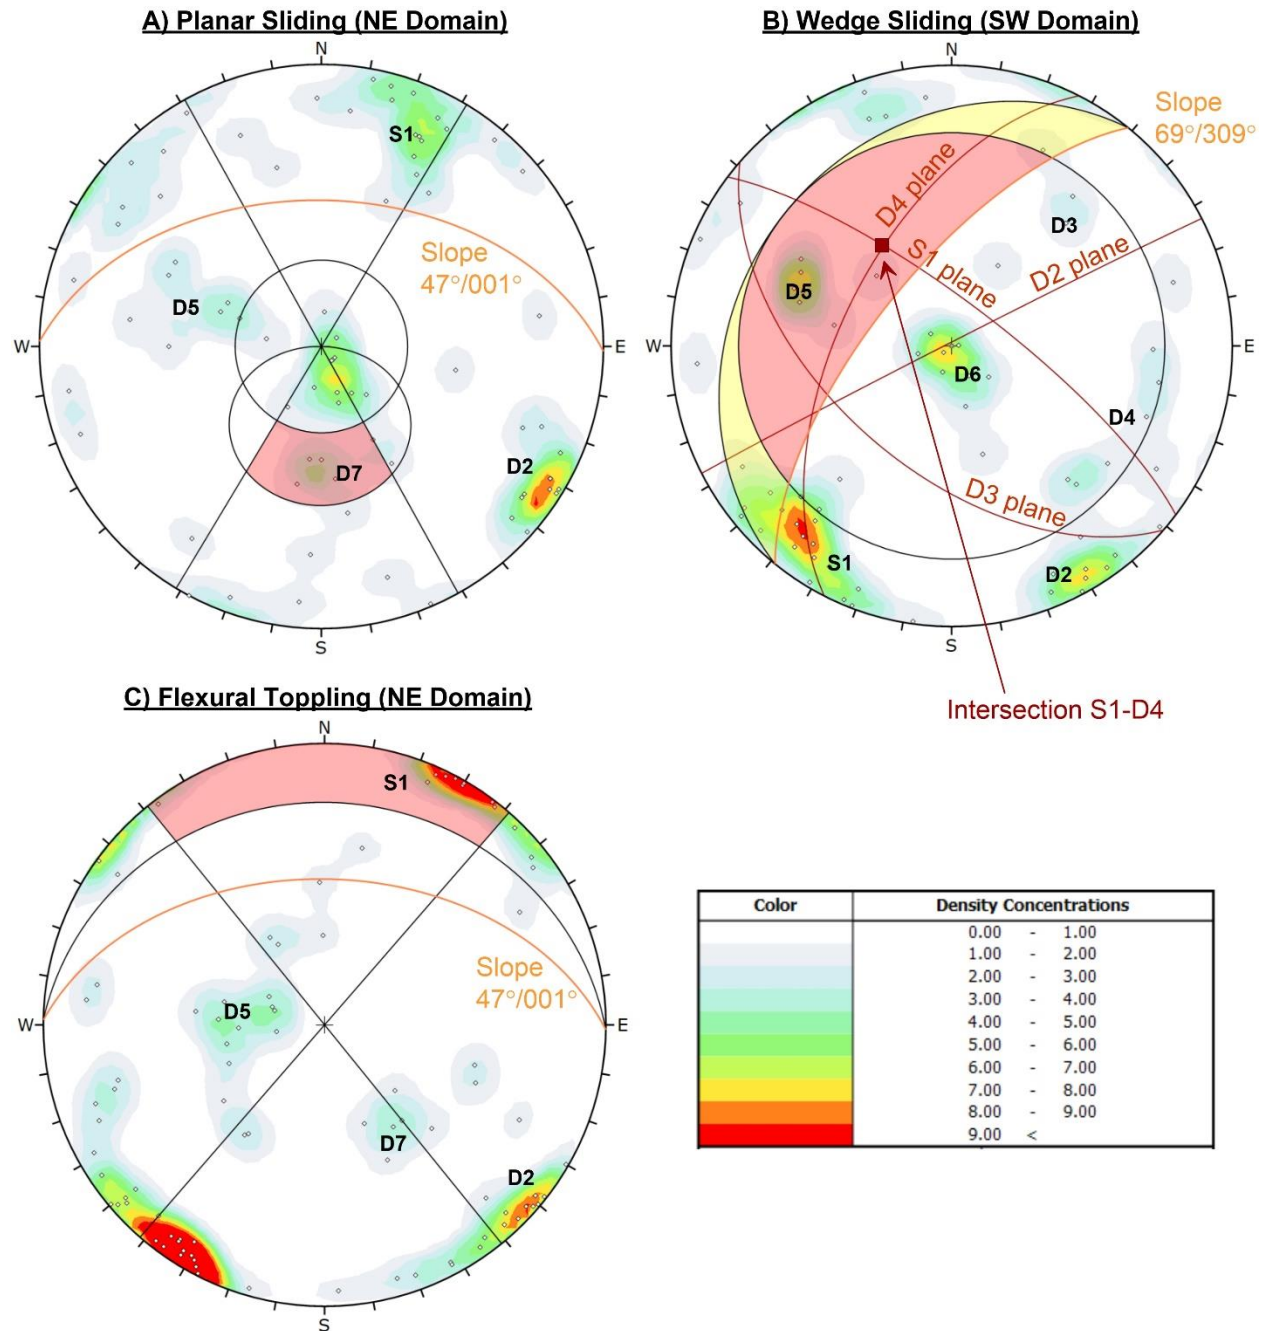
Figure D-2 Example of kinematic analysis for (a) planar sliding, (b) wedge sliding, and (c) flexural toppling. The stereonet shows lower hemisphere equal area projections, and the contours are percentage of total pole measurements per 1% area.

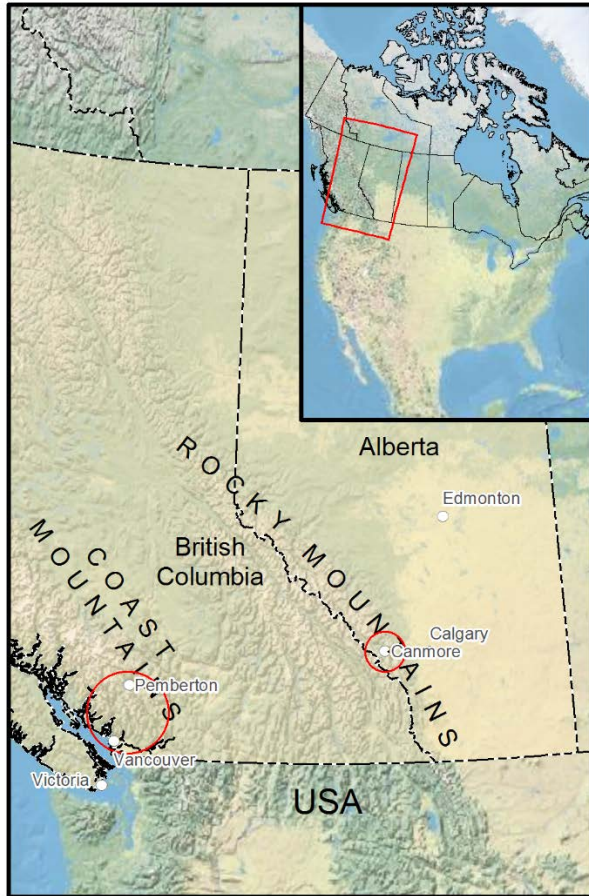
Figure 1. The left-hand circle pertains to the debris-flow study areas in southwestern British Columbia, and the right hand circle pertains to the debris-flood study area in southwestern Alberta.

Two study areas are considered in this paper, as shown in Figure 1. One area is located in southwestern B.C.'s Coast Mountains, and the other is located in the eastern Rocky Mountains of Alberta, centred around the Town of Canmore and the Hamlet of Exshaw.
