SQUAMISH-LILLOOET REGIONAL DISTRICT

MOUNT CURRIE LANDSLIDE RISK ASSESSMENT

PROJECT NO.: 1358004

DATE: January 16, 2018

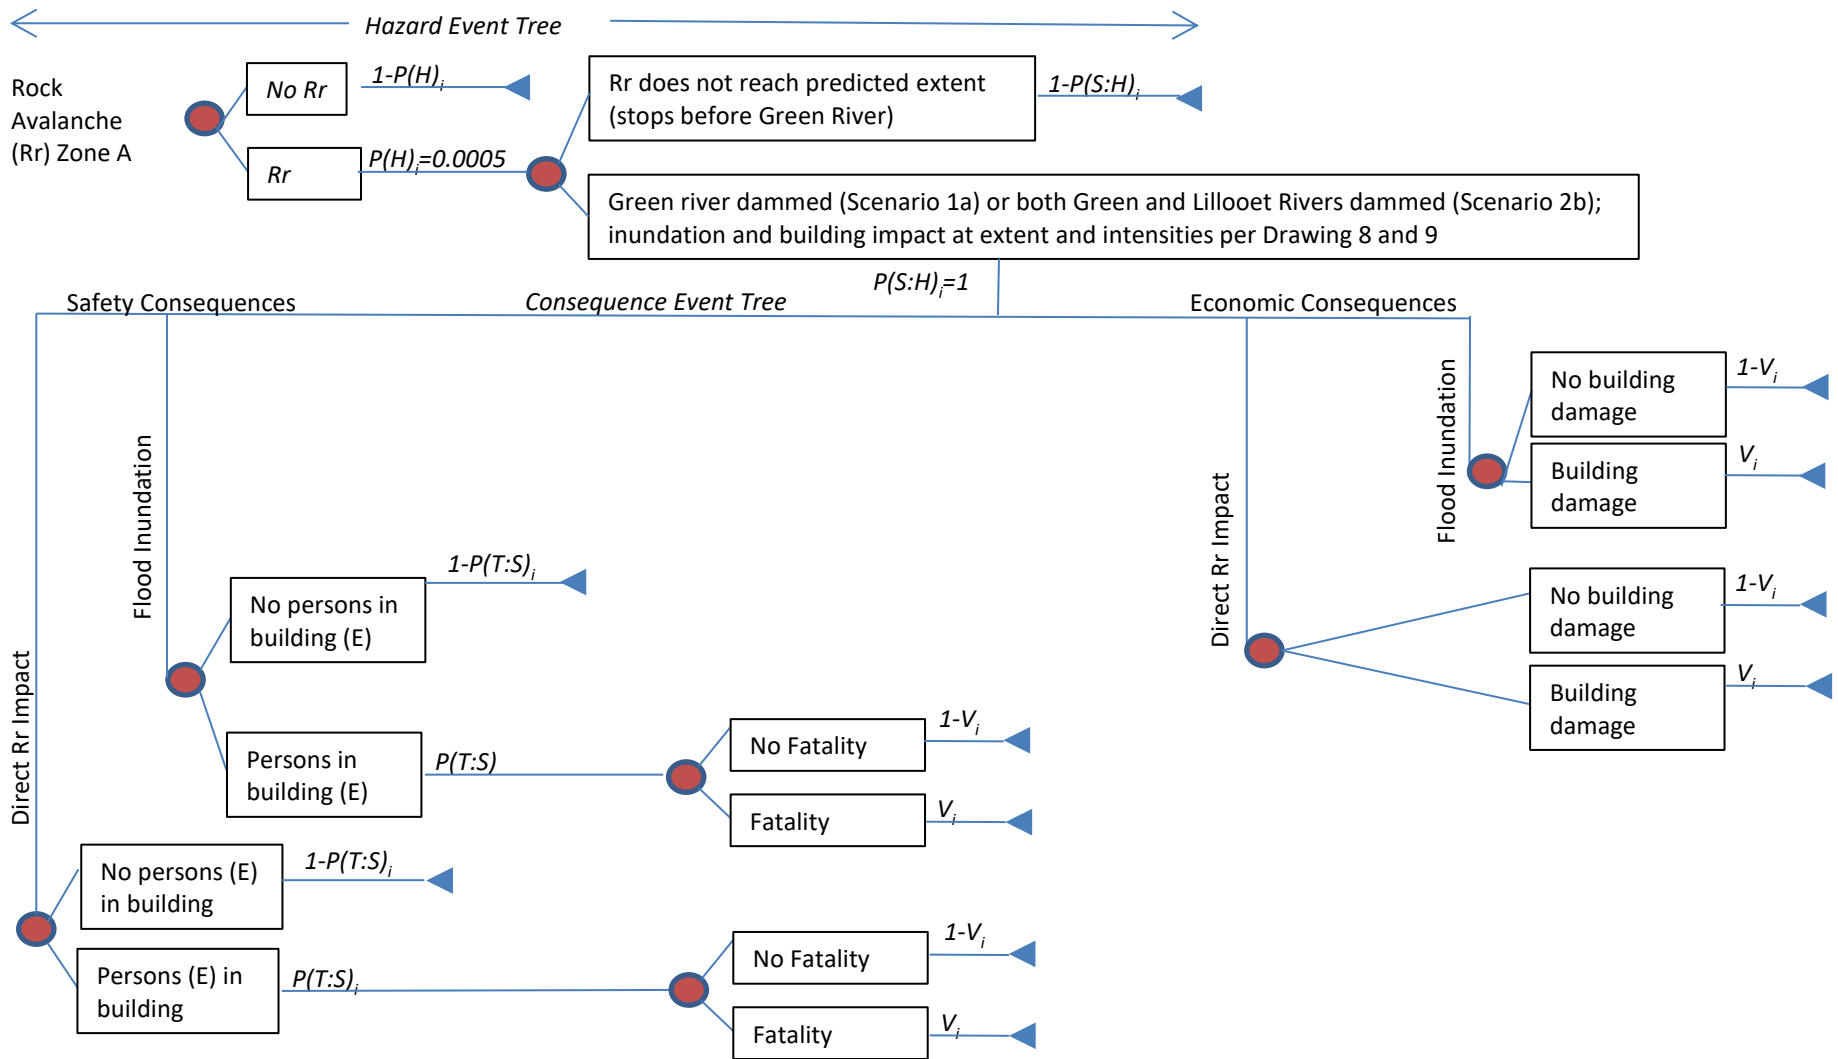
Figure H-1. Geohazard Event Tree, Scenarios 1a and 2b.
