Reference No. VAN-00217089

**Re: Pemberton Recreation Complex
Preliminary Geotechnical Review**

1.0 INTRODUCTION

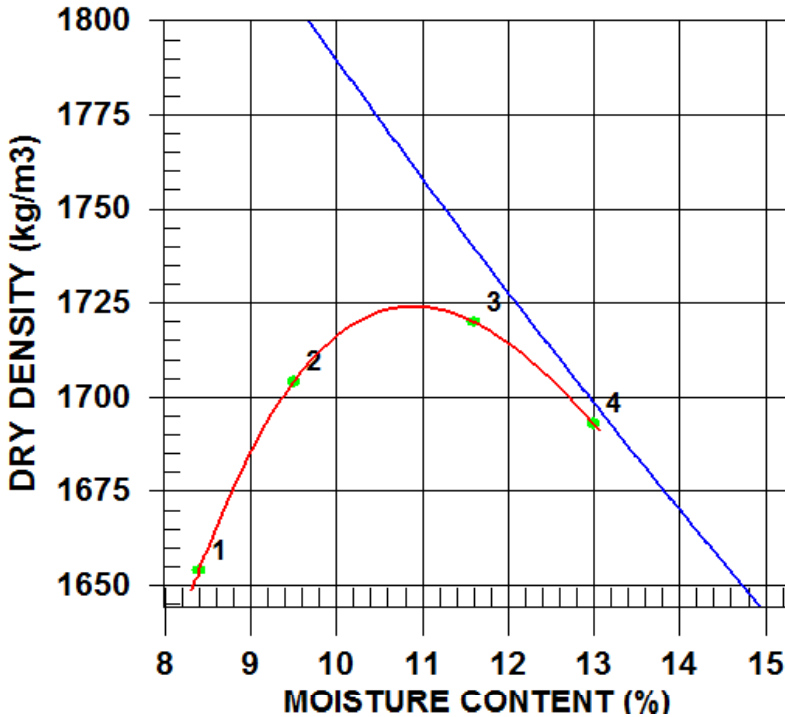
COMPACTION STANDARD Modified Proctor,
ASTM D1557
COMPACTION PROCEDURE C: 152.4mm Mold,
Passing 19mm
RAMMER TYPE Manual
PREPARATION Moist
OVERSIZE CORRECTION METHOD ASTM 4718
RETAINED 19mm SCREEN 27.0 %
OVERSIZE SPECIFIC GRAVITY 2.14
