**RE: Preliminary Geotechnical Report, Proposed Mixed-Use Development,
Lot 2 Harrow Road, Pemberton, BC**

Geotechnical Investigation Plan
 Proposed Mixed-Use Development
 Lot 2 Harrow Road, Pemberton, BC

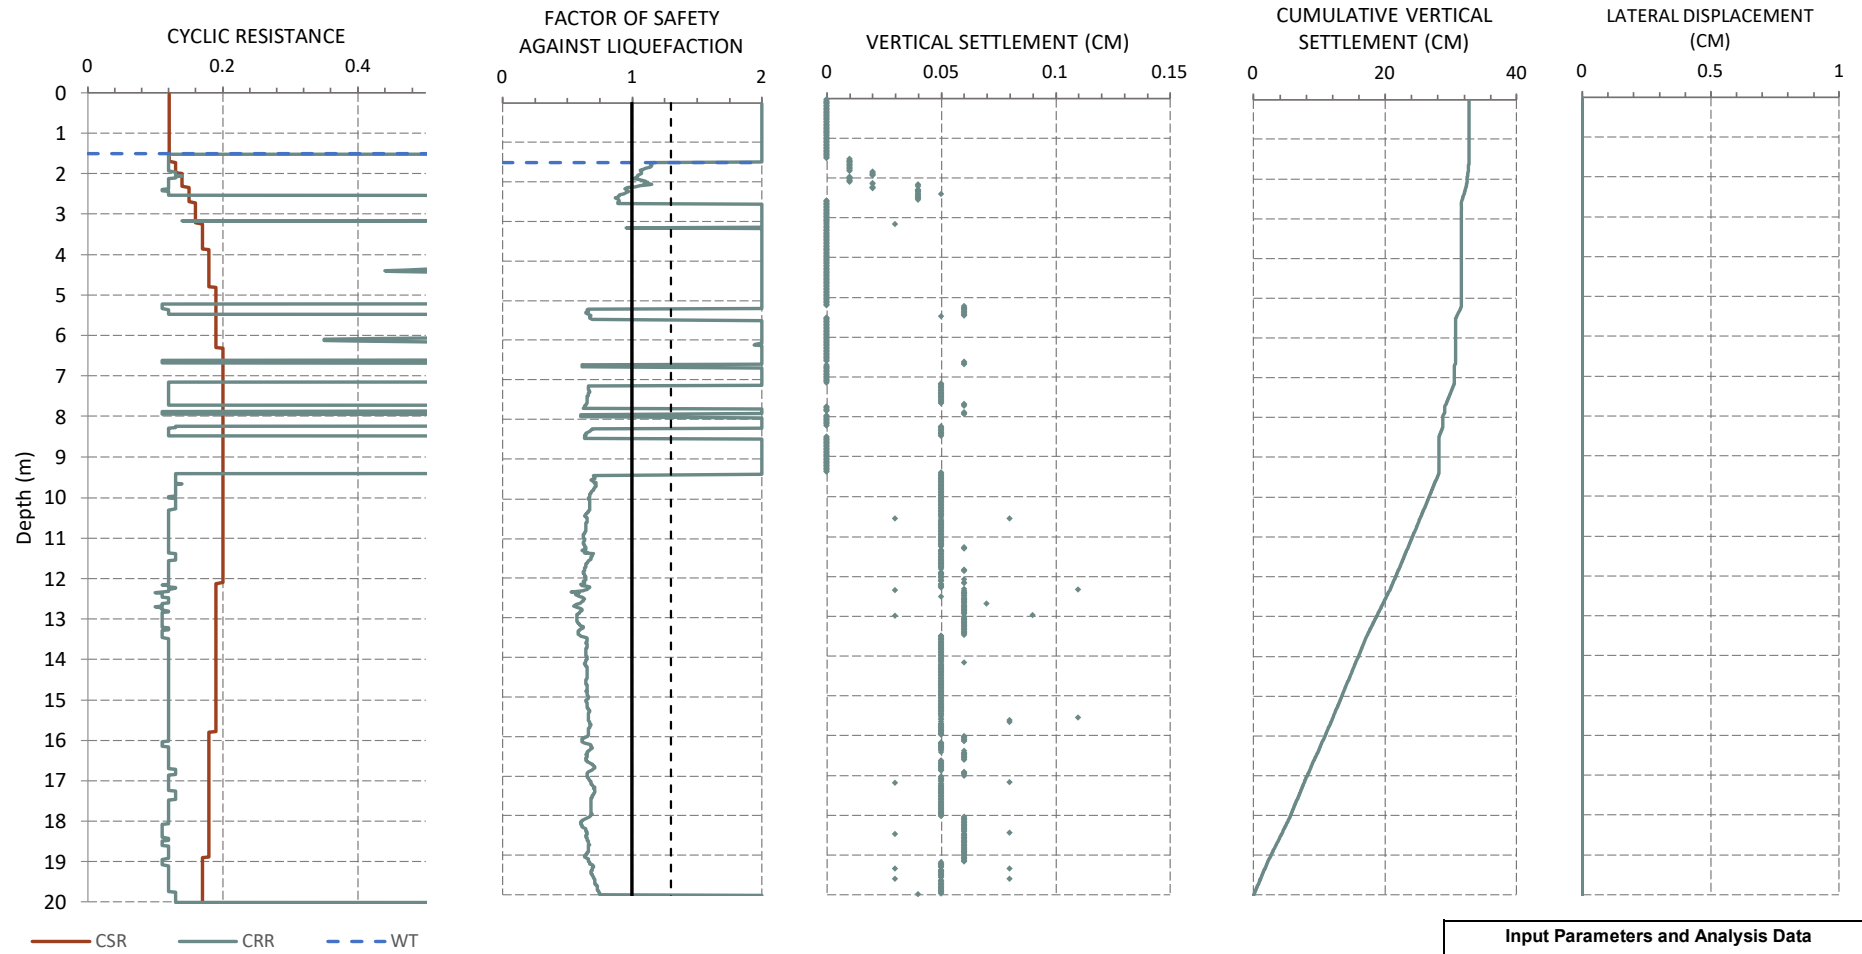
Client: Sea to Sky Community Services Society
Job No. 1706
Location: Lot 2 Harrow Road, Pemberton, BC
Date: October 22, 2021
CPT Trace: CPT21-01

APPENDIX C.1
1 IN 2,475 YEAR SEISMIC HAZARD CPT BASED
LIQUEFACTION ANALYSIS

Analysis Method:	B&I 2014
Fines Correction Method:	B&I 2014
Earthquake Magnitude:	7
Peak Ground Acceleration:	0.18
Seismic Hazard:	1 in 2,475
I_c cut-off value:	2.6
Transitional Layer Detection:	ON
Limit Depth:	20.00 m
Water Table (m, below grade):	1.5

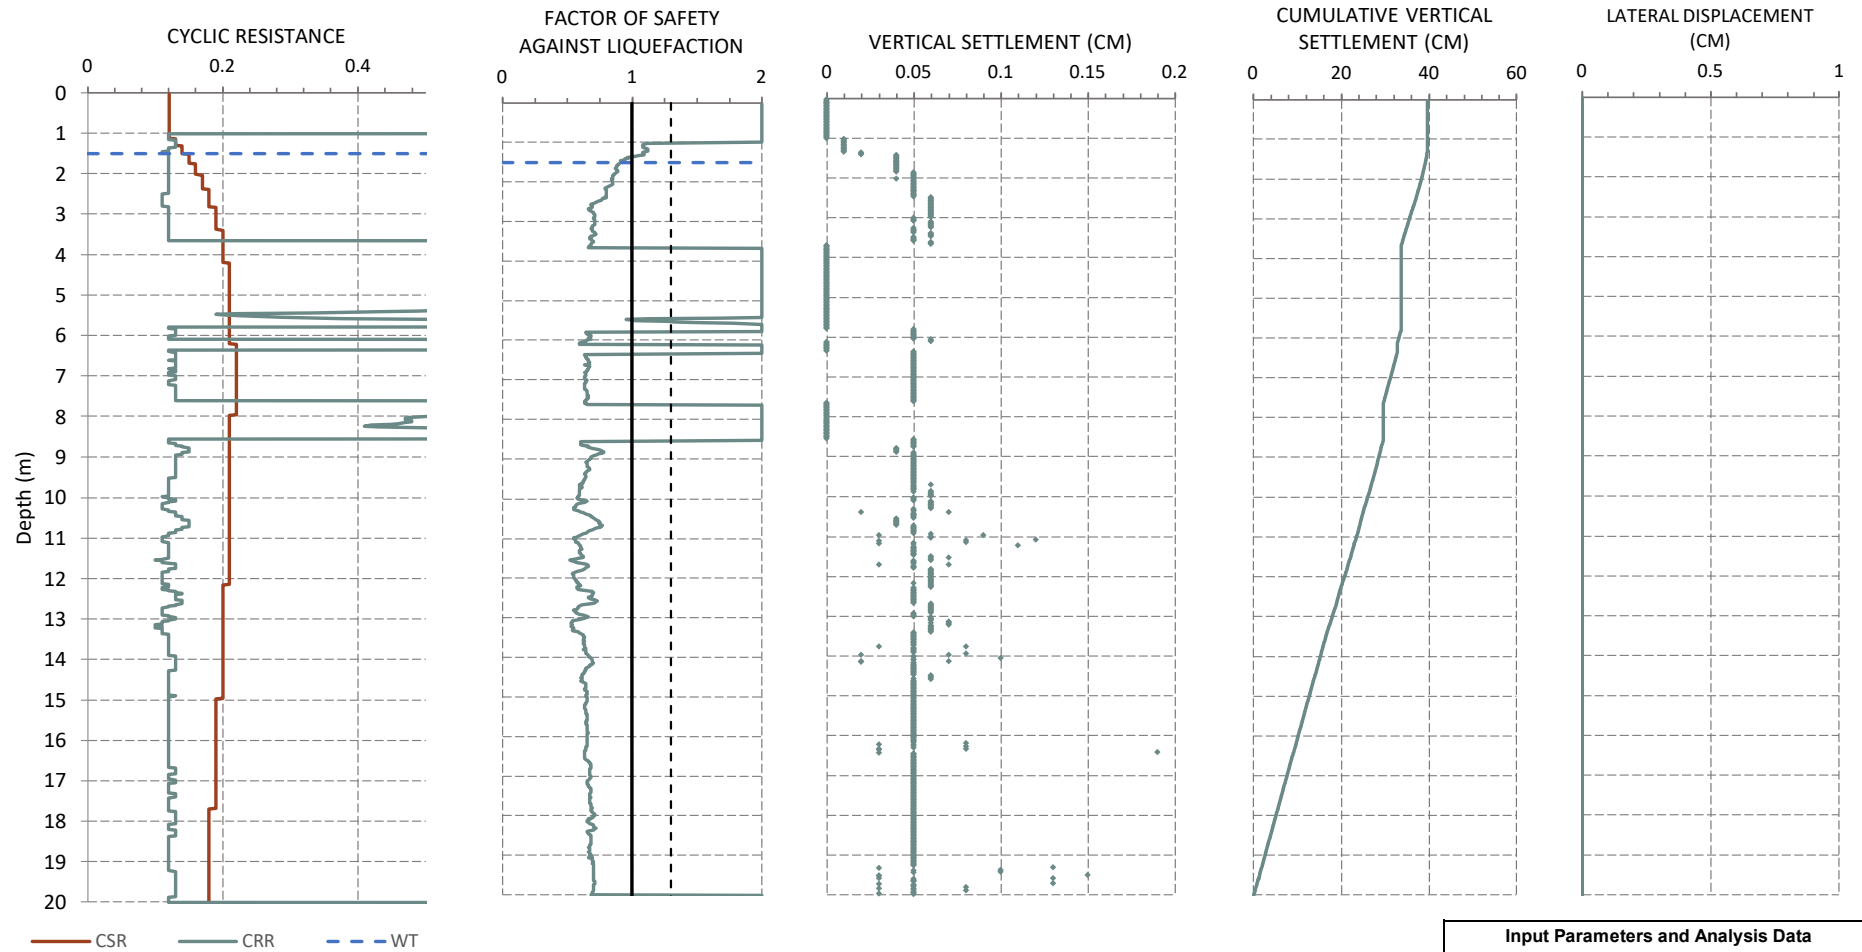
Client: Sea to Sky Community Services Society
Job No. 1706
Location: Lot 2 Harrow Road, Pemberton, BC
Date: October 22, 2021
CPT Trace: **CPT21-02**

Analysis Method:	B&I 2014
Fines Correction Method:	B&I 2014
Earthquake Magnitude:	7
Peak Ground Acceleration:	0.18
Seismic Hazard:	1 in 2,475
I_c cut-off value:	2.6
Transitional Layer Detection:	ON
Limit Depth:	20.00 m
Water Table (m, below grade):	1.5

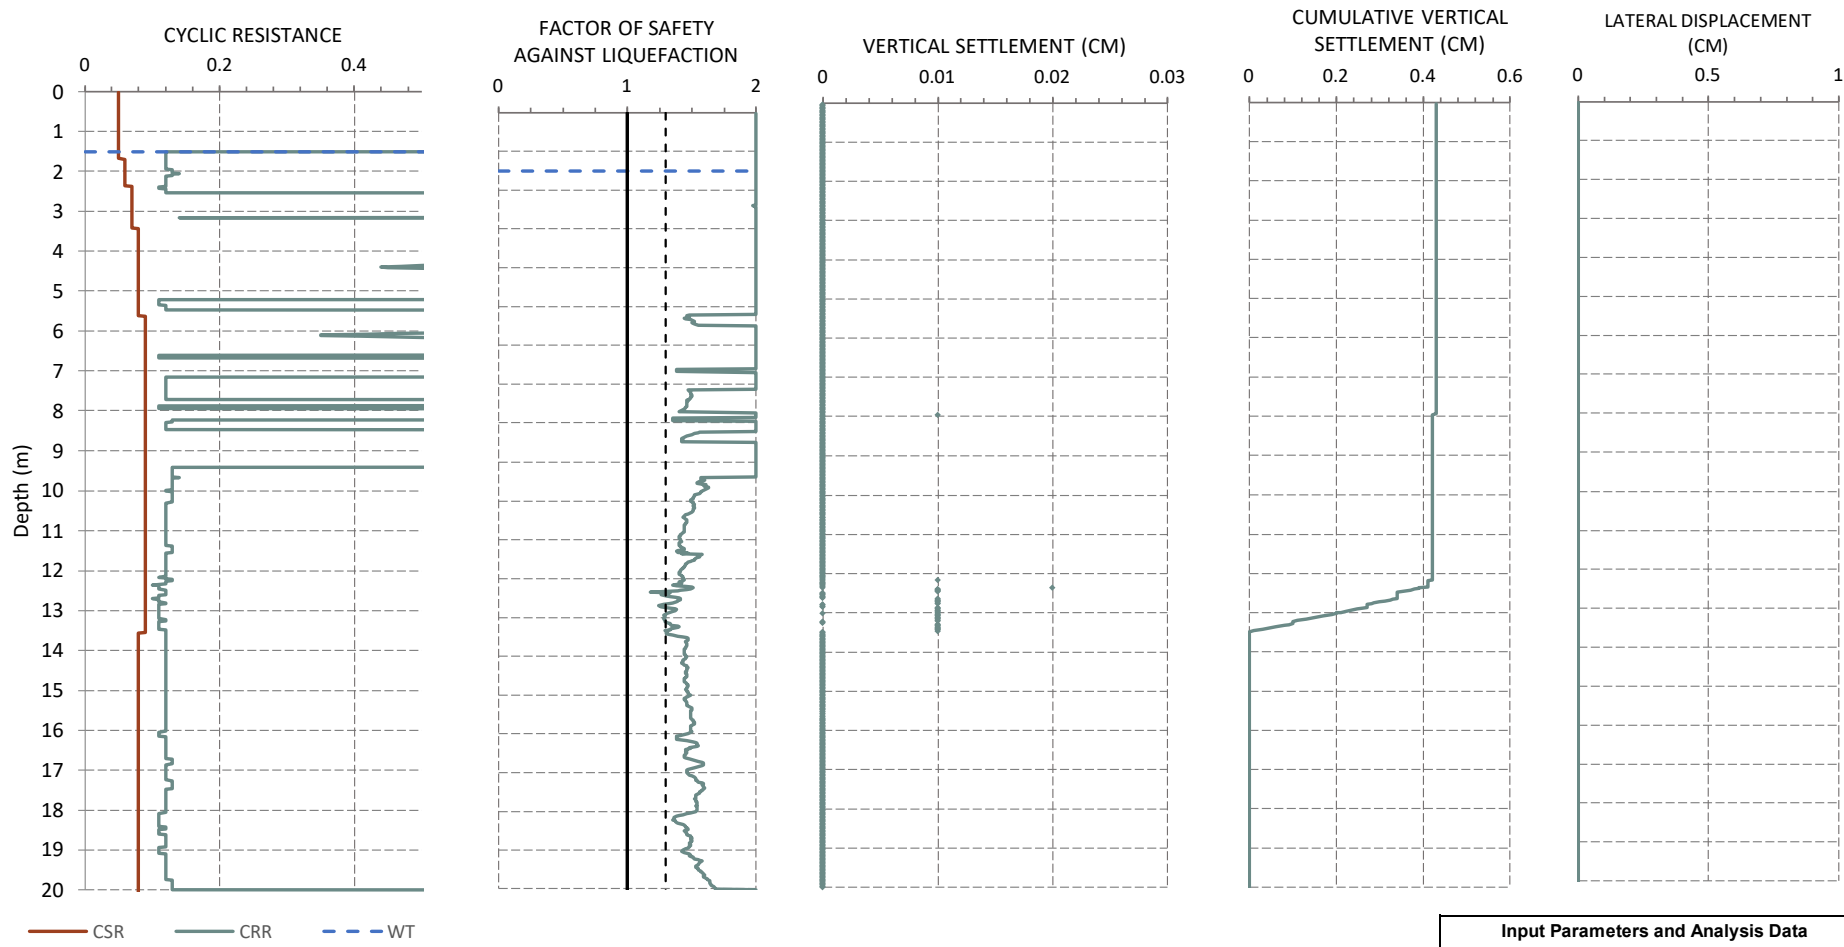
Client: Sea to Sky Community Services Society
Job No. 1706
Location: Lot 2 Harrow Road, Pemberton, BC
Date: October 22, 2021
CPT Trace: CPT21-01

APPENDIX C.2
1 IN 475 YEAR SEISMIC HAZARD CPT BASED
LIQUEFACTION ANALYSIS

Input Parameters and Analysis Data	
Analysis Method:	B&I 2014
Fines Correction Method:	B&I 2014
Earthquake Magnitude:	7
Peak Ground Acceleration:	0.08
Seismic Hazard:	1 in 475
I_c cut-off value:	2.6
Transitional Layer Detection:	ON
Limit Depth:	20.00 m
Water Table (m, below grade):	1.5
